Region 9 Enforcement and Compliance Assurance Division
INSPECTION REPORT

Inspection Date:	December 17, 2024	Inspection Announced: Yes	
Media:	Safe Drinking Water Act		
Regulatory Program(s)	Public Water System Supervision		
Facility or Site Name:	Havasu Water Company		
Facility/Site Physical Location:	148896 Havasu Lake Road		
(city, state, zip code)	Needles, CA 92363		
Mailing Address:	P.O. Box 1690		
(city, state, zip code)	Havasu Lake, CA 29363		
County:	San Bernardino		
Facility/Site Contact:	Jennifer Hodges	President	
	havasuwat@outlook.com		
Facility/Site Identifier:	PWS I.D. 090600202		
EPA Inspectors:			
Christopher Chen (author)	Signature: CHRISTOPHER CHEN Digitally signed by CHRISTOPHER CHEN Date: 2025.02.06 09:07:00 -08'00'		
	ECAD-3-3	Inspector	(213) 244-1853
David Parker	NEIC	Inspector	(303) 462-9012
Supervisor Review:			
Lawrence Torres	Signature:		
	ECAD-3-3	Manager	(415) 947-4211

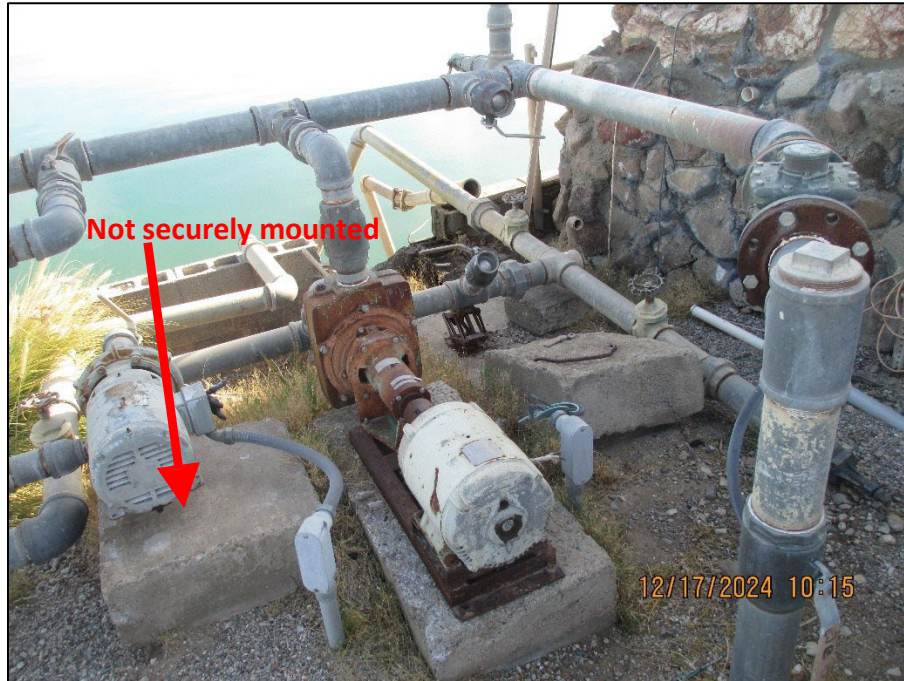
6. The surface water intake only had one functional pump.
7. The intake pump, its piping, and the retaining wall did not have supports to ensure structural integrity.

Photograph 1. The surface water intake had one functional pump. This pump was not securely mounted below.

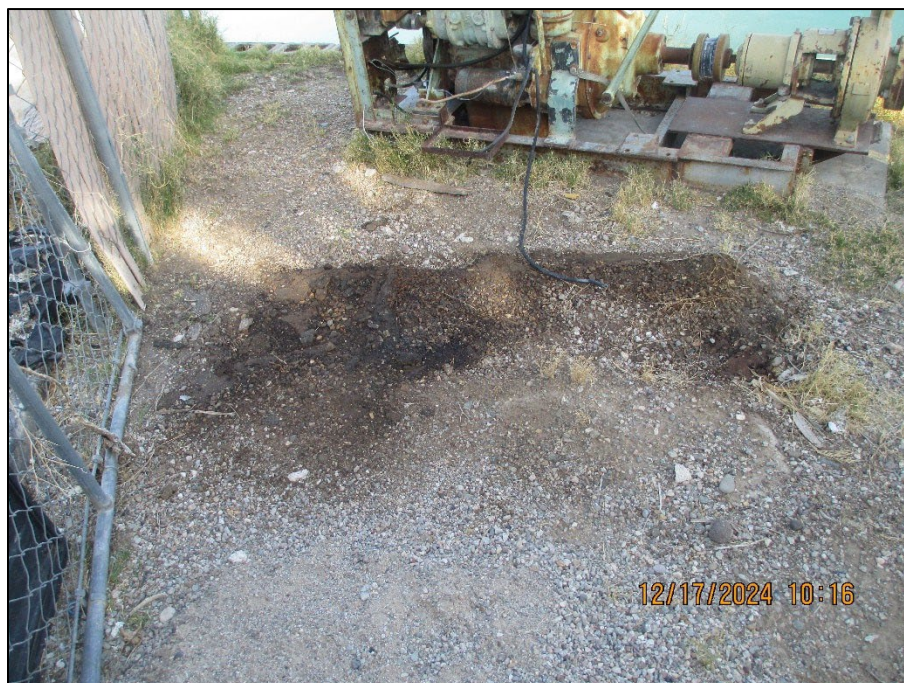
No flow meter was available for the untreated raw water. The old diesel tank located onsite was removed, although some contaminated soil remained. Hoban stated that they intend to remove the remaining contaminated soil soon.

8. While the intake location's diesel tank was removed, contaminated soil remained near Lake Havasu's shore.
9. The storage tank's second overflow screen at the inlet line was higher than the recommended 12-24 inches above the surface and did not have drainage away from the foundation of the storage tank.

Photograph 2. The leaking diesel tank near Lake Havasu's shore was removed but contaminated soil remained.

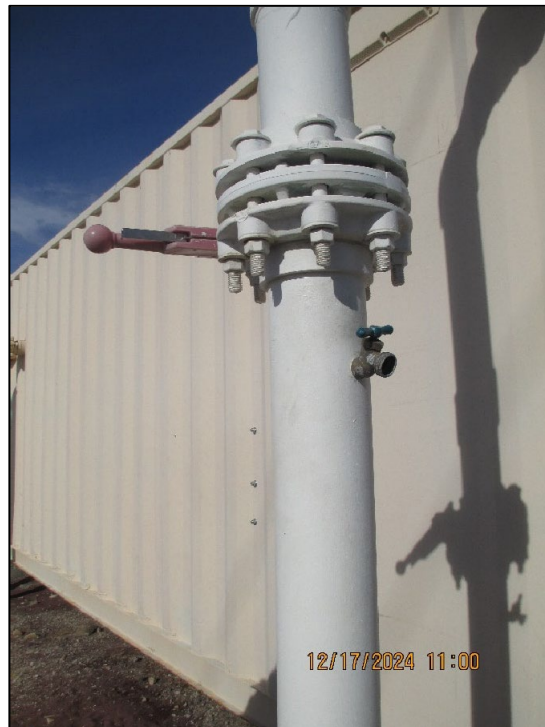
Photograph 3. The raw water sample tap before the water entered the treatment facility was threaded.

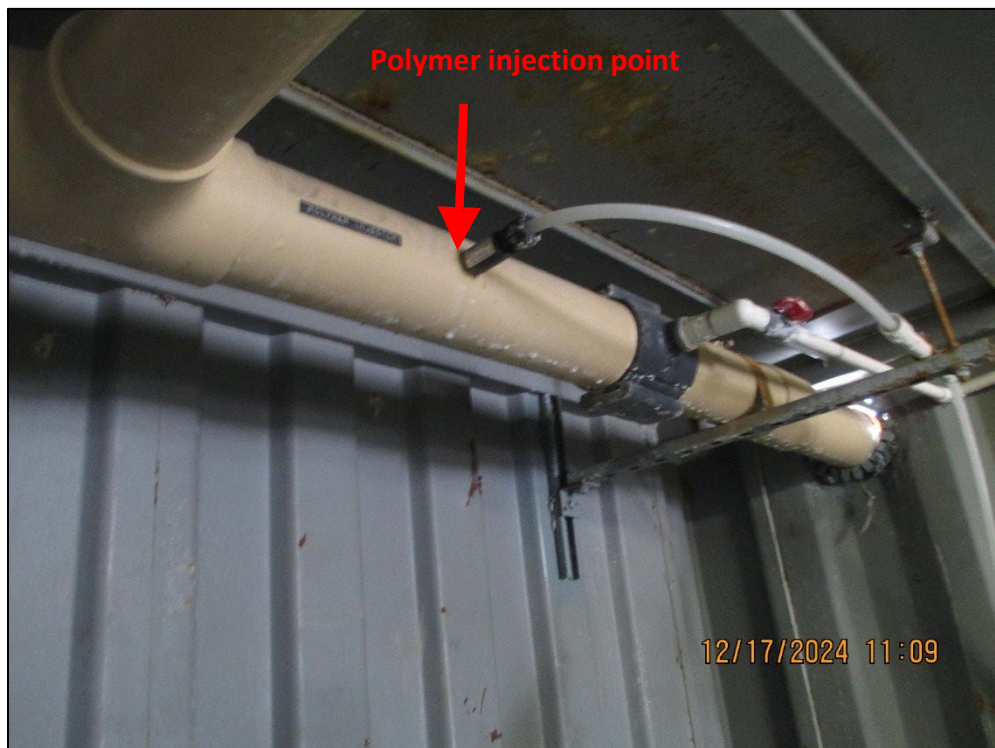
Photograph 4. The first polymer injection point before the water went through the filters.

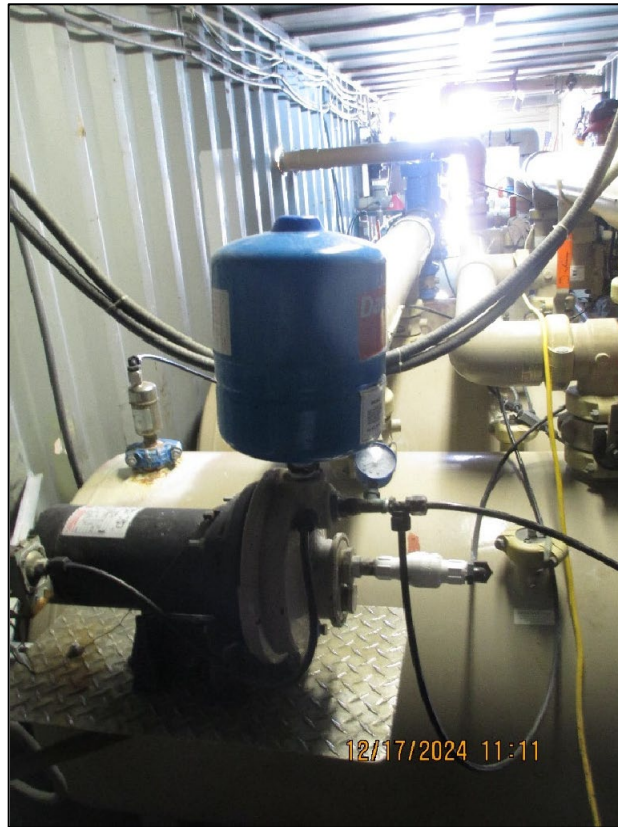
A backwash pump was located at the very back of the treatment facility. The pump appeared to have a leak. Hoban stated that they typically ran backwash almost every time the treatment plant was run. Backwash was typically triggered when there was a 15-20 psi pressure differential. Hoban added that the backwash differential was never less than 12 psi, even after a backwash was just completed.

Photograph 5. The backwash pump is at the front of the photograph. The filters extend towards the entrance.

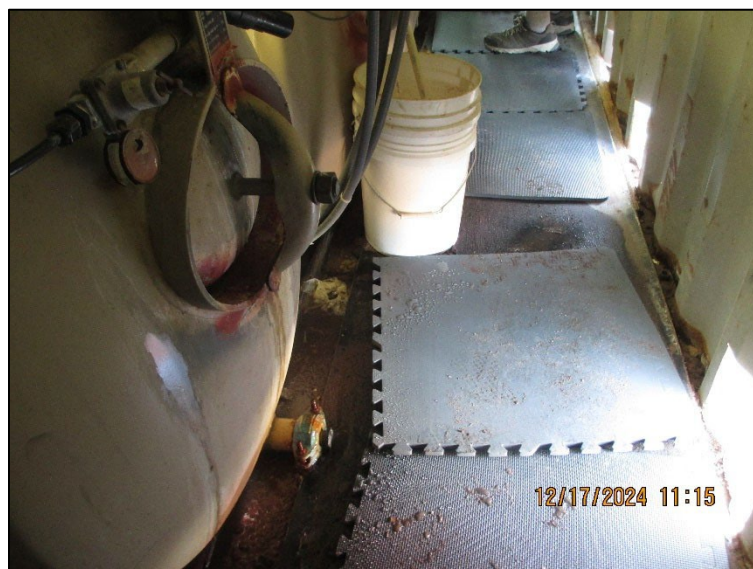
I observed that the treatment facility had wooden floor panels that were degraded and falling apart. Most of the ground was wet from multiple leaks. The polymer storage container was much improved compared to the last EPA inspection conducted on December 15, 2023. The treatment facility and backflow did not have a flow meter.

14. A couple of the filters for the surface water treatment were leaking.
15. The treatment system did not have auto-dialers to notify System personnel of incidents such as high/low chlorine or high turbidity.

Photograph 6. A couple of filters were leaking and the ground was wet throughout most of the facility.

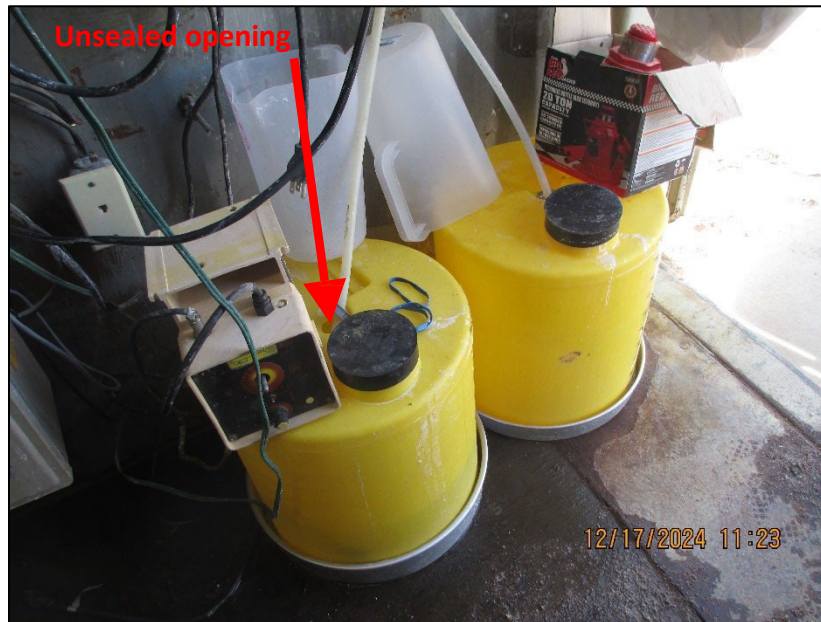
12. The polymer injection containers had an unprotected seal where the injection line entered the polymer container.
13. The wooden floor panels of the treatment facility were degrading due to water leaks.

Photograph 7. The polymer containers were more secure than the last EPA inspection. Openings where the injection lines enter were not fully protected.

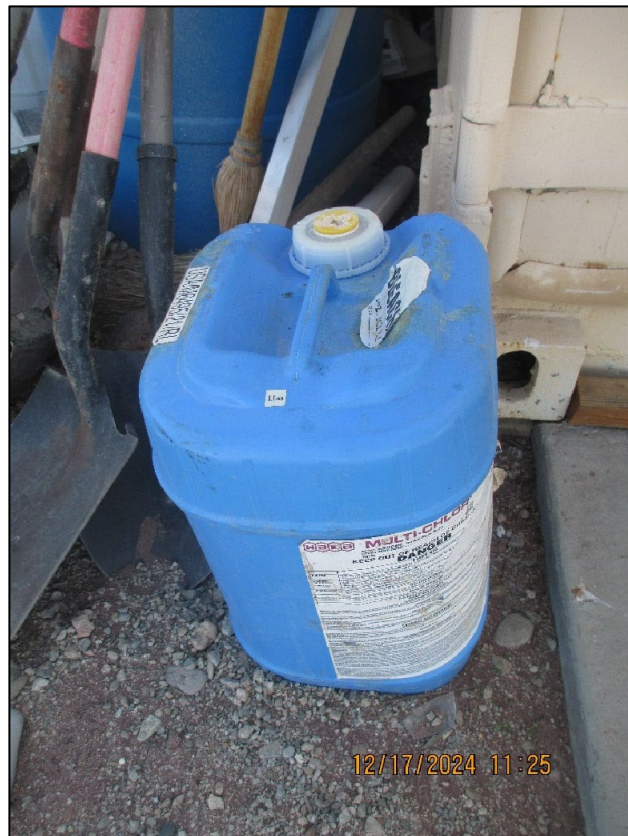
19. A liquid sodium hypochlorite container and treatment filter media were stored in direct sunlight instead of under shade or a location protected from environmental conditions.

Photograph 8. A jug of liquid sodium hypochlorite was stored outside and exposed to light instead of stored indoors.

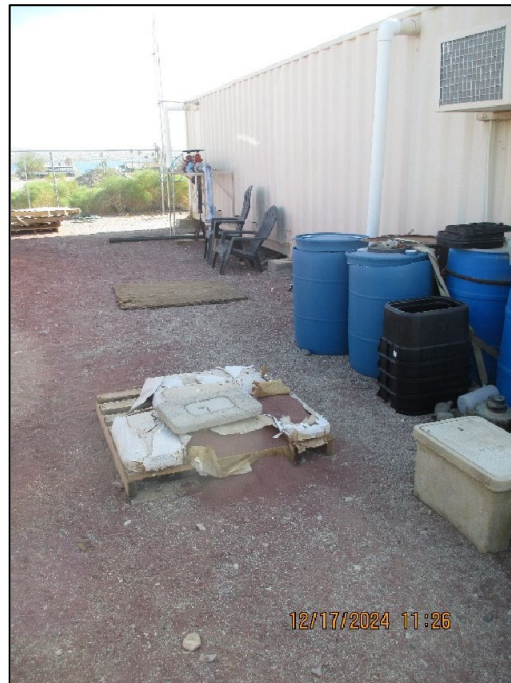
Photograph 9. The extra filter media was stored outside and exposed to the environment instead of protected in an indoor setting.

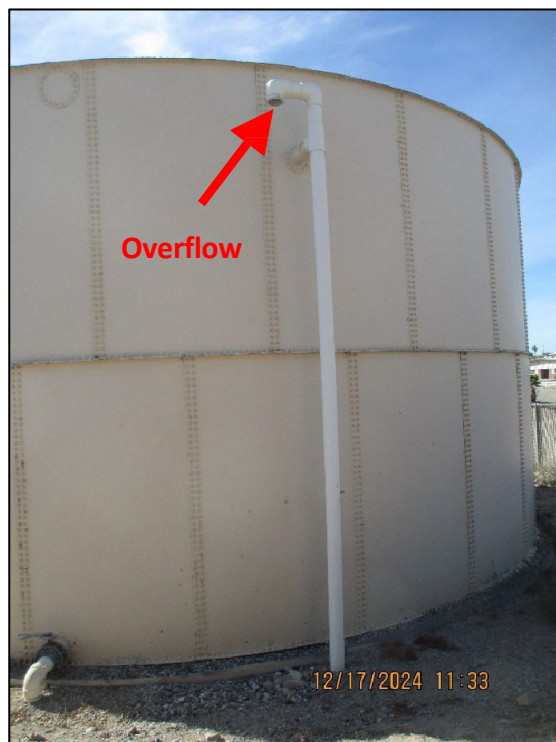
Photograph 10. The storage tank's inlet line had an overflow line connected which was too high above the ground and would lead to water flooding around the tank's foundation instead of draining away.

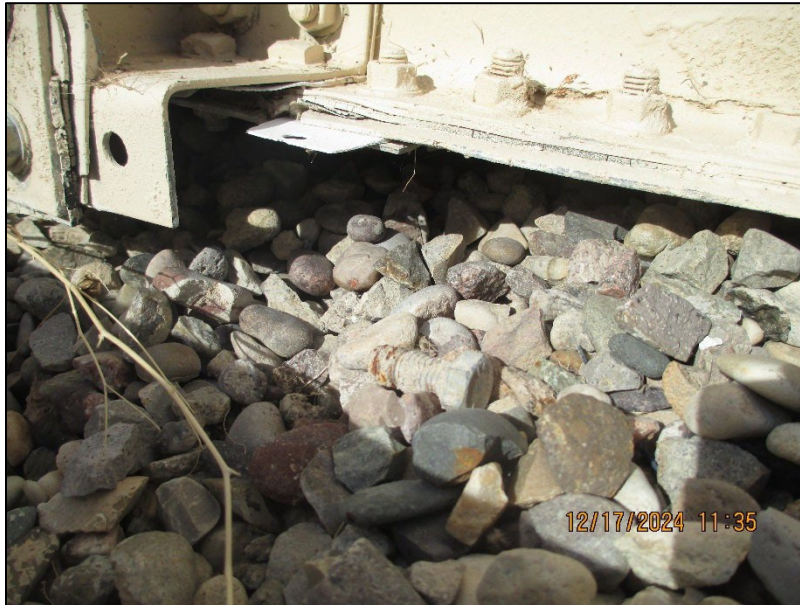
10. The storage tank's foundation along the southern end had gaps from the ground.

Photograph 11. The storage tank's foundation had gaps along the southern portion.

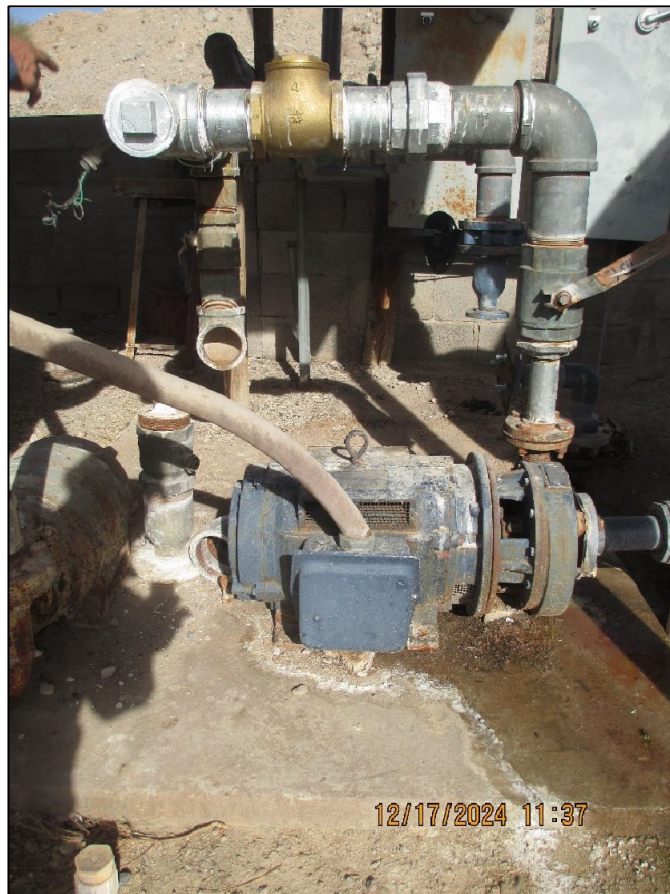
The pump station had a wooden roof but otherwise had minimal protection from the environment. Only one pump was operational as the other was removed due to poor condition. I observed the new distribution pump, but Hoban explained that he needed additional manpower to install the pump. Until there was additional staff available, he would be unable to move and install the new pump.

16. The pressure tank did not have a pressure relief valve or sight gauge.
17. The System only had one active booster pump, which was leaking.
18. The system did not have any flow meters, including missing flow meters for the raw water inlet, finished water outlet, and backwash.

Photograph 12. There was one functional distribution pump, which showed signs of minor leaking. The other pump was fully removed at the time of the inspection.

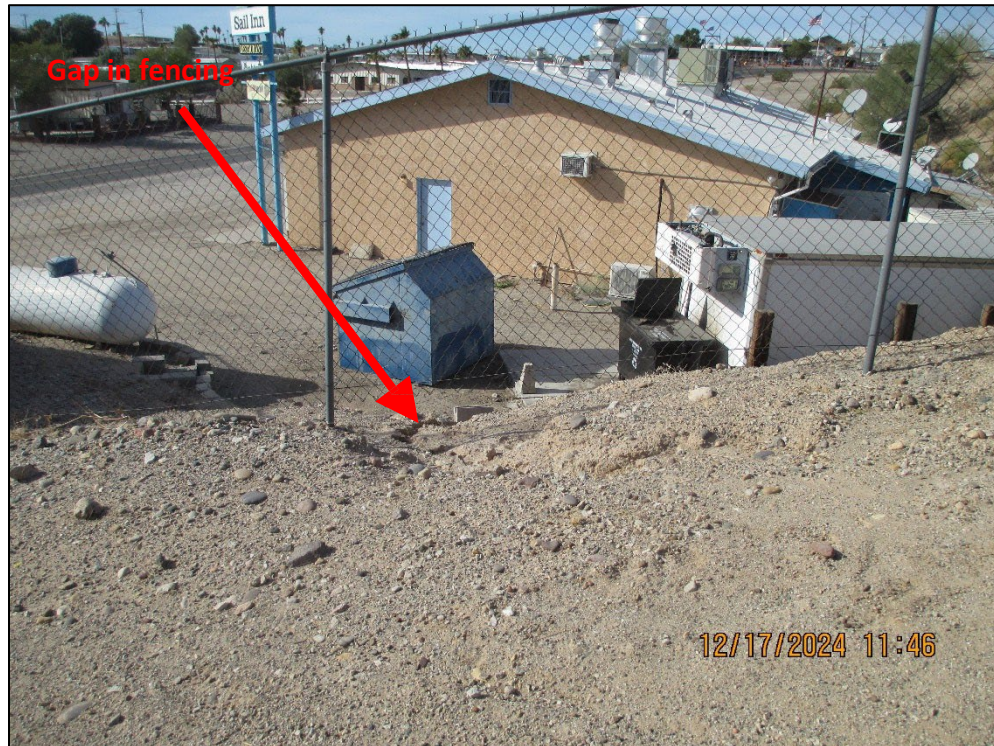
20. The System had expired turbidimeter reagents.
21. The security fencing had a gap that needed repairs.

Photograph 13. Security fencing near the storage tank was not fully protective.

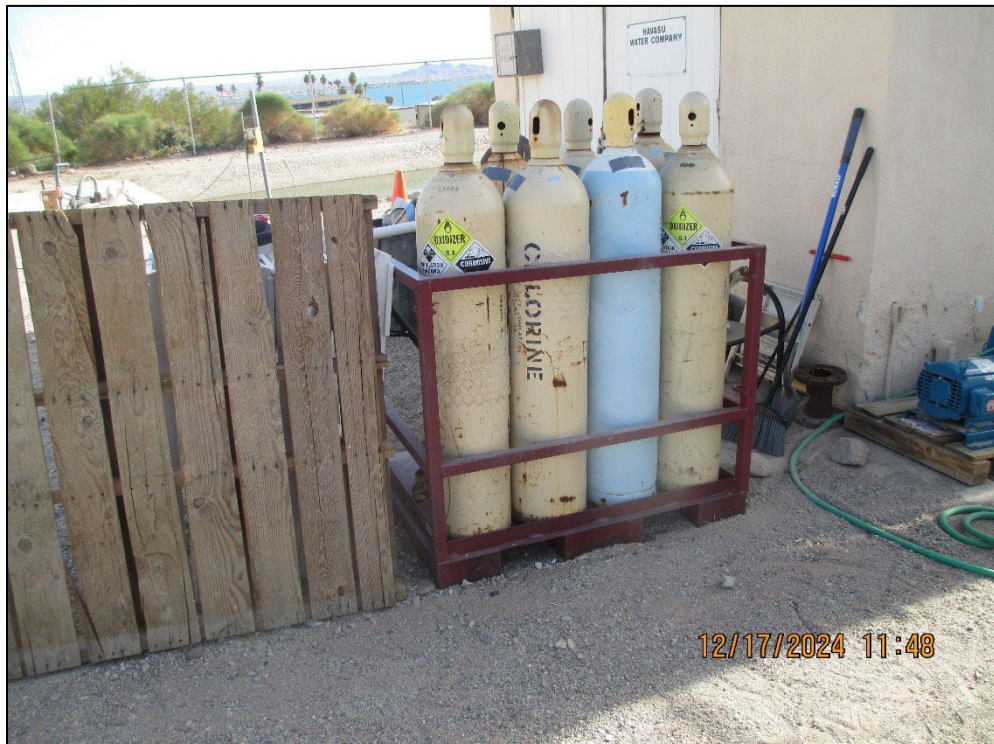
several chlorine gas cylinders located outside. Most cylinders were empty but there were a couple that appeared to have gas within.

Photograph 14. Chlorine gas cylinders, even if most were empty, were stored in direct sunlight instead of indoors or under shade.

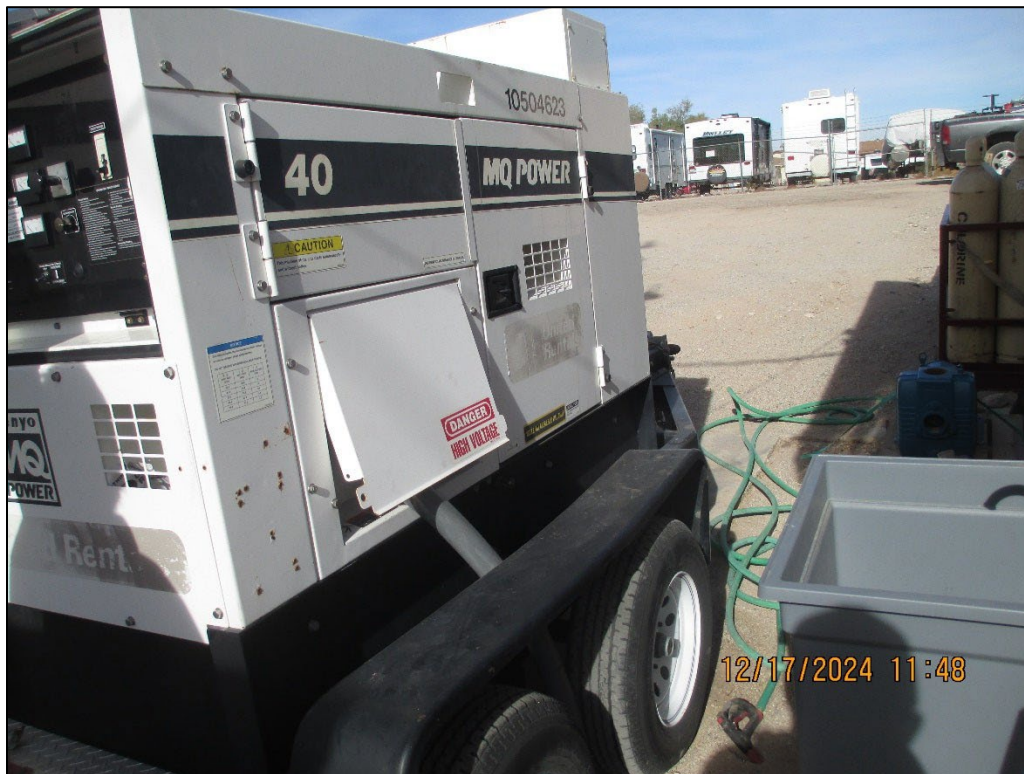
The System had a back-up generator connected. Hoban stated it was a Multiquip 40kw and was owned by the System. It was last tested on December 10, 2024. Maintenance

Photograph 15. The System had a back-up generator on-site.

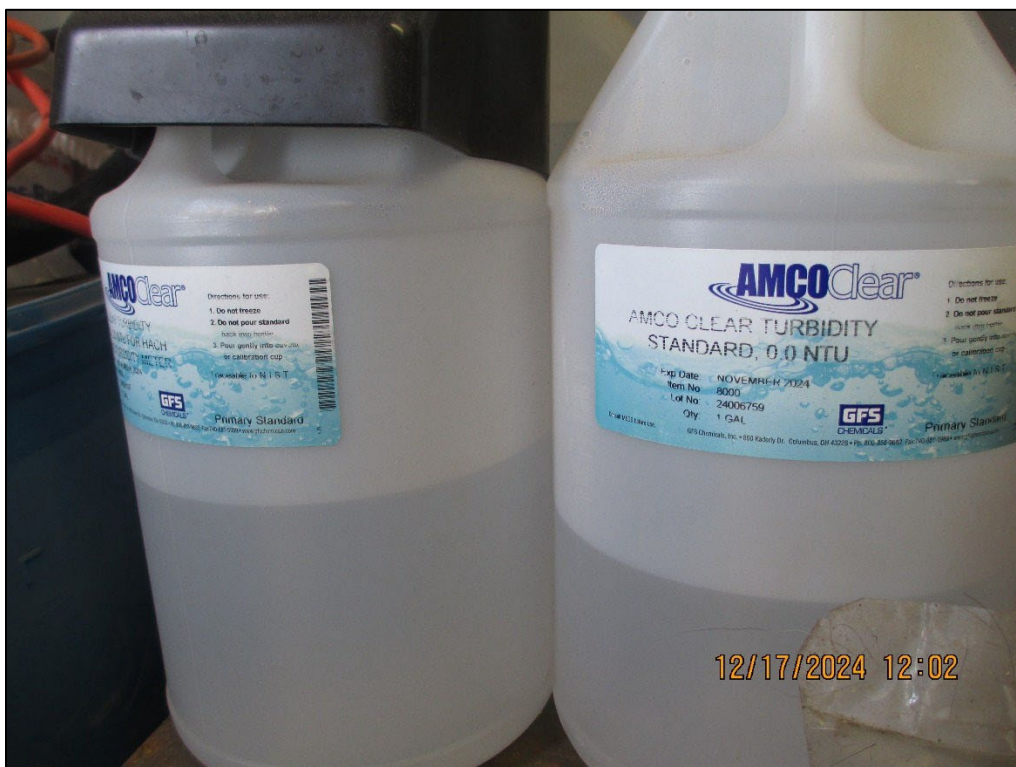
Photograph 16. The turbidity standard reagents were expired in November 2024.
