**Municipality/Organization:** City of Malden  
**EPA NPDES Permit Number:** MA041046  
**MADEP Transmittal Number:** 041088  
**Annual Report Number  
& Reporting Period:** No. 10: April 1, 2012-March 31, 2013

## NPDES PII Small MS4 General Permit Annual Report

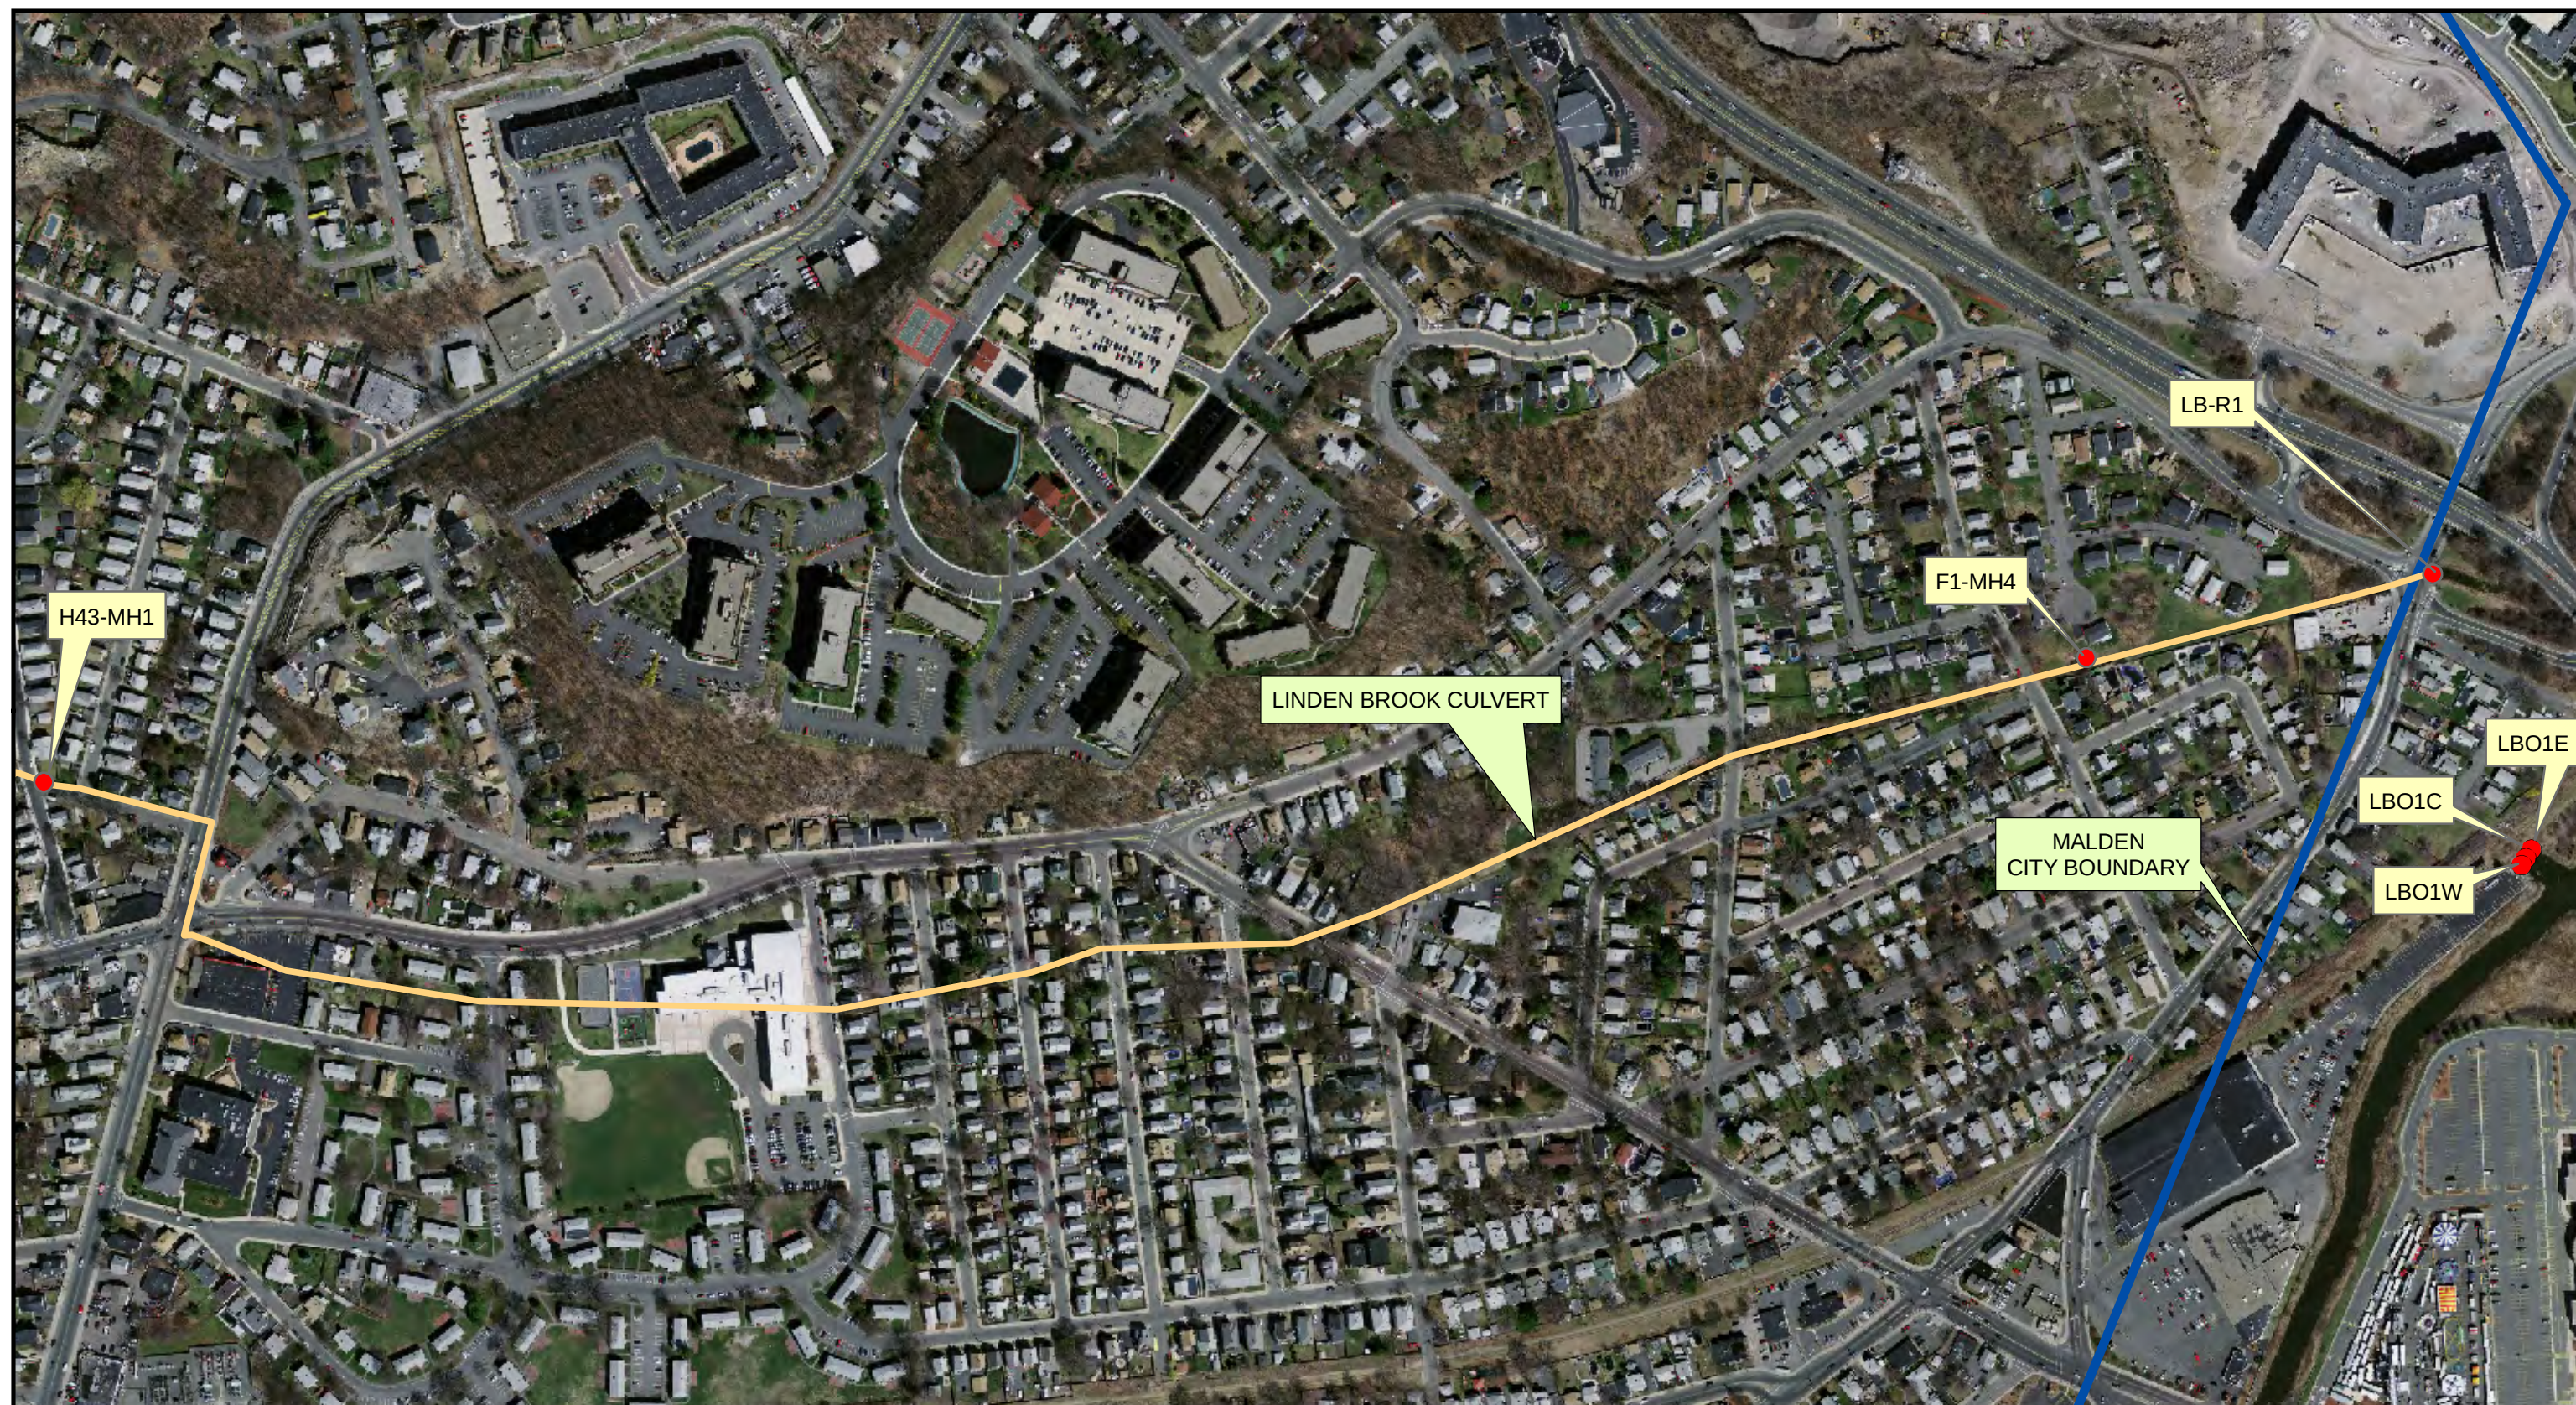
**Figure 1 - September 2012 Dry Weather Sampling Program**

During the September 2012 sampling event, representatives of the USEPA collected a water sample from outfall LBR-1, located in Revere, where distinct indications of sewage odors were noted (Figure 1). Consistent with identification of strong sewage odors and immediately apparent from a review of Table 1.0 are the significant levels of all sampling parameters, with the exception of Carbamazepine in sample LBR-1.

To investigate the elevated bacteria levels encountered at LBR-1, the City of Malden contracted with National Water Main Cleaning Company, under the supervision of CDM Smith. It is believed that line blockage due to grease build up may have been a crucial factor for the conditions identified at LBR-1, in addition to a “minor” defect in the form of a leaky joint. Although maintenance is routinely performed on this siphon, the extent of grease build up indicates that a higher frequency of cleaning and maintaining is necessary to further understand the condition. Based upon this recommendation, the City is now conducting weekly inspections of the siphon. These inspections have not revealed any significant blockage or grease buildup within the sewer network proximate to the siphon infrastructure. In addition, two (2) sampling events have been performed at LBR-1, with no significant E. coli levels detected.

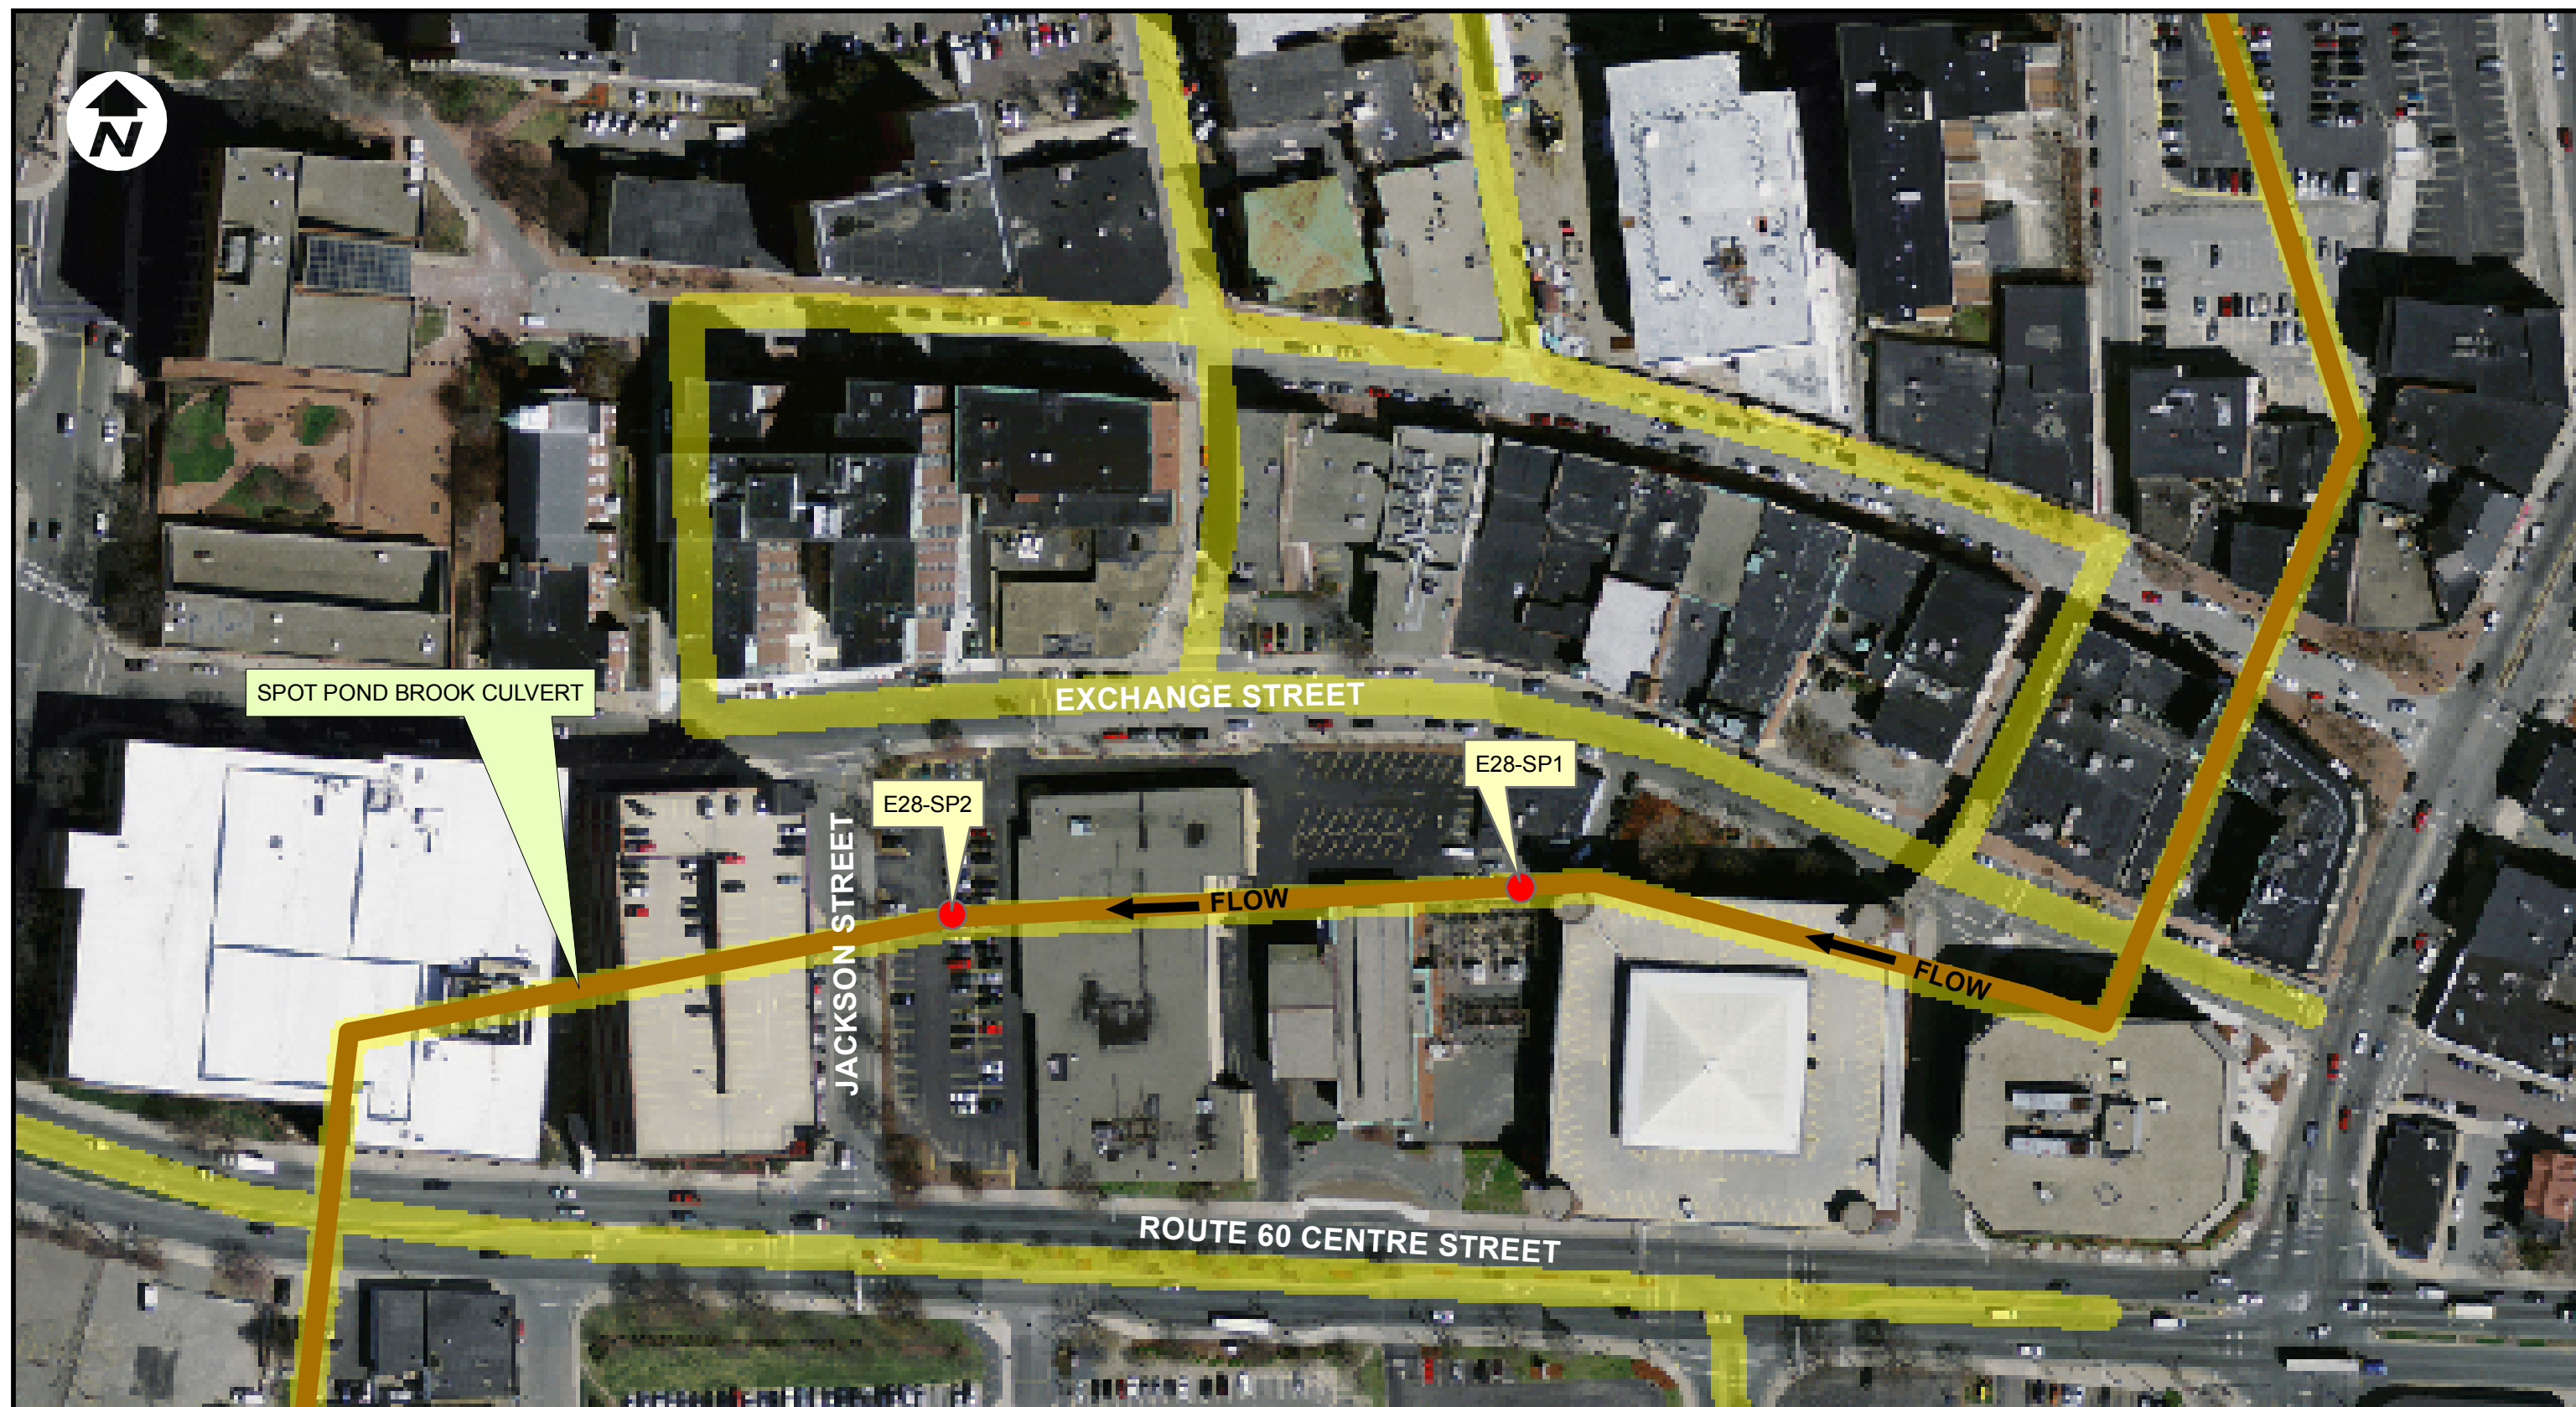
Figure 6 - Exchange Street Detail - Dry Weather Sampling Program

In addition to the investigation of possible sewer trunk line issues along Exchange Street, the downstream sample (E28-SP2) was also intended to quantify potential contributions from this segment of the drainage infrastructure that discharges to the outfall for the Malden River (MR-0). As summarized on Table 2.0, the concentrations of the constituents detected in sample E28-SP2 during the September 2012 sampling event were for the most part significantly lower than those observed at MR-0. To provide a similar isolation of flows contributing to the Malden River from Lower Spot Pond Brook, sample NG-C1 (National Grid property) was collected at the approximate location depicted on Figure 7. As shown on Table 2.0, an *E. coli* concentration of 510 col/100ml was identified, with concentrations for Acetaminophen, Cotinine, 1,7-Dimethylxanthine and Caffeine detected at levels greater than background.

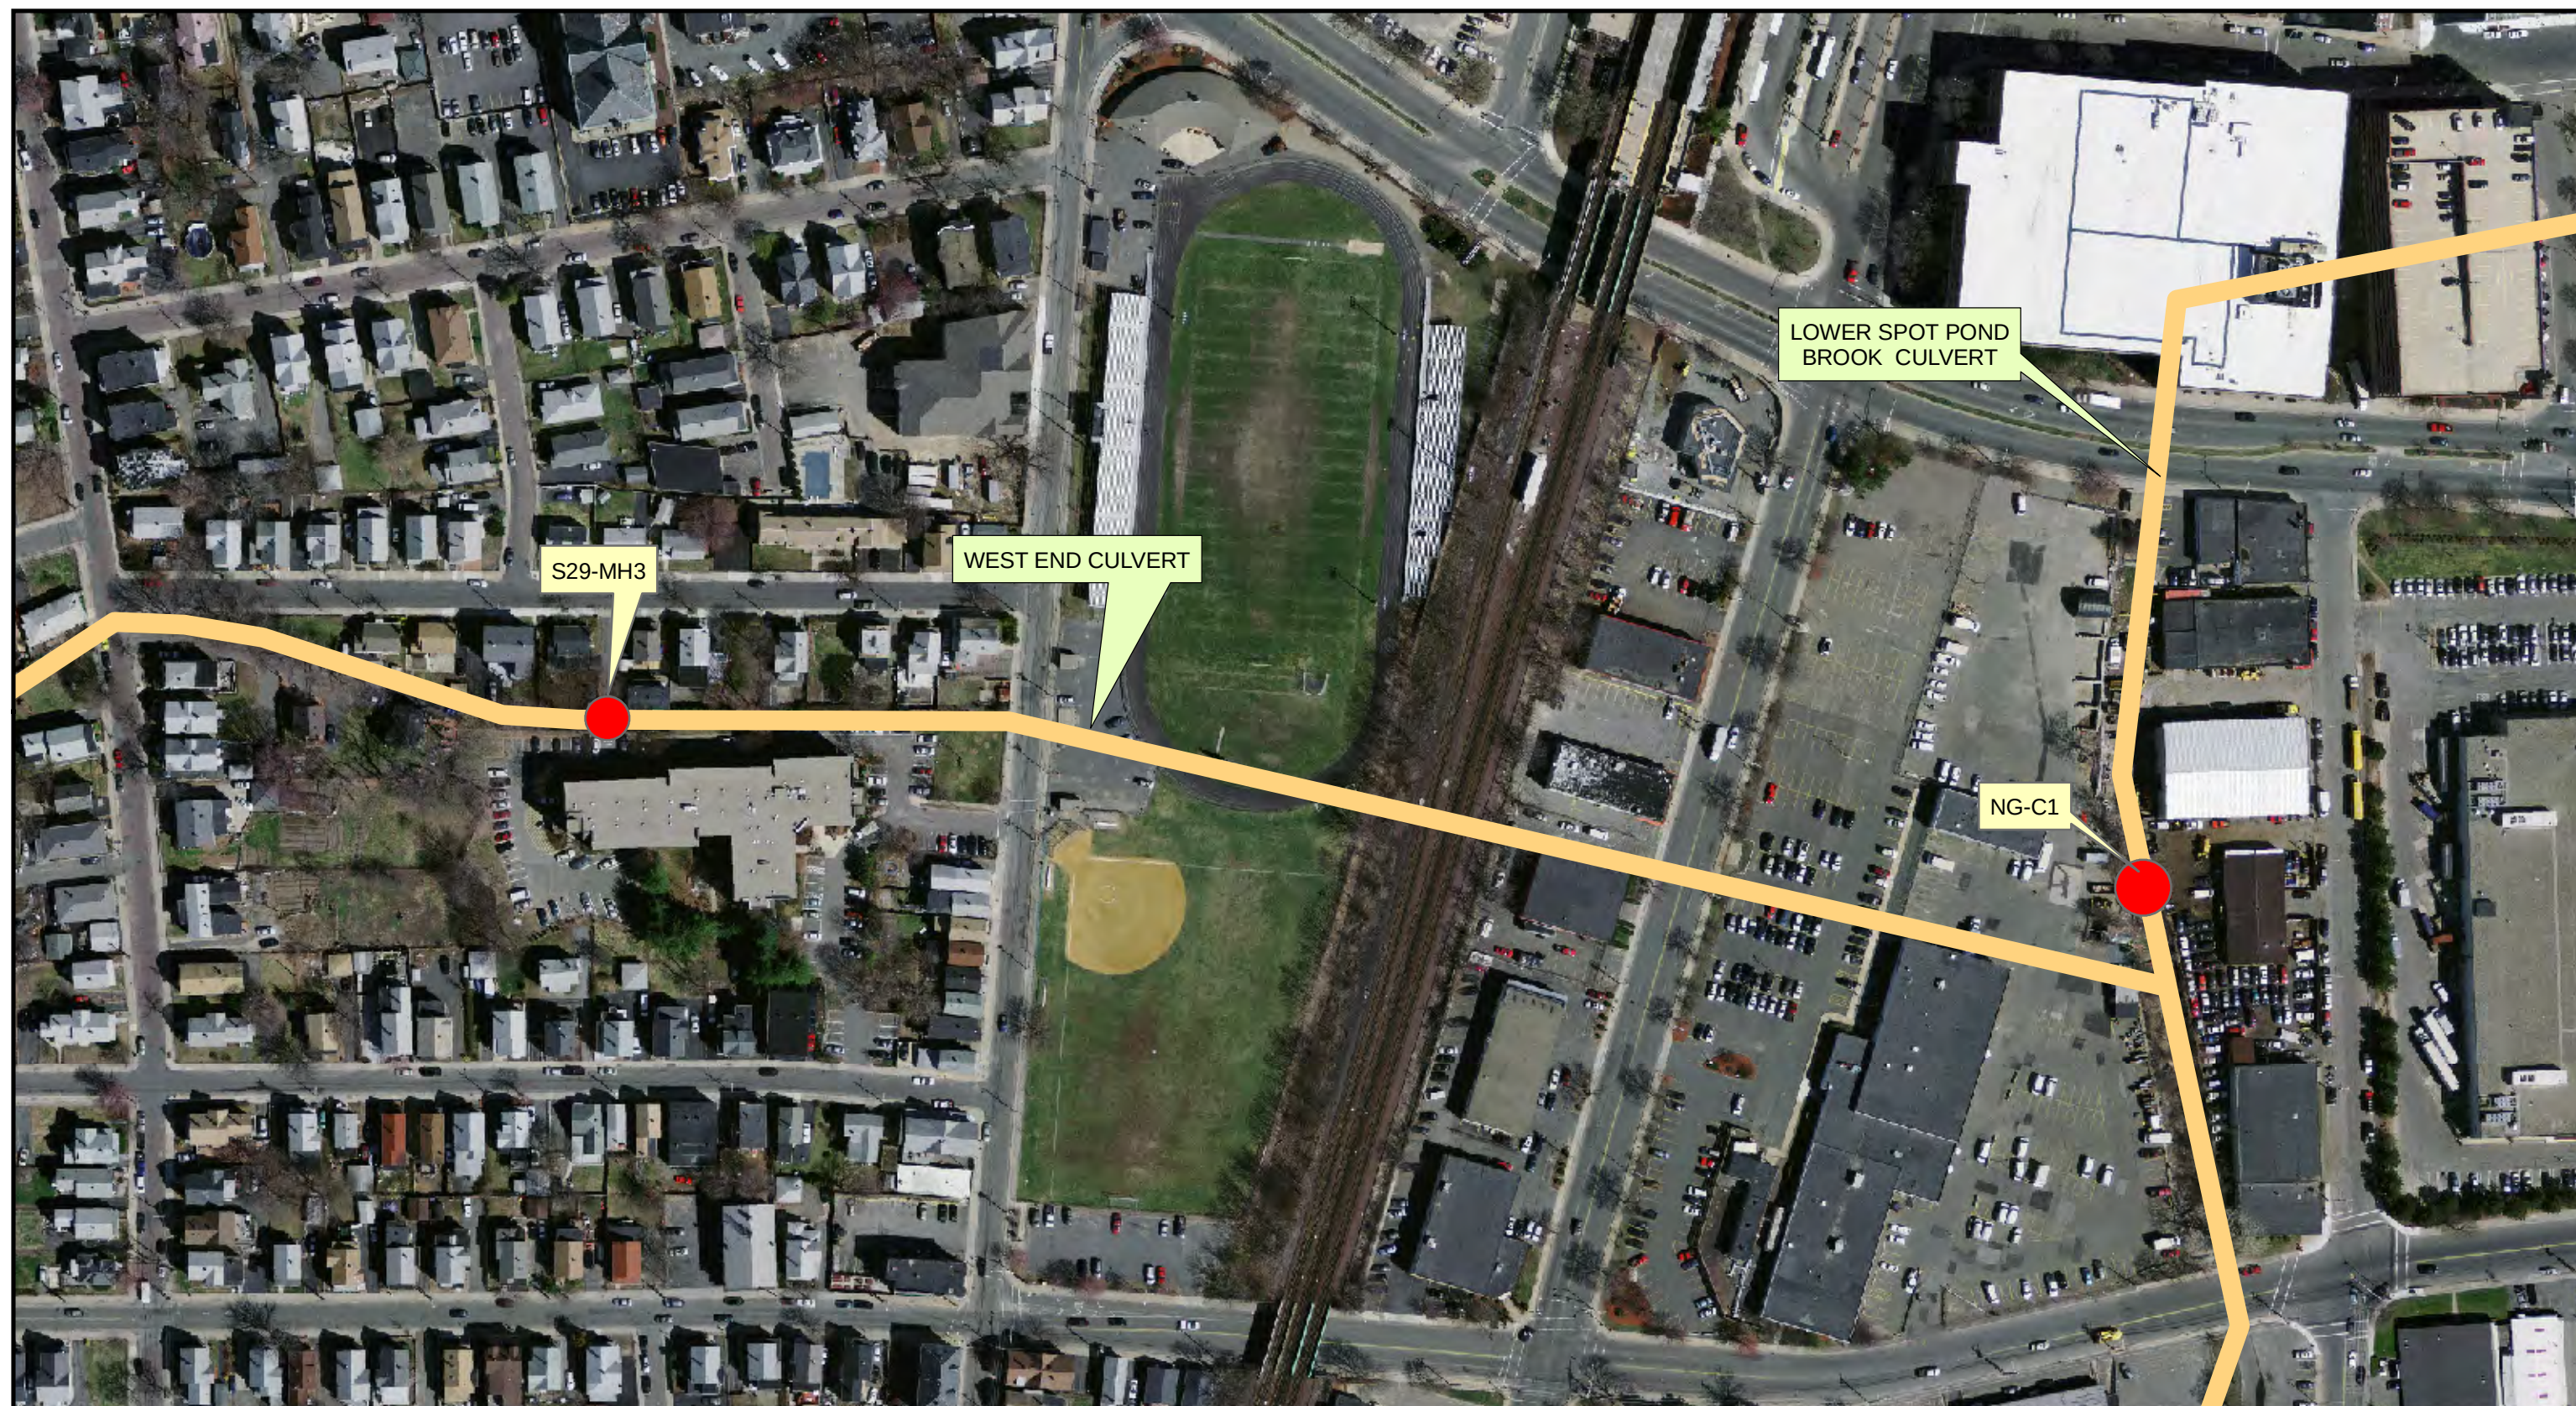
**Figure 7 - September 2012 Dry Weather Sampling Program**  
WEST END/ SPOT POND BROOK CULVERTS - MALDEN, MA

A similar flow isolation investigation was also performed for West End Brook through the collection of sample S29-MH3 (Stadium Road) at the approximate location shown on Figure 7. It was also proposed to sample upstream of S29-MH3 however, no flow within the culvert was identified at the intended location. It should be noted that flows emanating from the Fells Reservation enter the West End Brook in the area of S29-MH3. As indicated from a review of Table 2.0, elevated *E. coli* levels were detected during the September 2012 sampling event in manhole S29-MH3, in contrast to prior sampling results. In addition, high levels of additional indicators of human waste contributions, most noticeably Acetaminophen, were also observed. A re-evaluation of this condition will be performed during the next reporting period, together with additional flow isolation studies, as warranted.

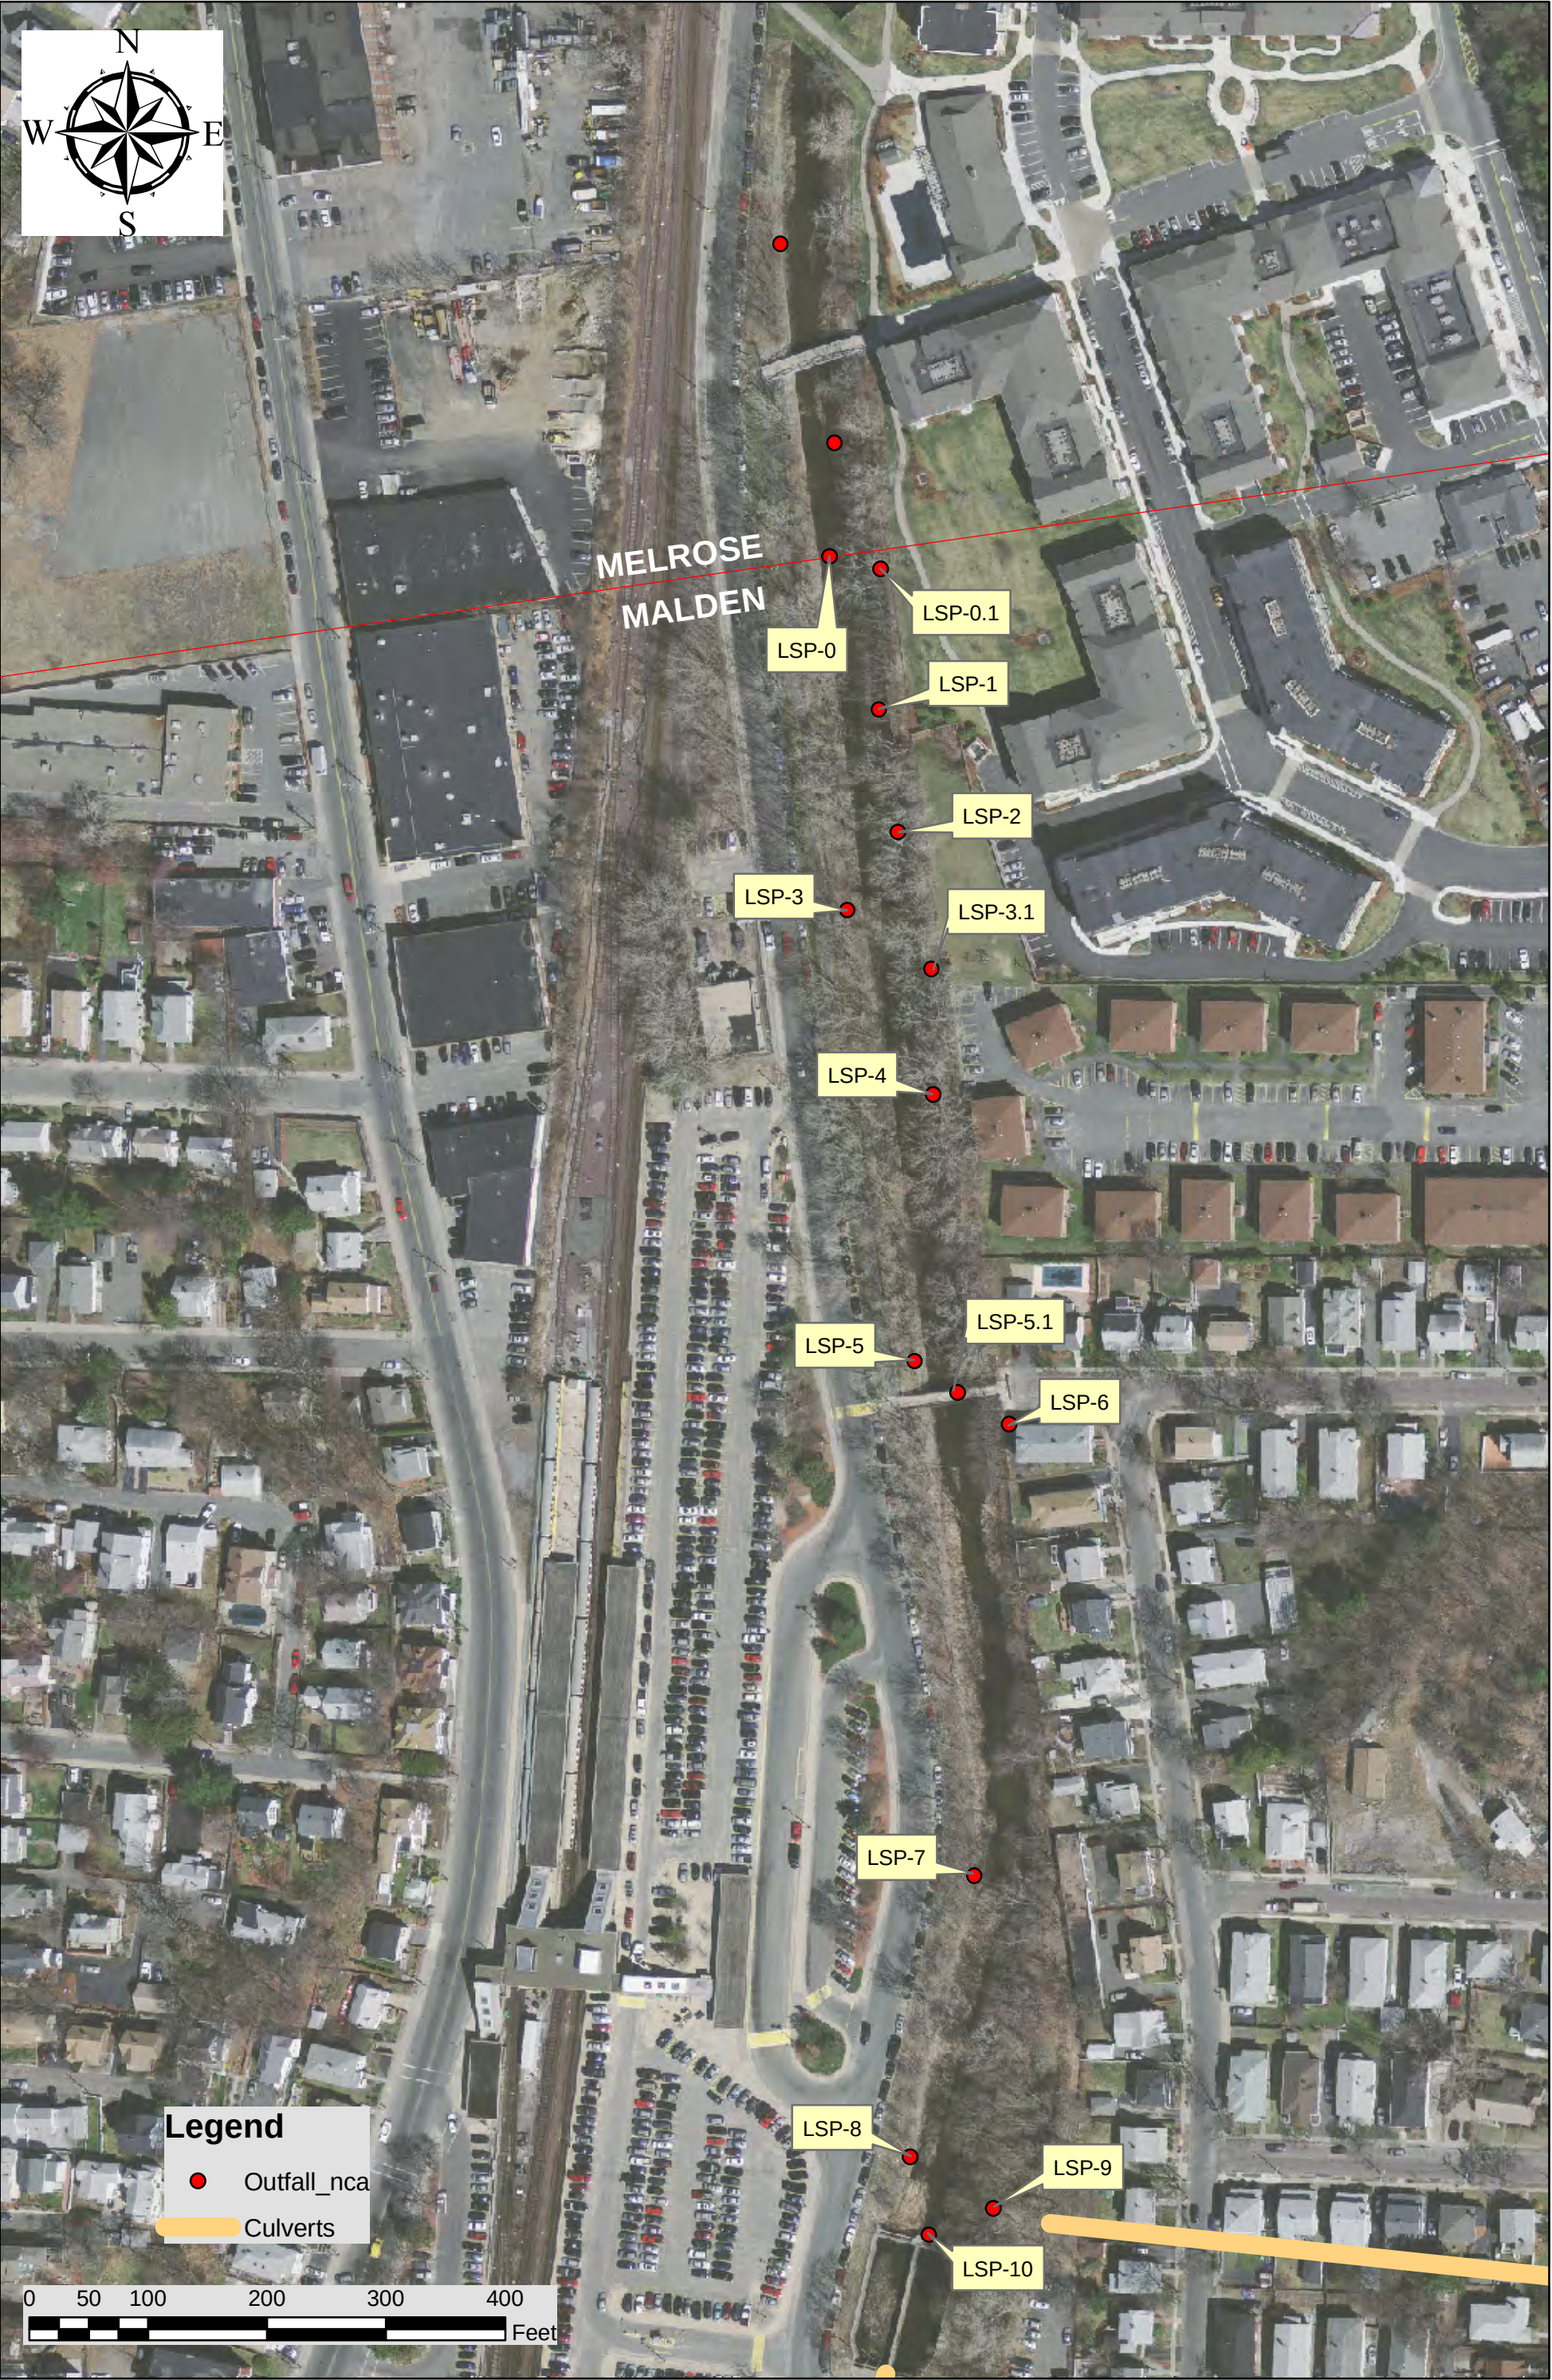
Figure 9 - Lower Spot Pond Brook Outfalls

The Stormwater Compliance Team has conducted numerous dry weather sampling events to investigate the elevated *E. coli* levels encountered previously at LSP-4, an outfall for the drainage system located within Eldrich Drive (Figure 9). Base flow, as groundwater, is consistently observed within this drainage network and to isolate potential sewage contributions to this base flow, a comprehensive evaluation of the flow conveyance network associated with LSP-4 was completed in February 2012. Given the proximity of the sewer and drain lines to LSP-4, as well as the settlement of the drain line in the area of Buildings 1054 and 1056 Elrich Drive, the focus of assessment activities was directed towards the sewer laterals and nearby drainage line servicing the two apartment buildings.

Based upon the information provided by the City, sewer flows generated from Buildings 1054 and 1056, tie into a single sewer line located in close proximity to the drainage network associated with LSP-4. To investigate the possibility of exfiltration from the sewer laterals, fluorescent dye was introduced by flushing water into a sink connection located within the basement of Building 1054. Subsequently this process was then repeated within Building 1056. In each instance, indications of dye were noted within drain manhole DMH-4 following termination of water flow through the sewer lines. The observations noted by the Stormwater Compliance Team were provided to the owner of the Elrich Drive property. Recommendations made by the SCT involved restoring the integrity of the main drainage line to stop the discharges that have been documented at LSP-4. Working with representatives of the Malden Engineering Department, repairs to the sewer laterals in the area of Buildings 1054 and 1056 were completed in March of 2012.

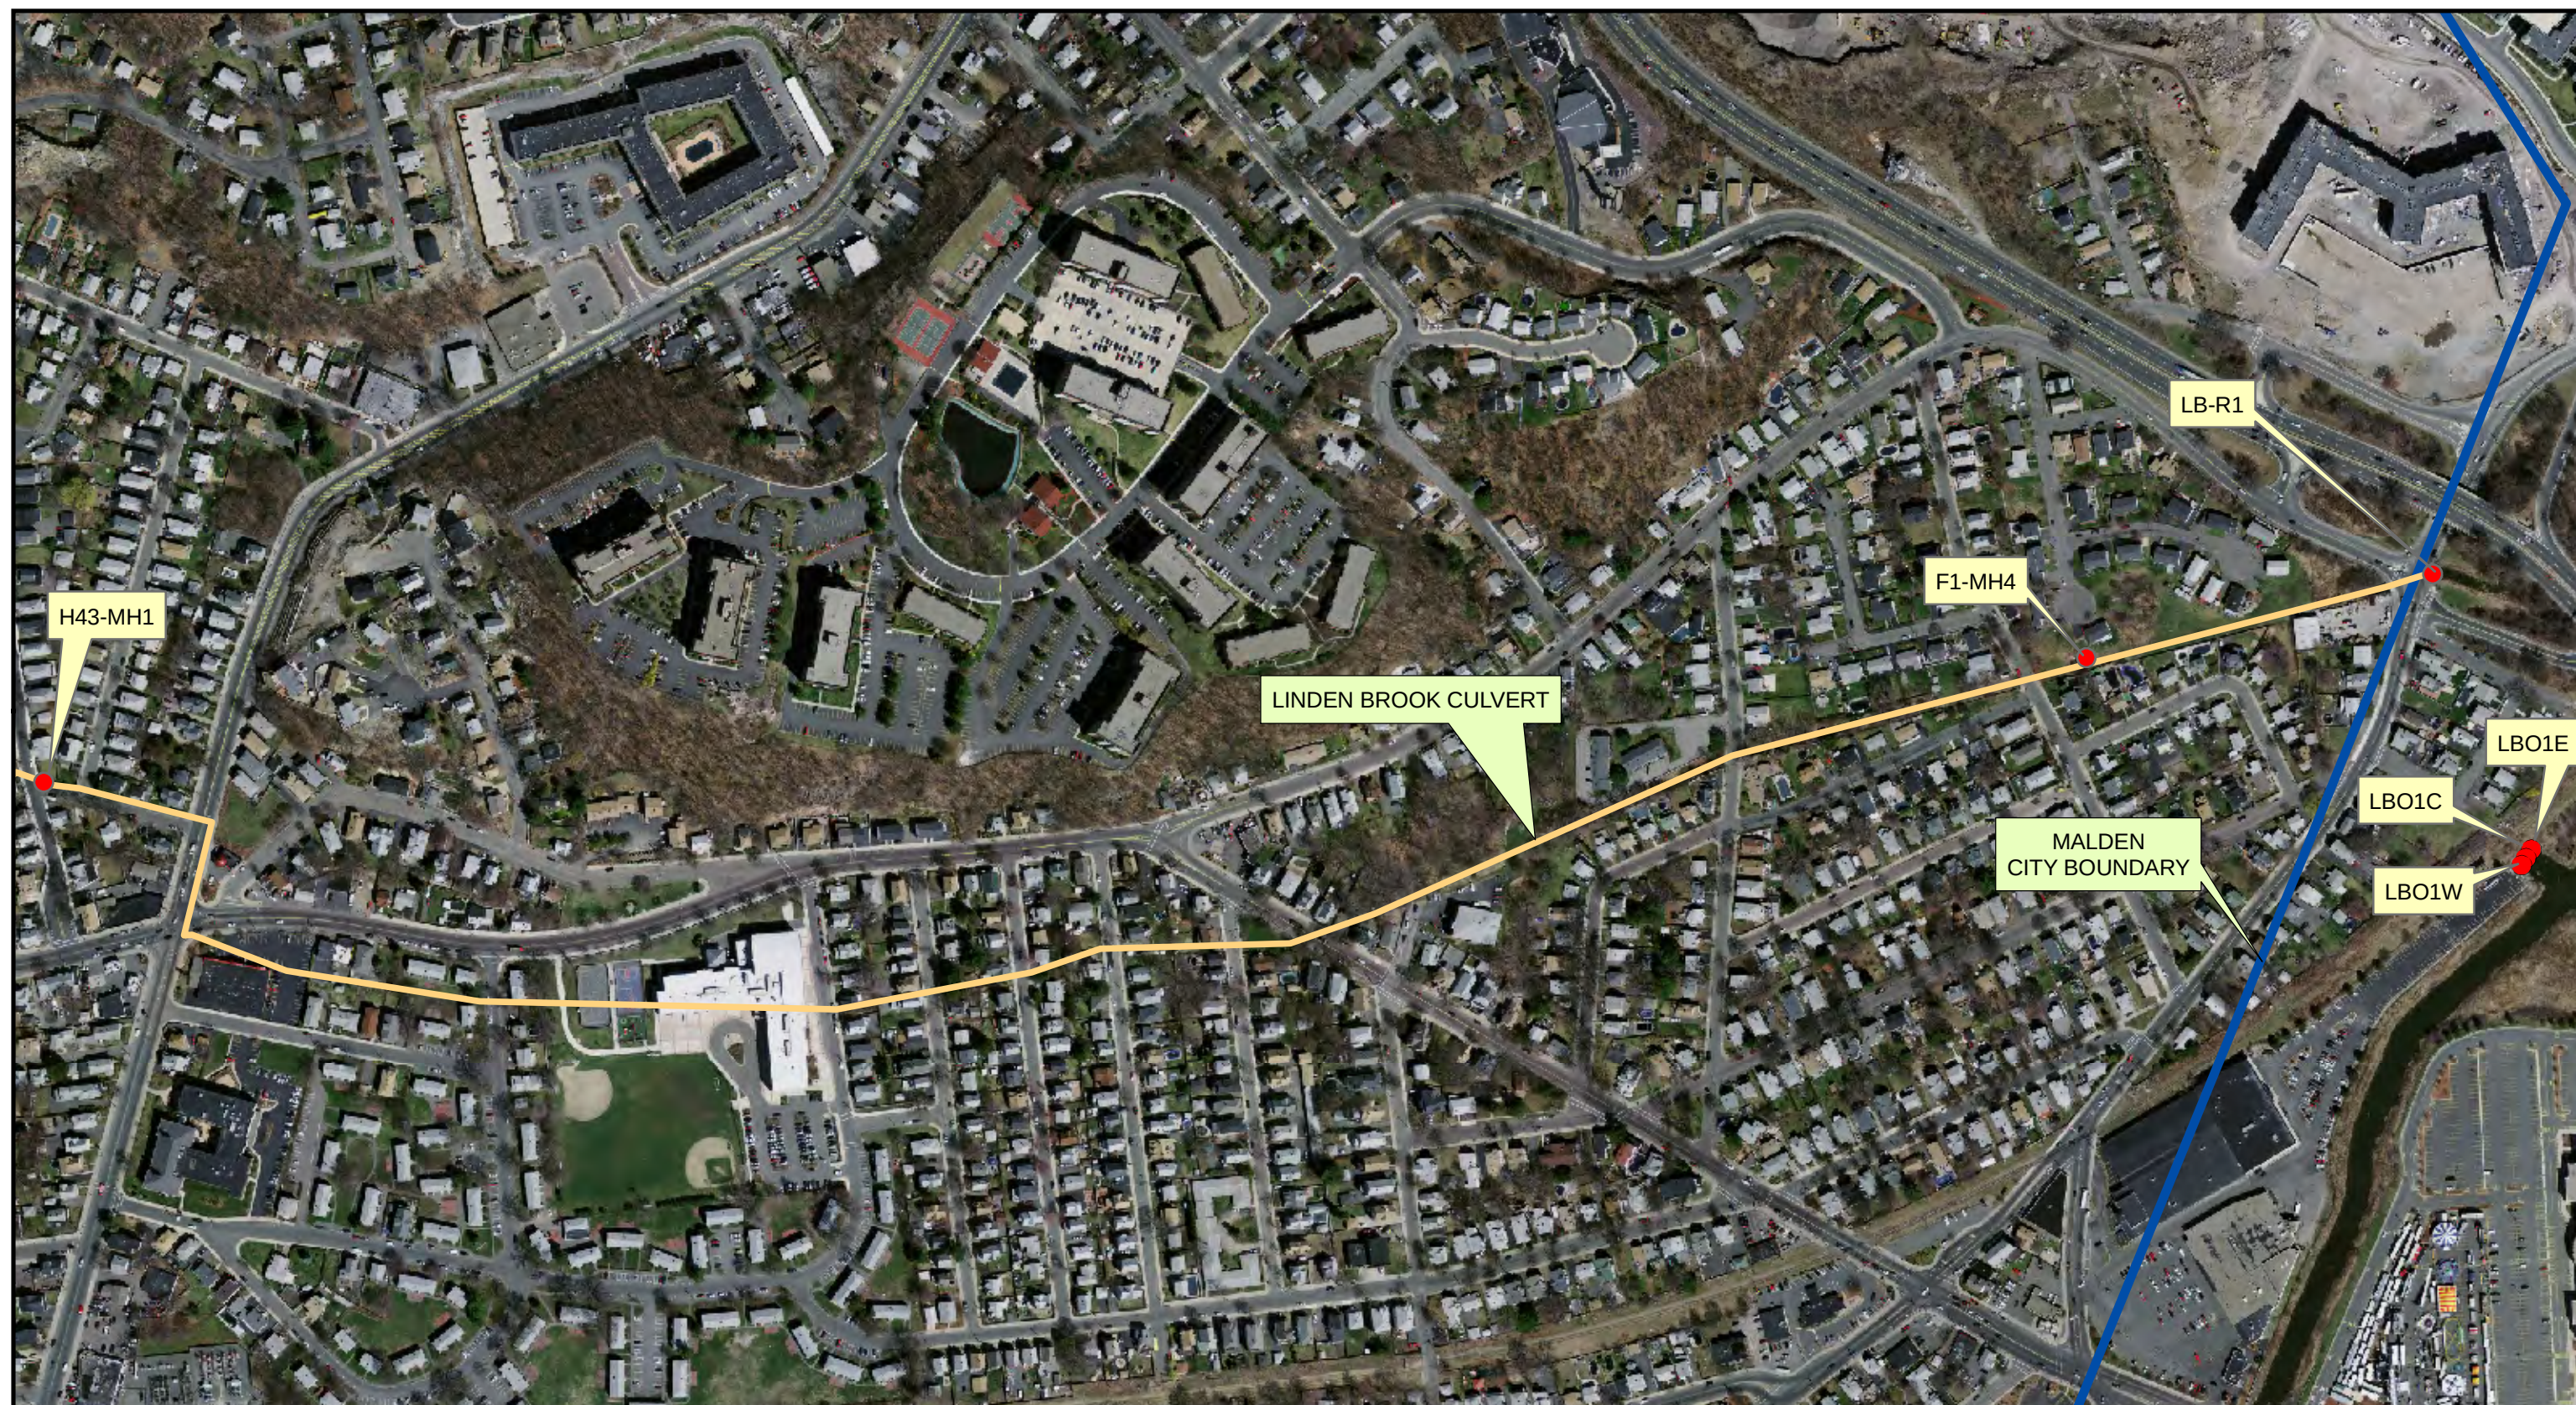
**Figure 12 - September 2012 Dry Weather Sampling Program**

During the September 2012 sampling event, representatives of the USEPA collected a water sample from outfall LBR-1, located in Revere, where distinct indications of sewage odors were noted. Three (3) additional samples were also collected by the USEPA in Revere from the open channel flow of Town Line Brook (Figure 12), the results of which are summarized on Table 2.0. Consistent with identification of strong sewage odors and immediately apparent from a review of Table 2.0 are the significant elevated levels of all sampling parameters, with the exception of Carbamazepine in sample LBR-1. It is important to note that the more uncommon drugs such as this tended to exhibit more variation within the overall sampling program in comparison to the more common constituents, caffeine and acetaminophen.

To investigate the elevated bacteria levels encountered at LBR-1, the City of Malden contracted with National Water Main Cleaning Company, under the supervision of CDM Smith. As summarized in the following excerpt from an email to the City of Malden from CDM Smith, it is believed that line blockage due to grease build up may have been a crucial factor for the conditions identified at LBR-1, in addition to a “minor” defect in the form of a leaky joint. Although maintenance is routinely performed on this siphon, the extent of grease build up indicates that a higher frequency of cleaning and maintaining is necessary to further understand the condition.

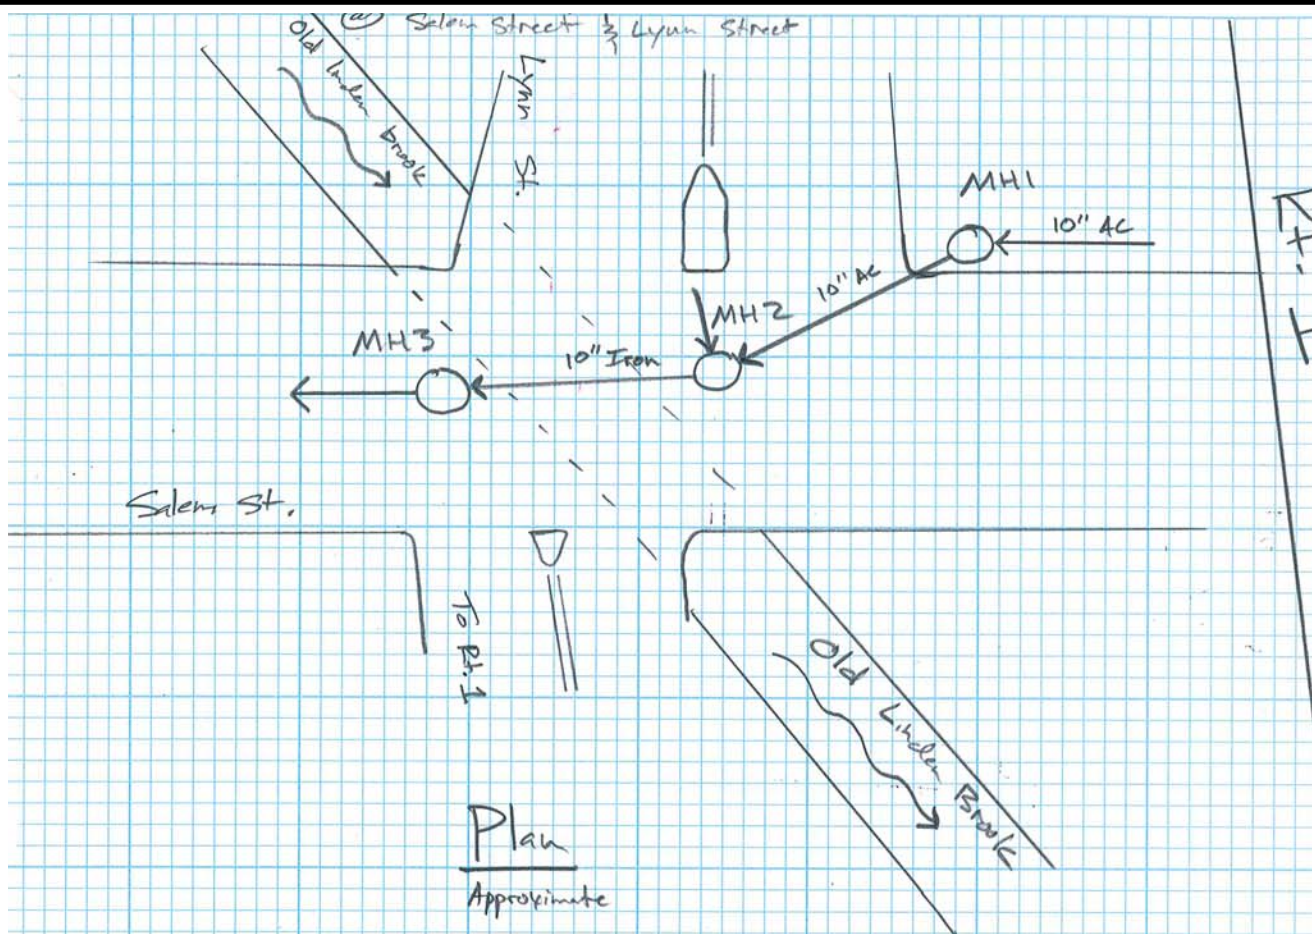
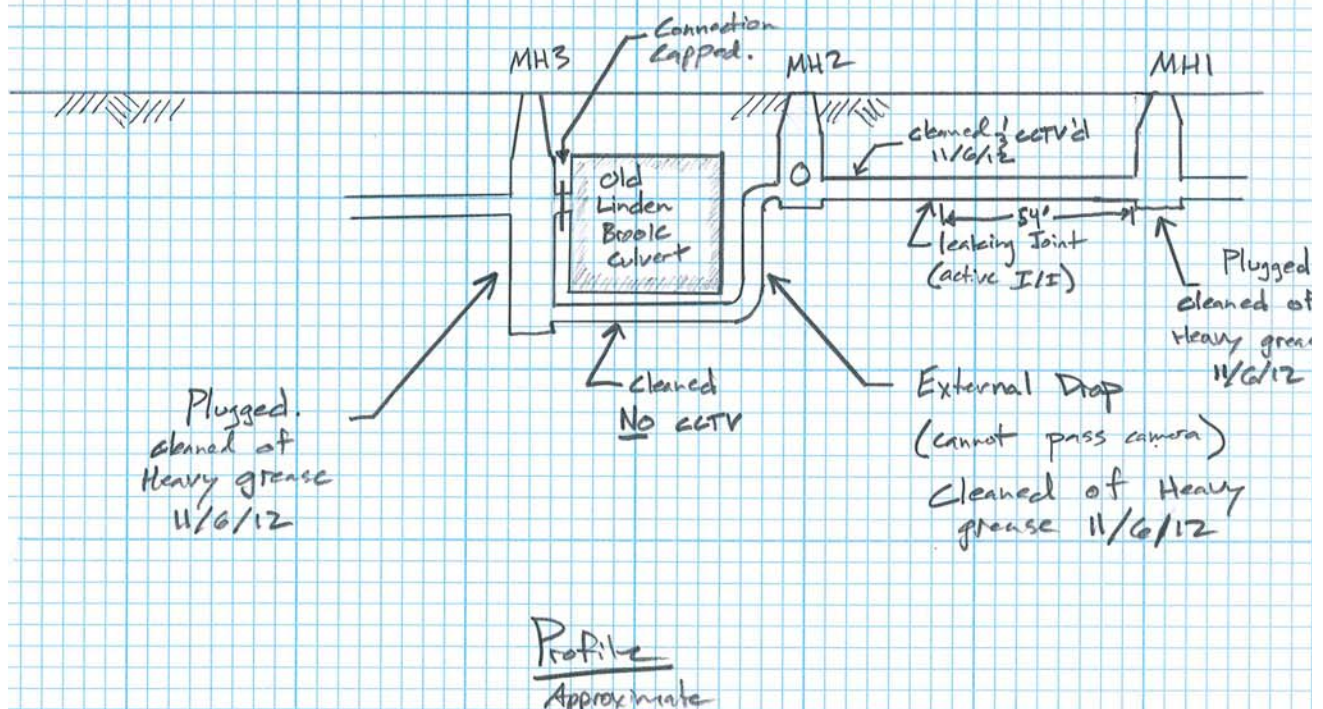
SKETCH SHOWING SEWER SYPHON AT  
LYNN STREET - MALDEN/REVERE CITY LINE

National Water Main was onsite to clean and CCTV the siphon under the Old Linden Brook culvert. Upon arrival the condition of the sewers had not changed from the previous visit held 2 weeks prior: The downstream manhole (MH 3 in the attached figure) and a manhole upstream of the siphon (MH 1 in the figure) were completely plugged with heavy grease. A limited amount of liquid was passing through MH 3. Heavy cleaning of MH 3 and the sewer under the culvert took longer than expected. From MH 3 upstream to MH 1 an enormous amount of grease and sediment was removed. The pipe was 100% clogged with slugs of grease in several spots.

The sewer between MH 1 and MH 2 was successfully CCTV’d with the aid of the jetter (upstream of the siphon). This pipe was found to be in good condition. The most notable defect was a leaking joint (runner) at 9pm 54-ft from MH 1 (while traveling downstream). This was a rather minor defect. Active I/I was observed, however, it is possible that when the siphon builds some head, a small amount of sewage could exfiltrate from this same joint.

upstream direction would require two jetters or bypass pumping, (one to keep MH 3 drained and one to intercept flow from upstream in MH 2). This vertical drop was heavily blocked with grease. Approximately 80% of the grease in this pipe was removed with a root cutter and the pipe is in much better condition.

Last we lowered the camera into the 12-in connection to the culvert that once housed a gate valve (in MH 3). It no longer houses any gate, instead there is a masonry plug that seems to be in good condition. As the intent of finding the definitive source of sewage into the culvert was inconclusive, we recommend that we resample the outfall and test for parameters consistent with sewage. If the results are consistent with the previous results we should develop a new approach to finding the source.

Based upon the “inconclusive finding” cited by CDM, future high frequency inspection of the siphon and related service connections is recommended to be performed during the next reporting period.

At a minimum, it is recommended that the siphon at Lynn Street be inspected on a weekly basis. During this inspection program, recorded observations should include estimated flow volumes, upstream and downstream of the siphon, extent of grease buildup at the upstream manhole, depth to liquid in the downstream manhole, possible odors at the Linden Brook Outlet and any unusual conditions that may be present.
