**Municipality/Organization:** City of Malden  
**EPA NPDES Permit Number:** MA041046  
**MADEP Transmittal Number:** 041088  
**Annual Report Number  
& Reporting Period:** No. 11: April 1, 2013-March 31, 2014

## NPDES PII Small MS4 General Permit Annual Report

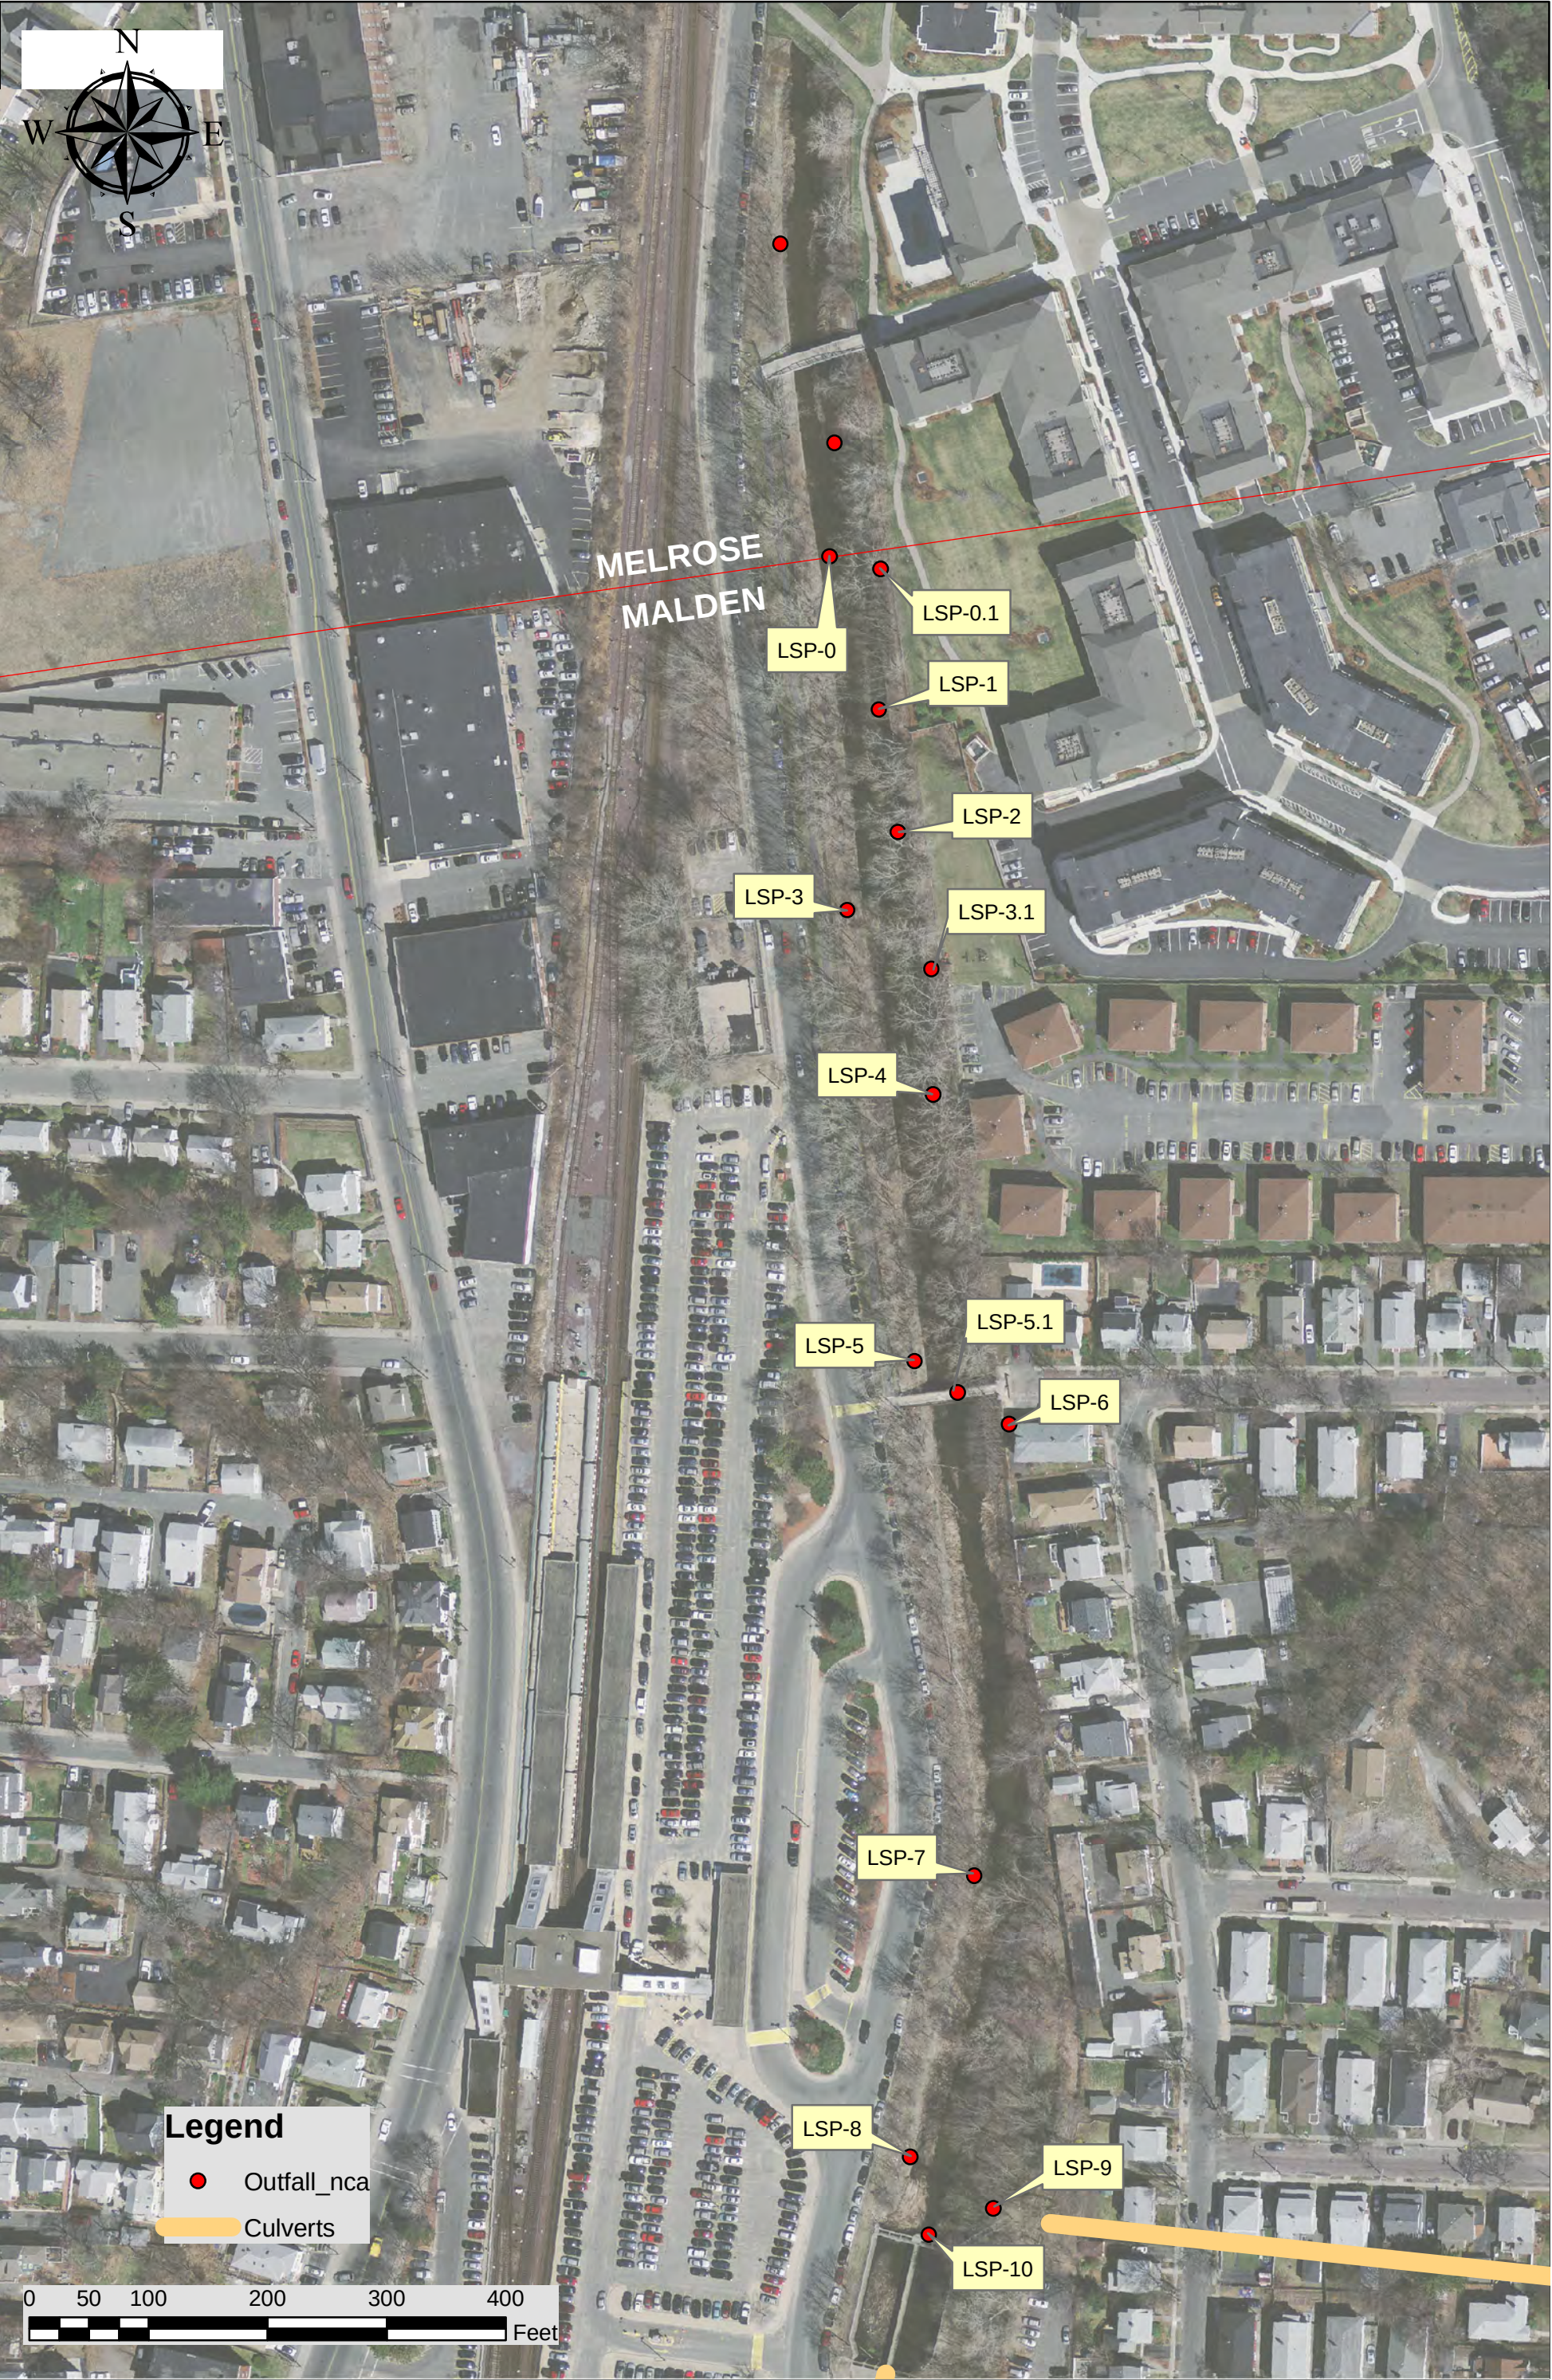
Figure 5 - Lower Spot Pond Brook Outfalls

The Stormwater Compliance Team has conducted numerous dry weather sampling events to investigate the elevated E. coli levels encountered previously at LSP-4, an outfall for the drainage system located within Eldrich Drive (Figure 5). Base flow, as groundwater, is consistently observed within this drainage network and to isolate potential sewage contributions to this base flow, a comprehensive evaluation of the flow conveyance network associated with LSP-4 was completed in February 2012. Given the proximity of the sewer and drain lines to LSP-4, as well as the settlement of the drain line in the area of Buildings 1054 and 1056 Elrich Drive, the focus of assessment activities was directed towards the sewer laterals and nearby drainage line servicing the two apartment buildings. Following dye testing by the Compliance Team, camera surveys performed by representatives of the property owner confirmed that compromises to the laterals servicing two (2) residential building had occurred. Recommendations made by the SCT involved restoring the integrity of the main drainage line to stop the discharges that have been documented at LSP-4. Working with representatives of the Malden Engineering Department, repairs to the sewer laterals in the area of Building 1054 and 1056 were completed by the property owner in March 2012. Since that time, several attempts have been made to collect a dry weather flow sample from LSP-4, however due to base flow within the Lower Spot Pond Brook; this sample location has been inaccessible. A sample from LSP-4, as well as upstream manhole E13-MH4 were collected during this reported period and as shown on Table 3.0, an E. coli level of 2,000 MPN/100 ml was detected at each location. Although still elevated, the levels detected have decreased significantly relative to concentrations detected in 2012. The City Engineering Department is in the process of contacting the property owner to discuss the most recent sampling results.

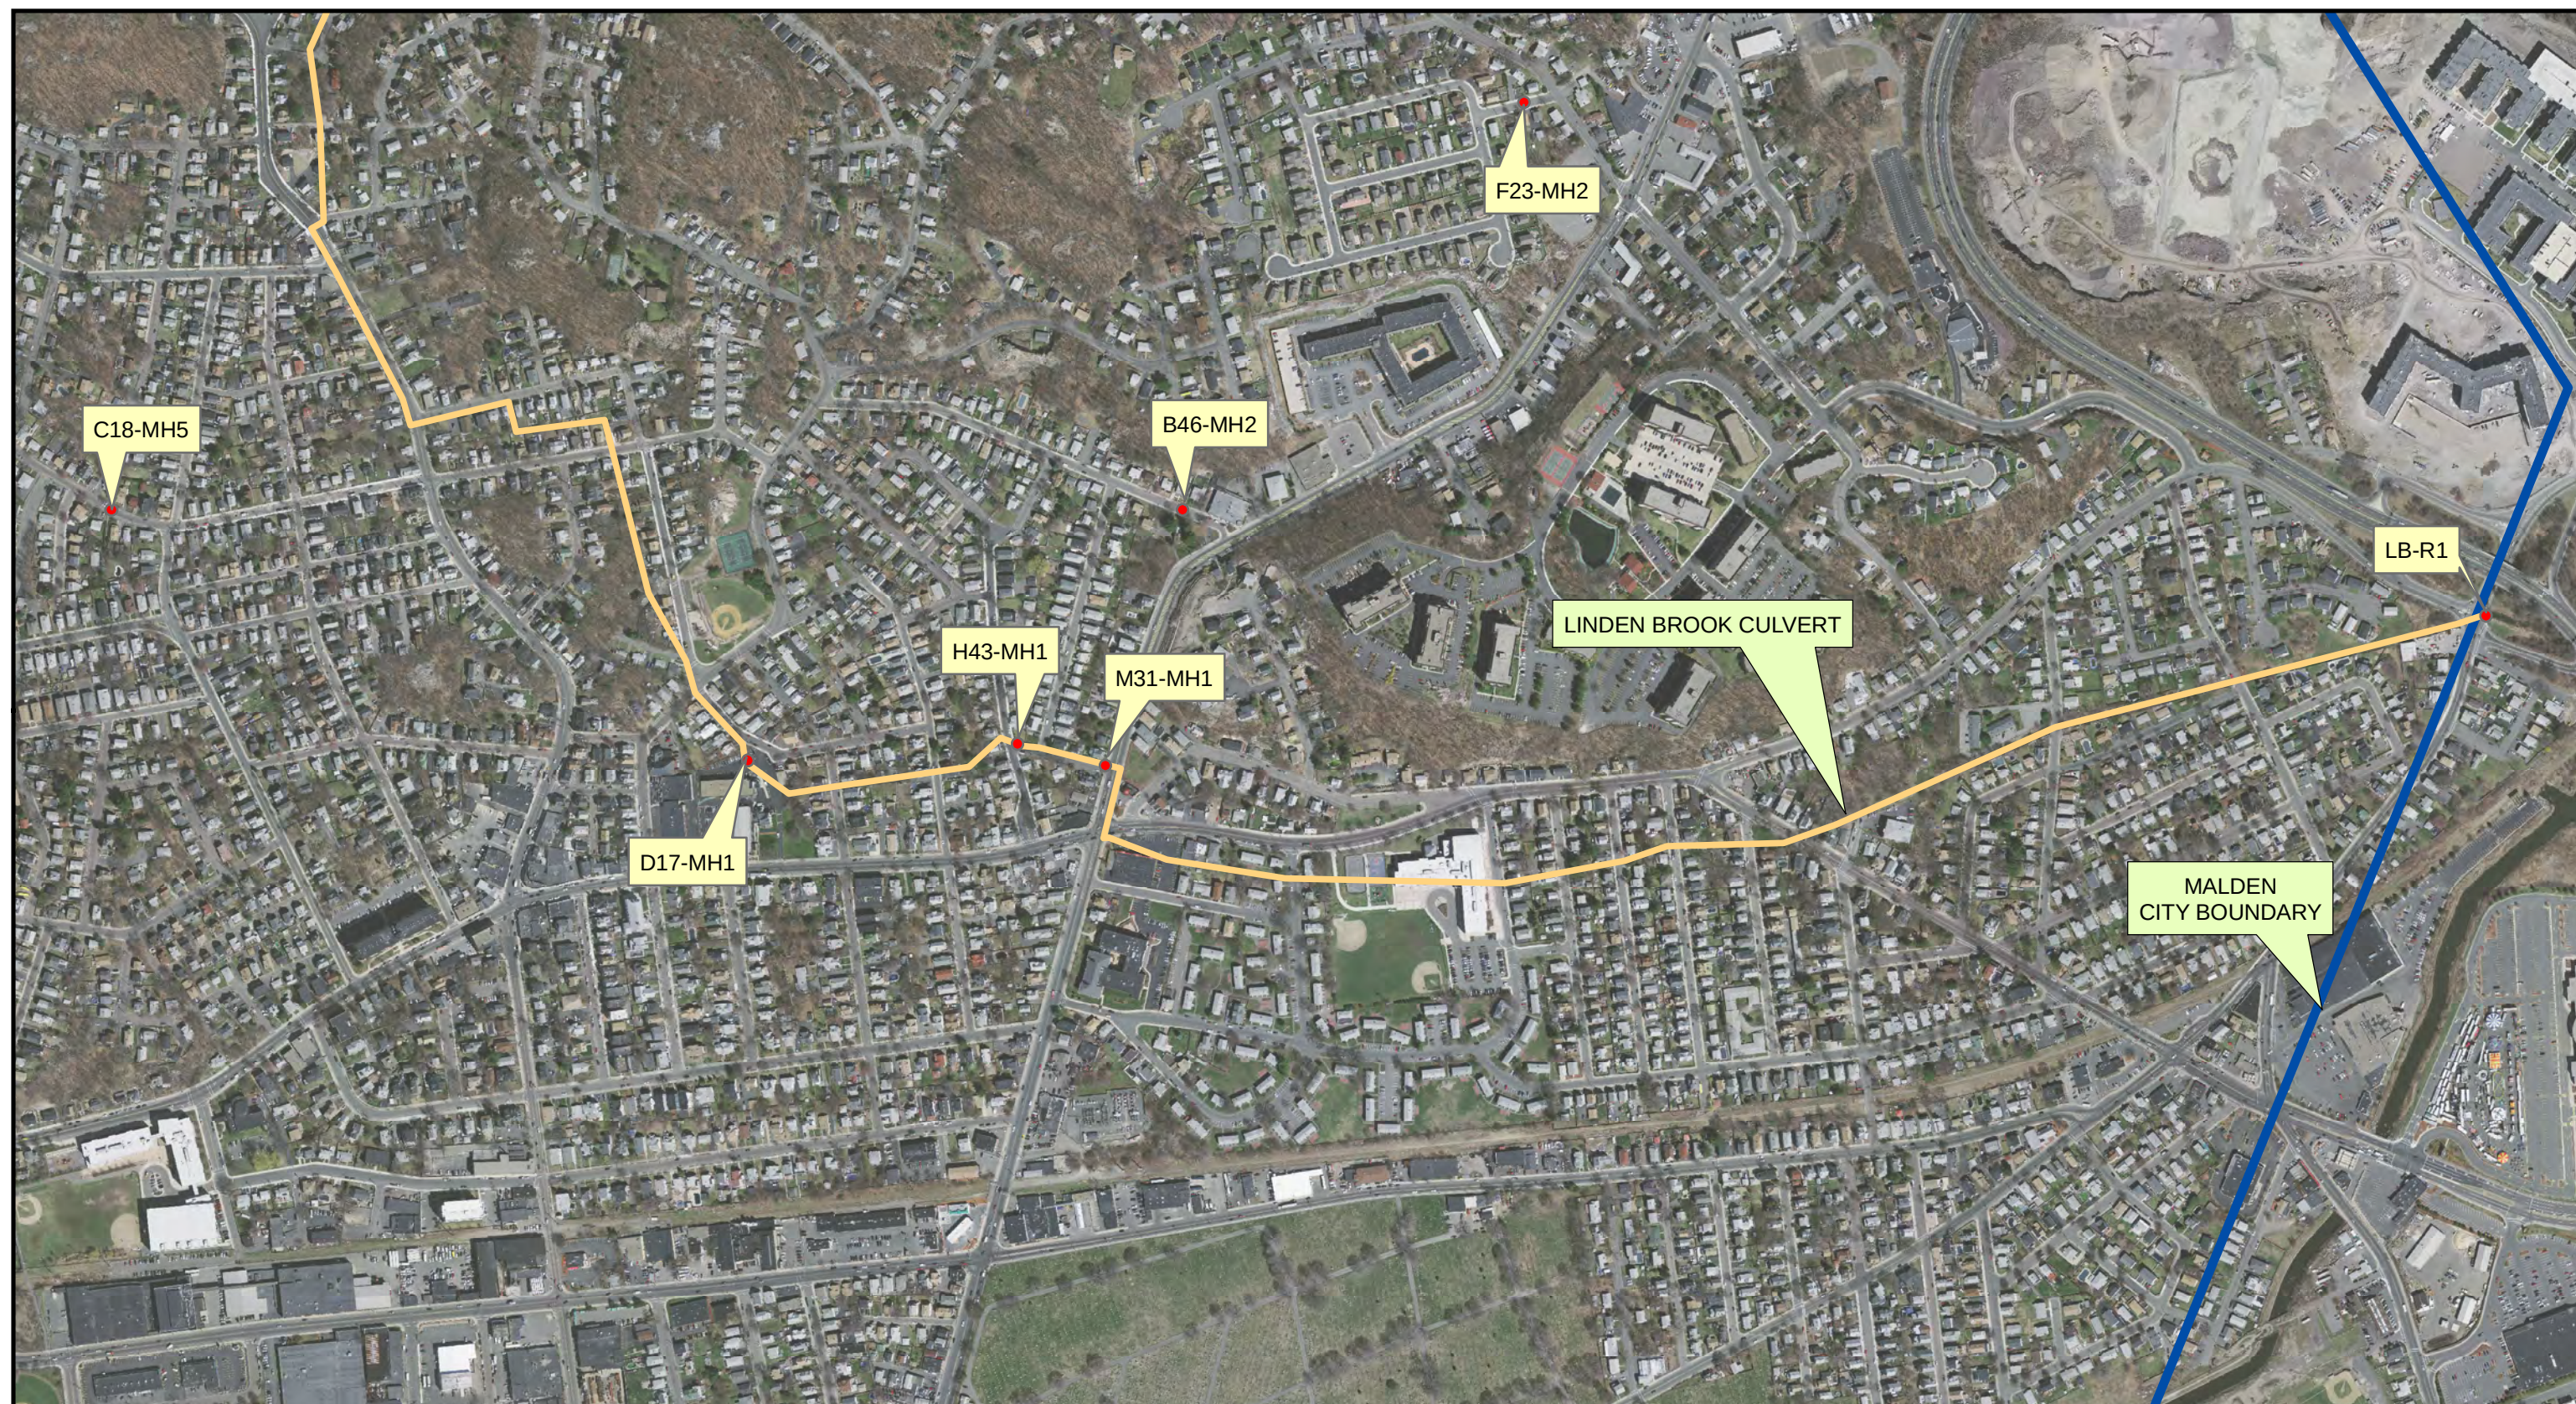
**Figure 7 - Dry Weather Sampling Program**  
MALDEN, MASSACHUSETTS

During the September 2012 sampling event, representatives of the USEPA collected a water sample from outfall LBR-1 (Figure 7), located in Revere, where distinct indications of sewage odors were noted. Consistent with identification of strong sewage odors and immediately apparent from a review of Table 3.0 is the significantly elevated level of E. coli (>241,920 MPN/100 ml) detected in sample LBR-1. To assess this condition and as described in prior status reports, the City of Malden contracted with National Water Main Cleaning Company, under the supervision of CDM Smith. As summarized in the following excerpt from an email to the City of Malden from CDM Smith, it is believed that line blockage due to grease build up may have been a crucial factor for the conditions identified at LBR-1, in addition to a “minor” defect in the form of a leaky joint. Although maintenance was routinely performed on this siphon, the extent of grease build up indicates that a higher frequency of cleaning and maintaining is necessary to further understand the condition.

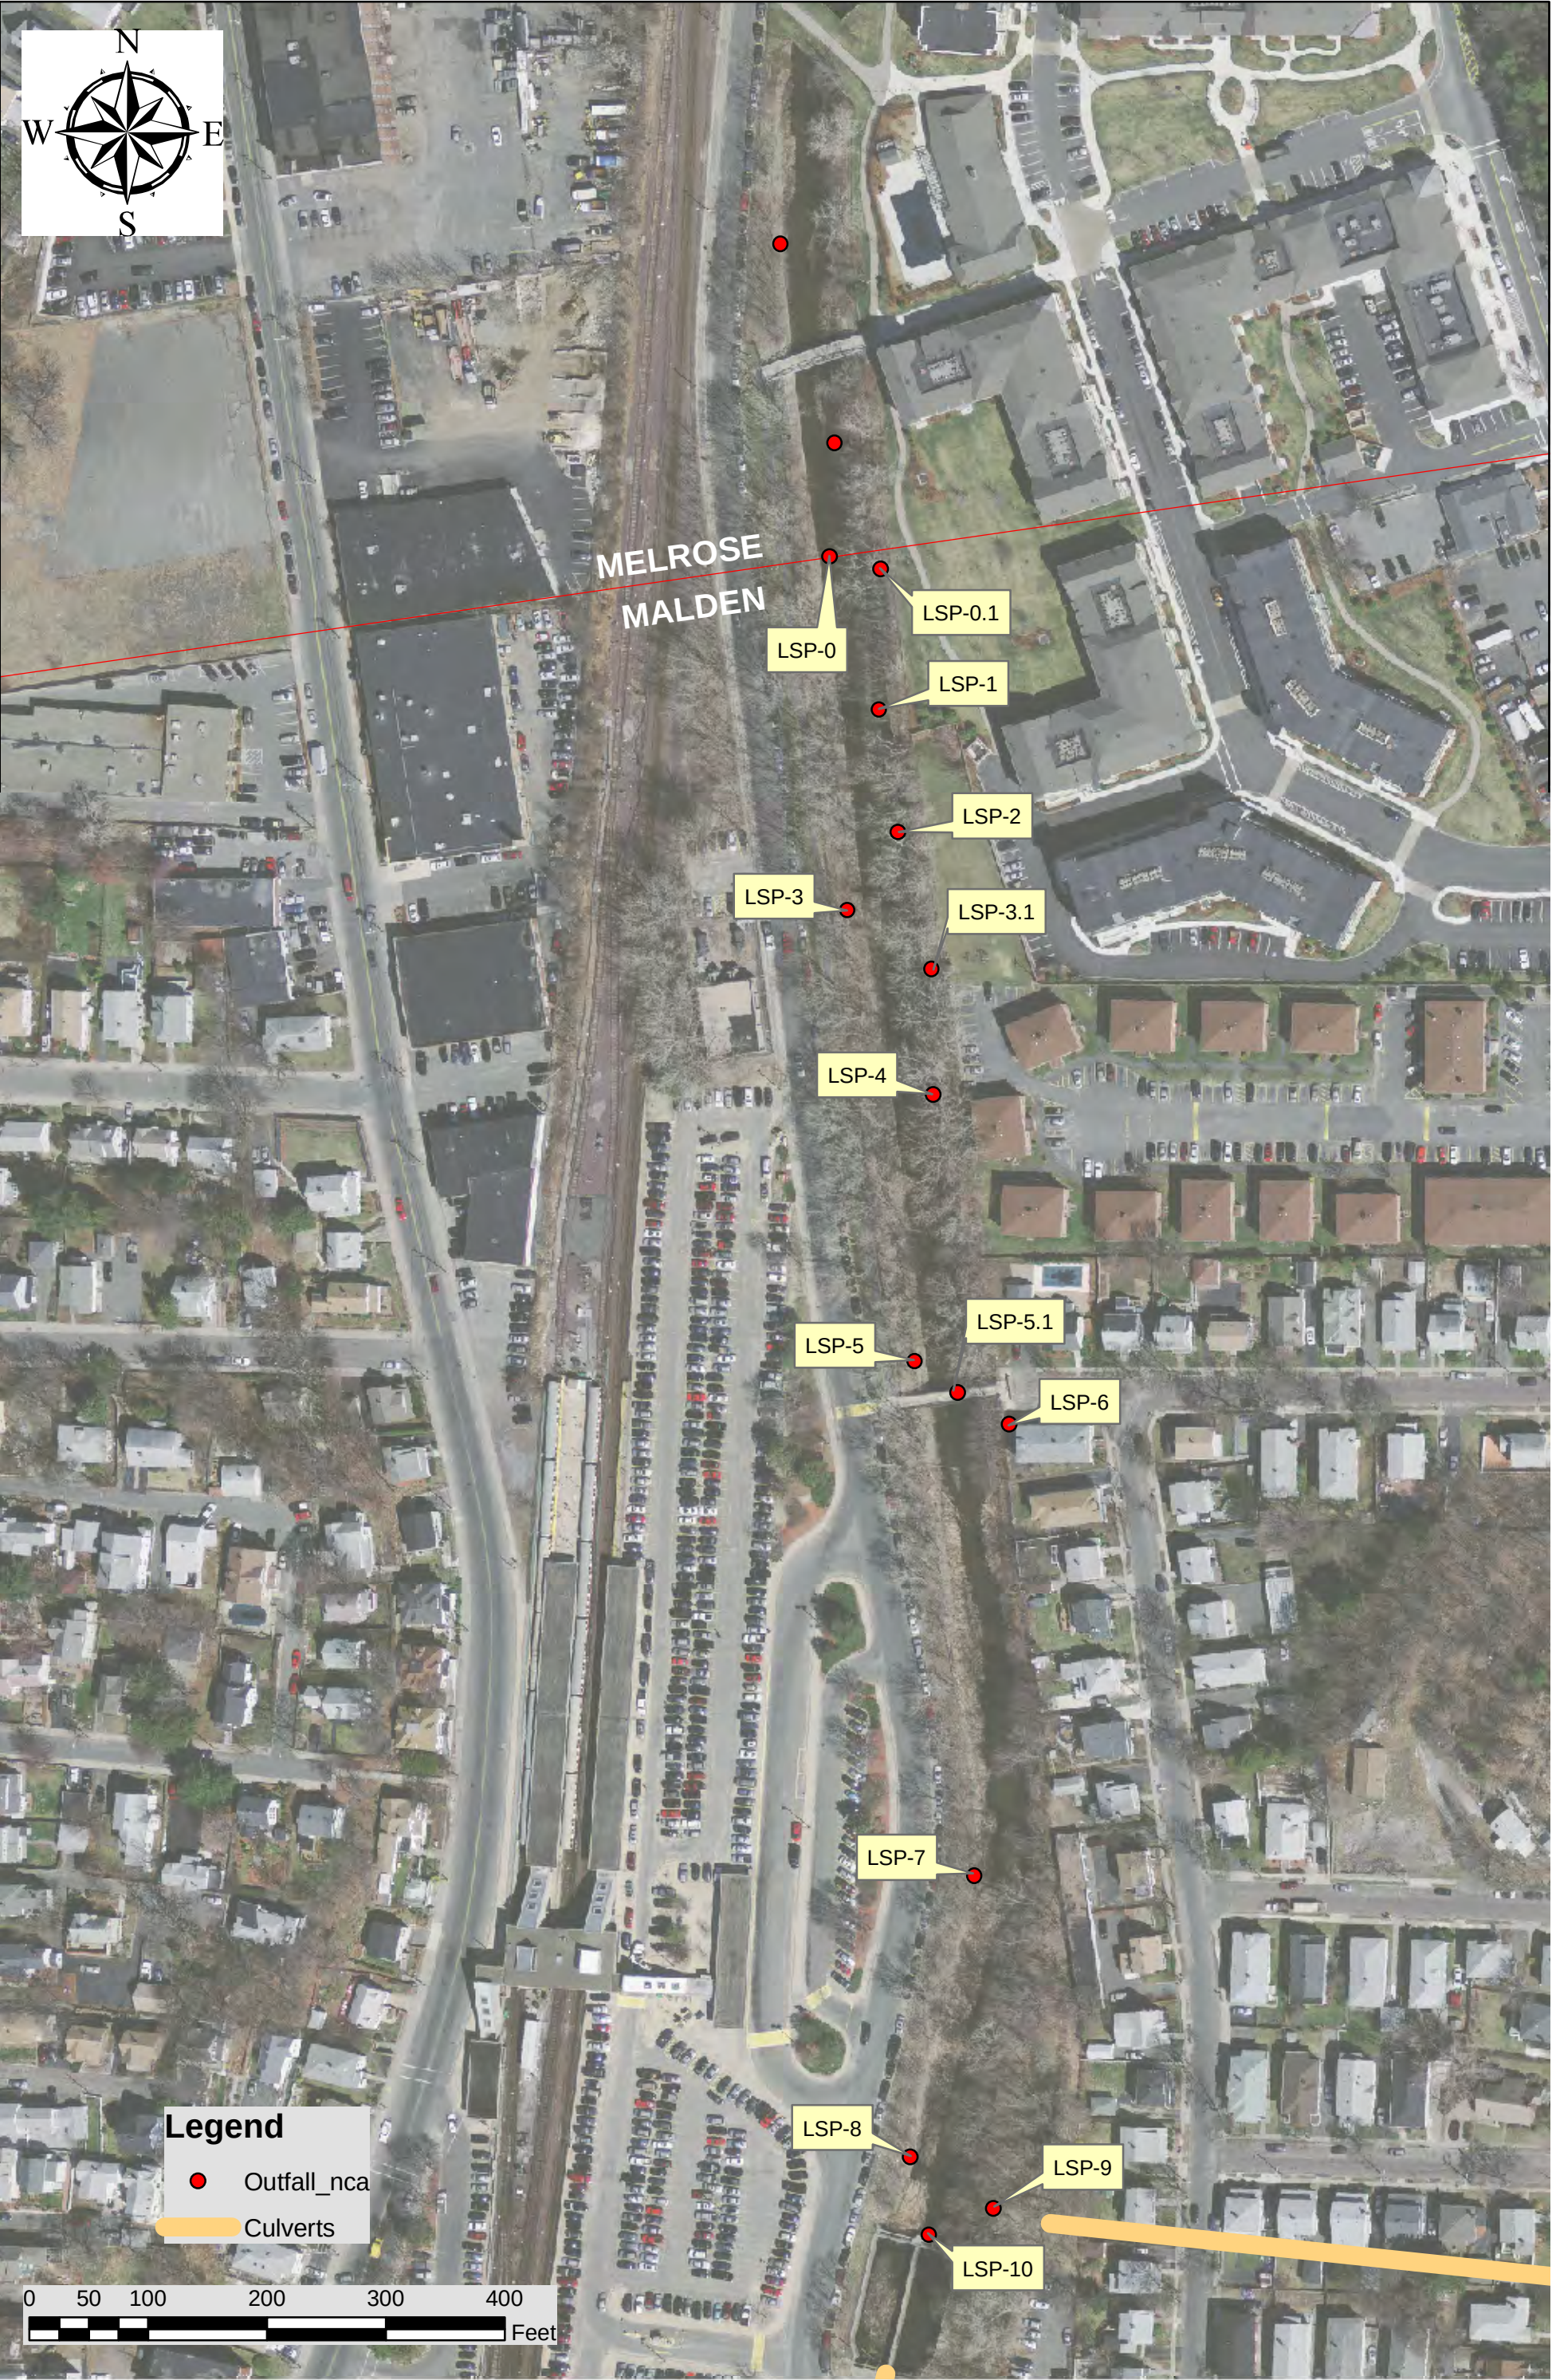
Figure 7 - Lower Spot Pond Brook Outfalls

The Stormwater Compliance Team has conducted numerous dry weather sampling events to investigate the elevated E. coli levels encountered previously at LSP-4, an outfall for the drainage system located within Eldrich Drive (Figure 7). Base flow, as groundwater, is consistently observed within this drainage network and to isolate potential sewage contributions to this base flow, a comprehensive evaluation of the flow conveyance network associated with LSP-4 was completed in February 2012. Given the proximity of the sewer and drain lines to LSP-4, as well as the settlement of the drain line in the area of Buildings 1054 and 1056 Elrich Drive, the focus of assessment activities was directed towards the sewer laterals and nearby drainage line servicing the two apartment buildings. Following dye testing by the Compliance Team, camera surveys performed by representatives of the property owner confirmed that compromises to the laterals servicing two (2) residential building had occurred. Recommendations made by the SCT involved restoring the integrity of the main drainage line to stop the discharges that have been documented at LSP-4. Working with representatives of the Malden Engineering Department, repairs to the sewer laterals in the area of Building 1054 and 1056 were completed by the property owner in March 2012. Several attempts have been made to collect a dry weather flow sample from LSP-4, however due to base flow within the Oak Grove

Channel; this sample location has been inaccessible. It is anticipated that during the next reporting period, a dry weather sample will be collected from LSP -4 to evaluate the effect of the sewer lateral repair.
