**Municipality/Organization:** City of Malden  
**EPA NPDES Permit Number:** MA041046  
**MADEP Transmittal Number:** 041088  
**Annual Report Number  
& Reporting Period:** No. 13: April 1, 2015-March 31, 2016

## NPDES PII Small MS4 General Permit Annual Report

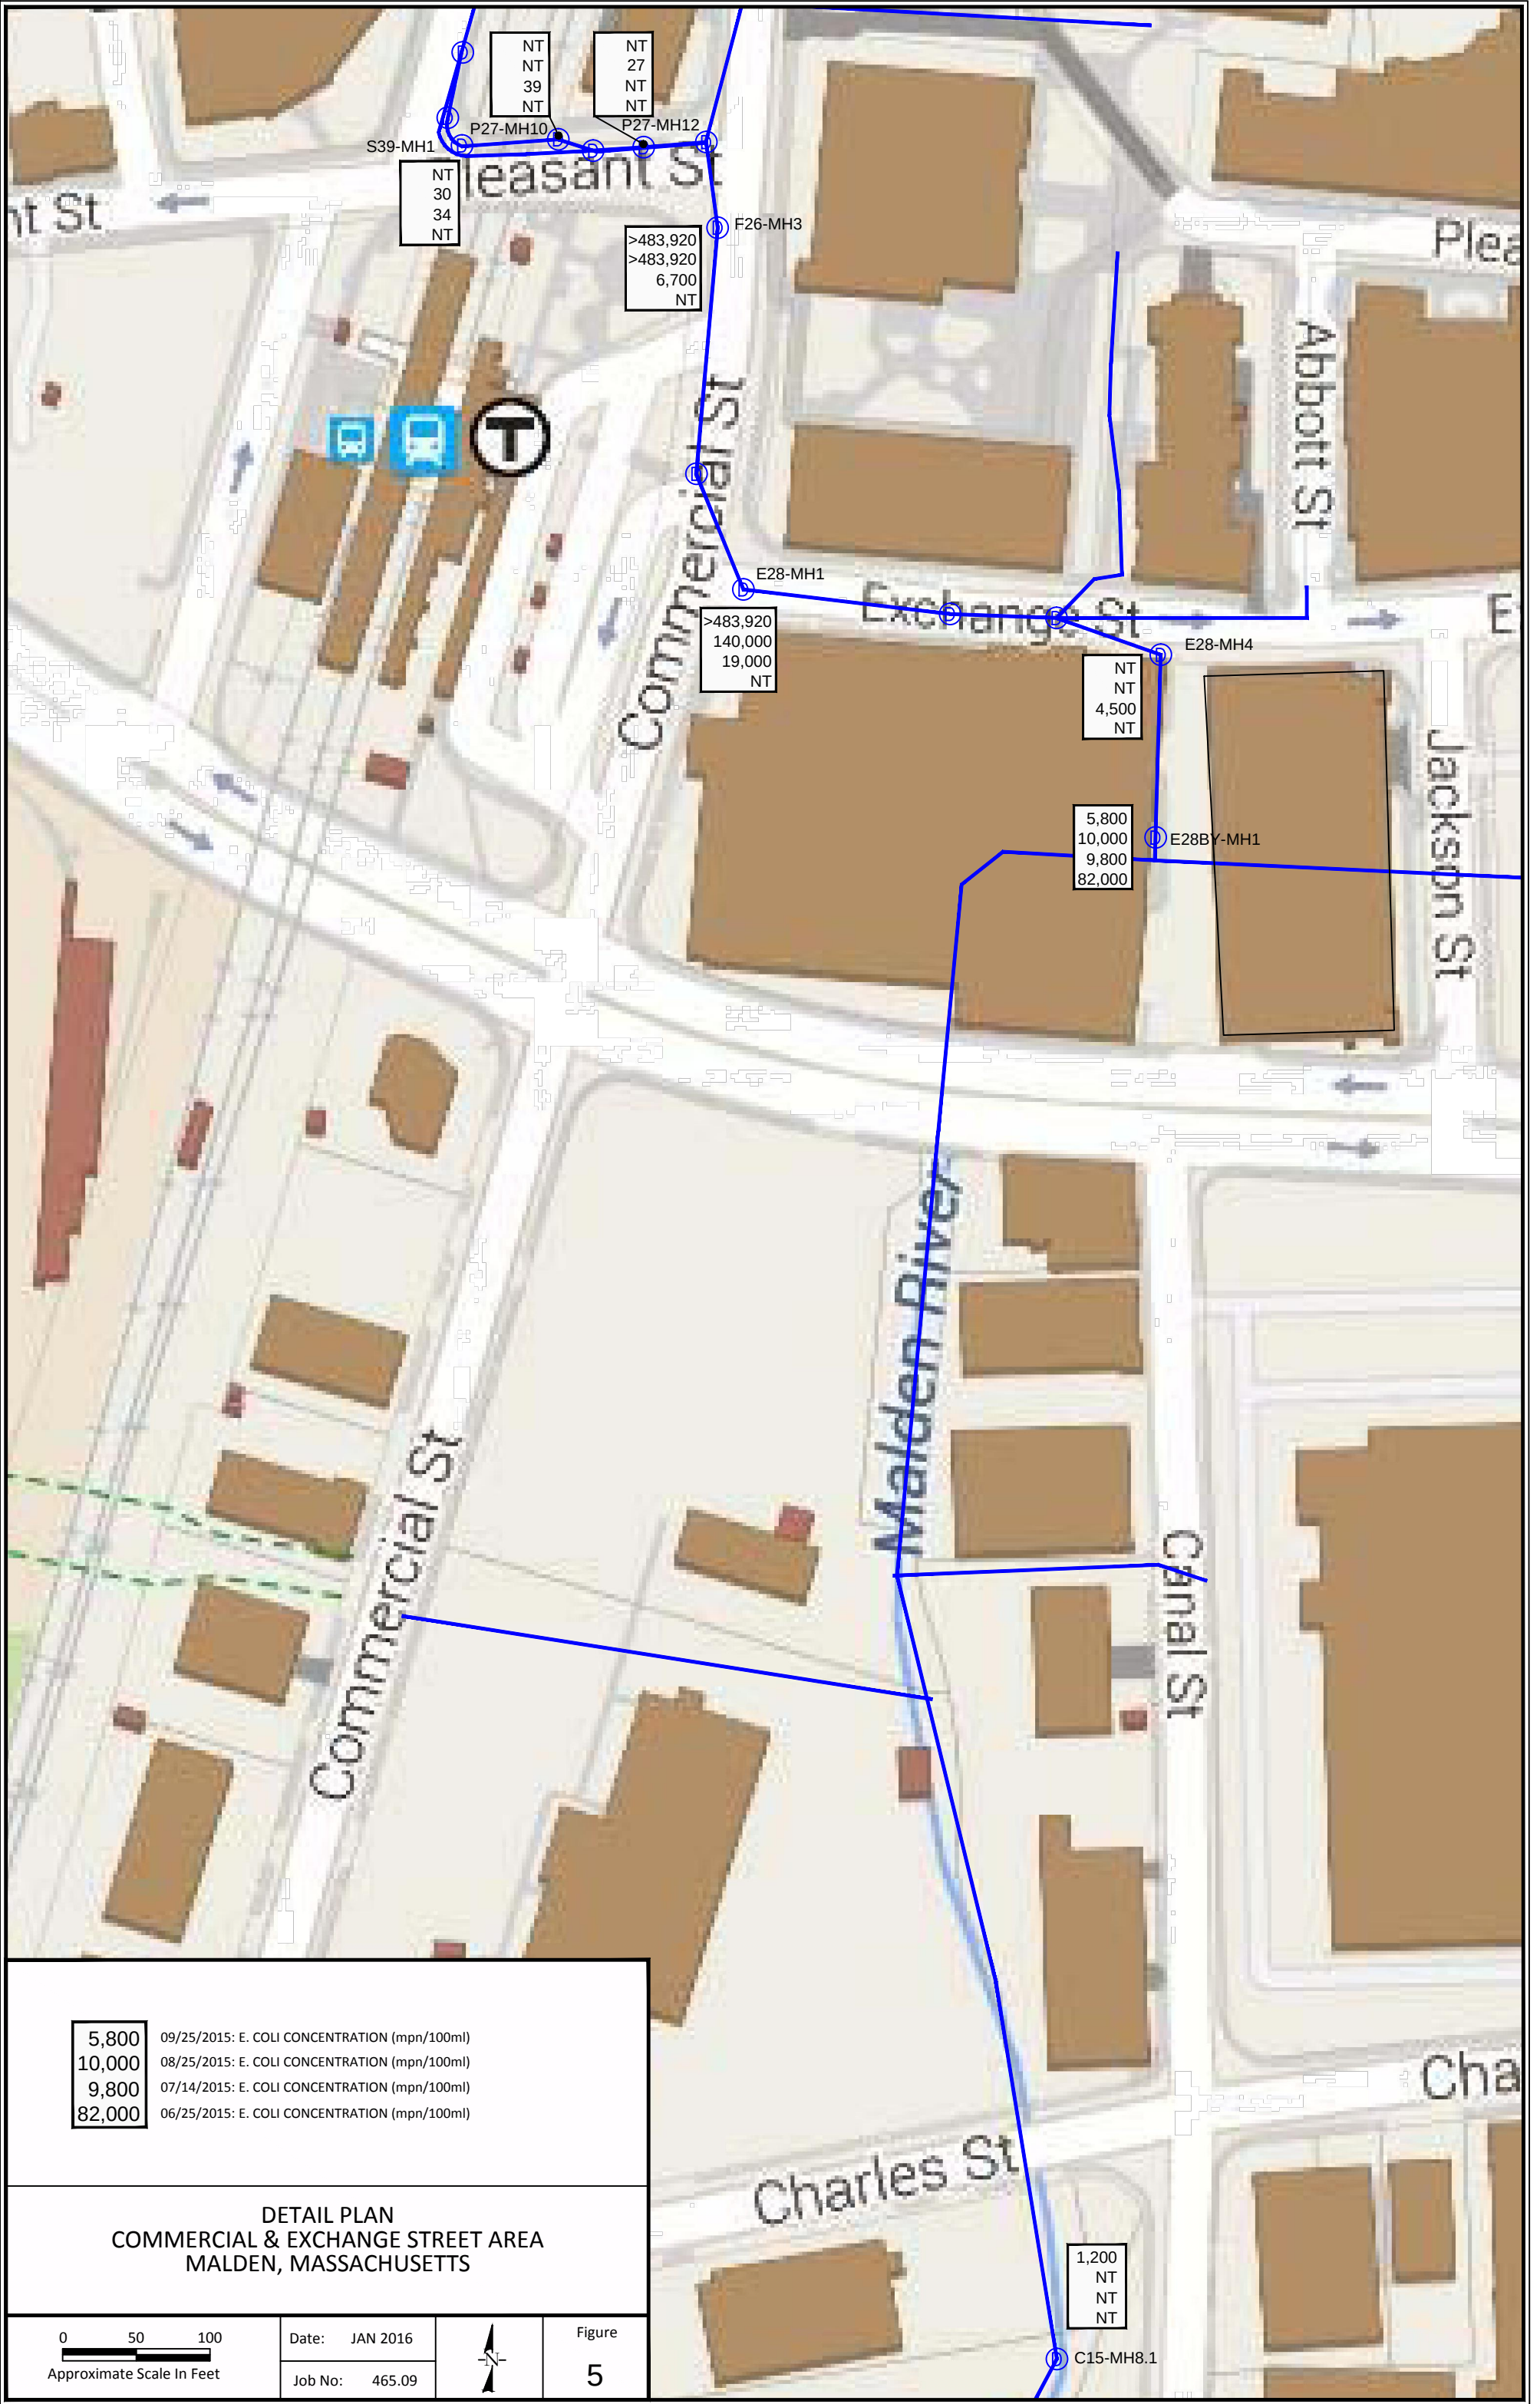
Figure  
5

During this reporting period, three (3) sampling events were conducted within the Exchange Street/Florence Street portion of the Malden River watershed in response to the detection of high *E. coli* levels during a 25 June 2015 dry weather sampling event at manhole E28BY-MH1, which is located between Route 60 and Exchange Street (Figure 5). As outlined with the last status report, an evaluation of the drainage manhole revealed an approximate 48-inch RCP line with a flow that was observed to be approximately 10 – 12 gallons per minute. Based upon a review of historic plan information, as well as field observations, it appears the flow moves in a southerly direction into the Spot Pond Brook culvert, which ultimately discharges into the Malden River. Due to the high levels of *E. coli* encountered at E28BY-MH1, an additional sampling round was conducted on 14 July, 2015 by the Stormwater Compliance Team at E28BY-MH1 and several upstream drain manholes located on Exchange Street, Commercial Street and Pleasant Street. As shown on Table 3.0 and Figure 5, an *E. coli* concentration of 9,800 MPN/100ml was encountered at E28BY-MH1. Elevated *E. coli* concentrations were also detected at three (3) of the five (5) upstream manholes, with the highest levels encountered at E28-MH1 (19,000 MPN/100ml), which is approximately 400 feet northwest of E28BY-MH1 (Figure 5).

at E28BY-MH1, where a concentration of 5,800 MPN/100ml was encountered. To determine if the elevated E. coli levels encountered within the drainage system in the Exchange Street area were impacting the Malden River, a sample was collected from the closest accessible manhole upstream of the river. This manhole, (C15-MH8.1) is located south of Charles Street and approximately 330 feet north of the Malden River (Figure 5). As shown on Table 3.0, an E. coli level of 1,200 MPN/100ml was detected. It should be noted that the water in manhole C15-MH8.1 was stagnant at the time of sampling. Further, the inspection of E39-MH1 revealed strong sewage odor and the evaluation of both the sewage and drainage infrastructure indicated that the invert elevations for the piping systems were very close. As the comprehensive assessment of the drainage system in the Exchange Street/Commercial Street area revealed no illicit connections or discharges, it is likely that the elevated E. coli levels are attributable to sewer discharge infiltration. In response to the observations recorded within the Exchange Street area, representatives of CDM were requested to review the results of their inflow/ infiltration investigation in the area and according to CDM, no significant or obvious signs of infiltration or exfiltration were noted. The City has allocated targeted emergency funding from the upcoming sewer repair contract to re-line the sewer lines in Pleasant and Exchange Streets, however according to City representatives, this work will not begin until August of 2016. In the interim, the City is in the process of hiring a water main company to camera the area of concern to investigate as necessary. Following the winter season, an increase in sampling frequency for E. coli will be initiated in the Pleasant and Exchange Street area.

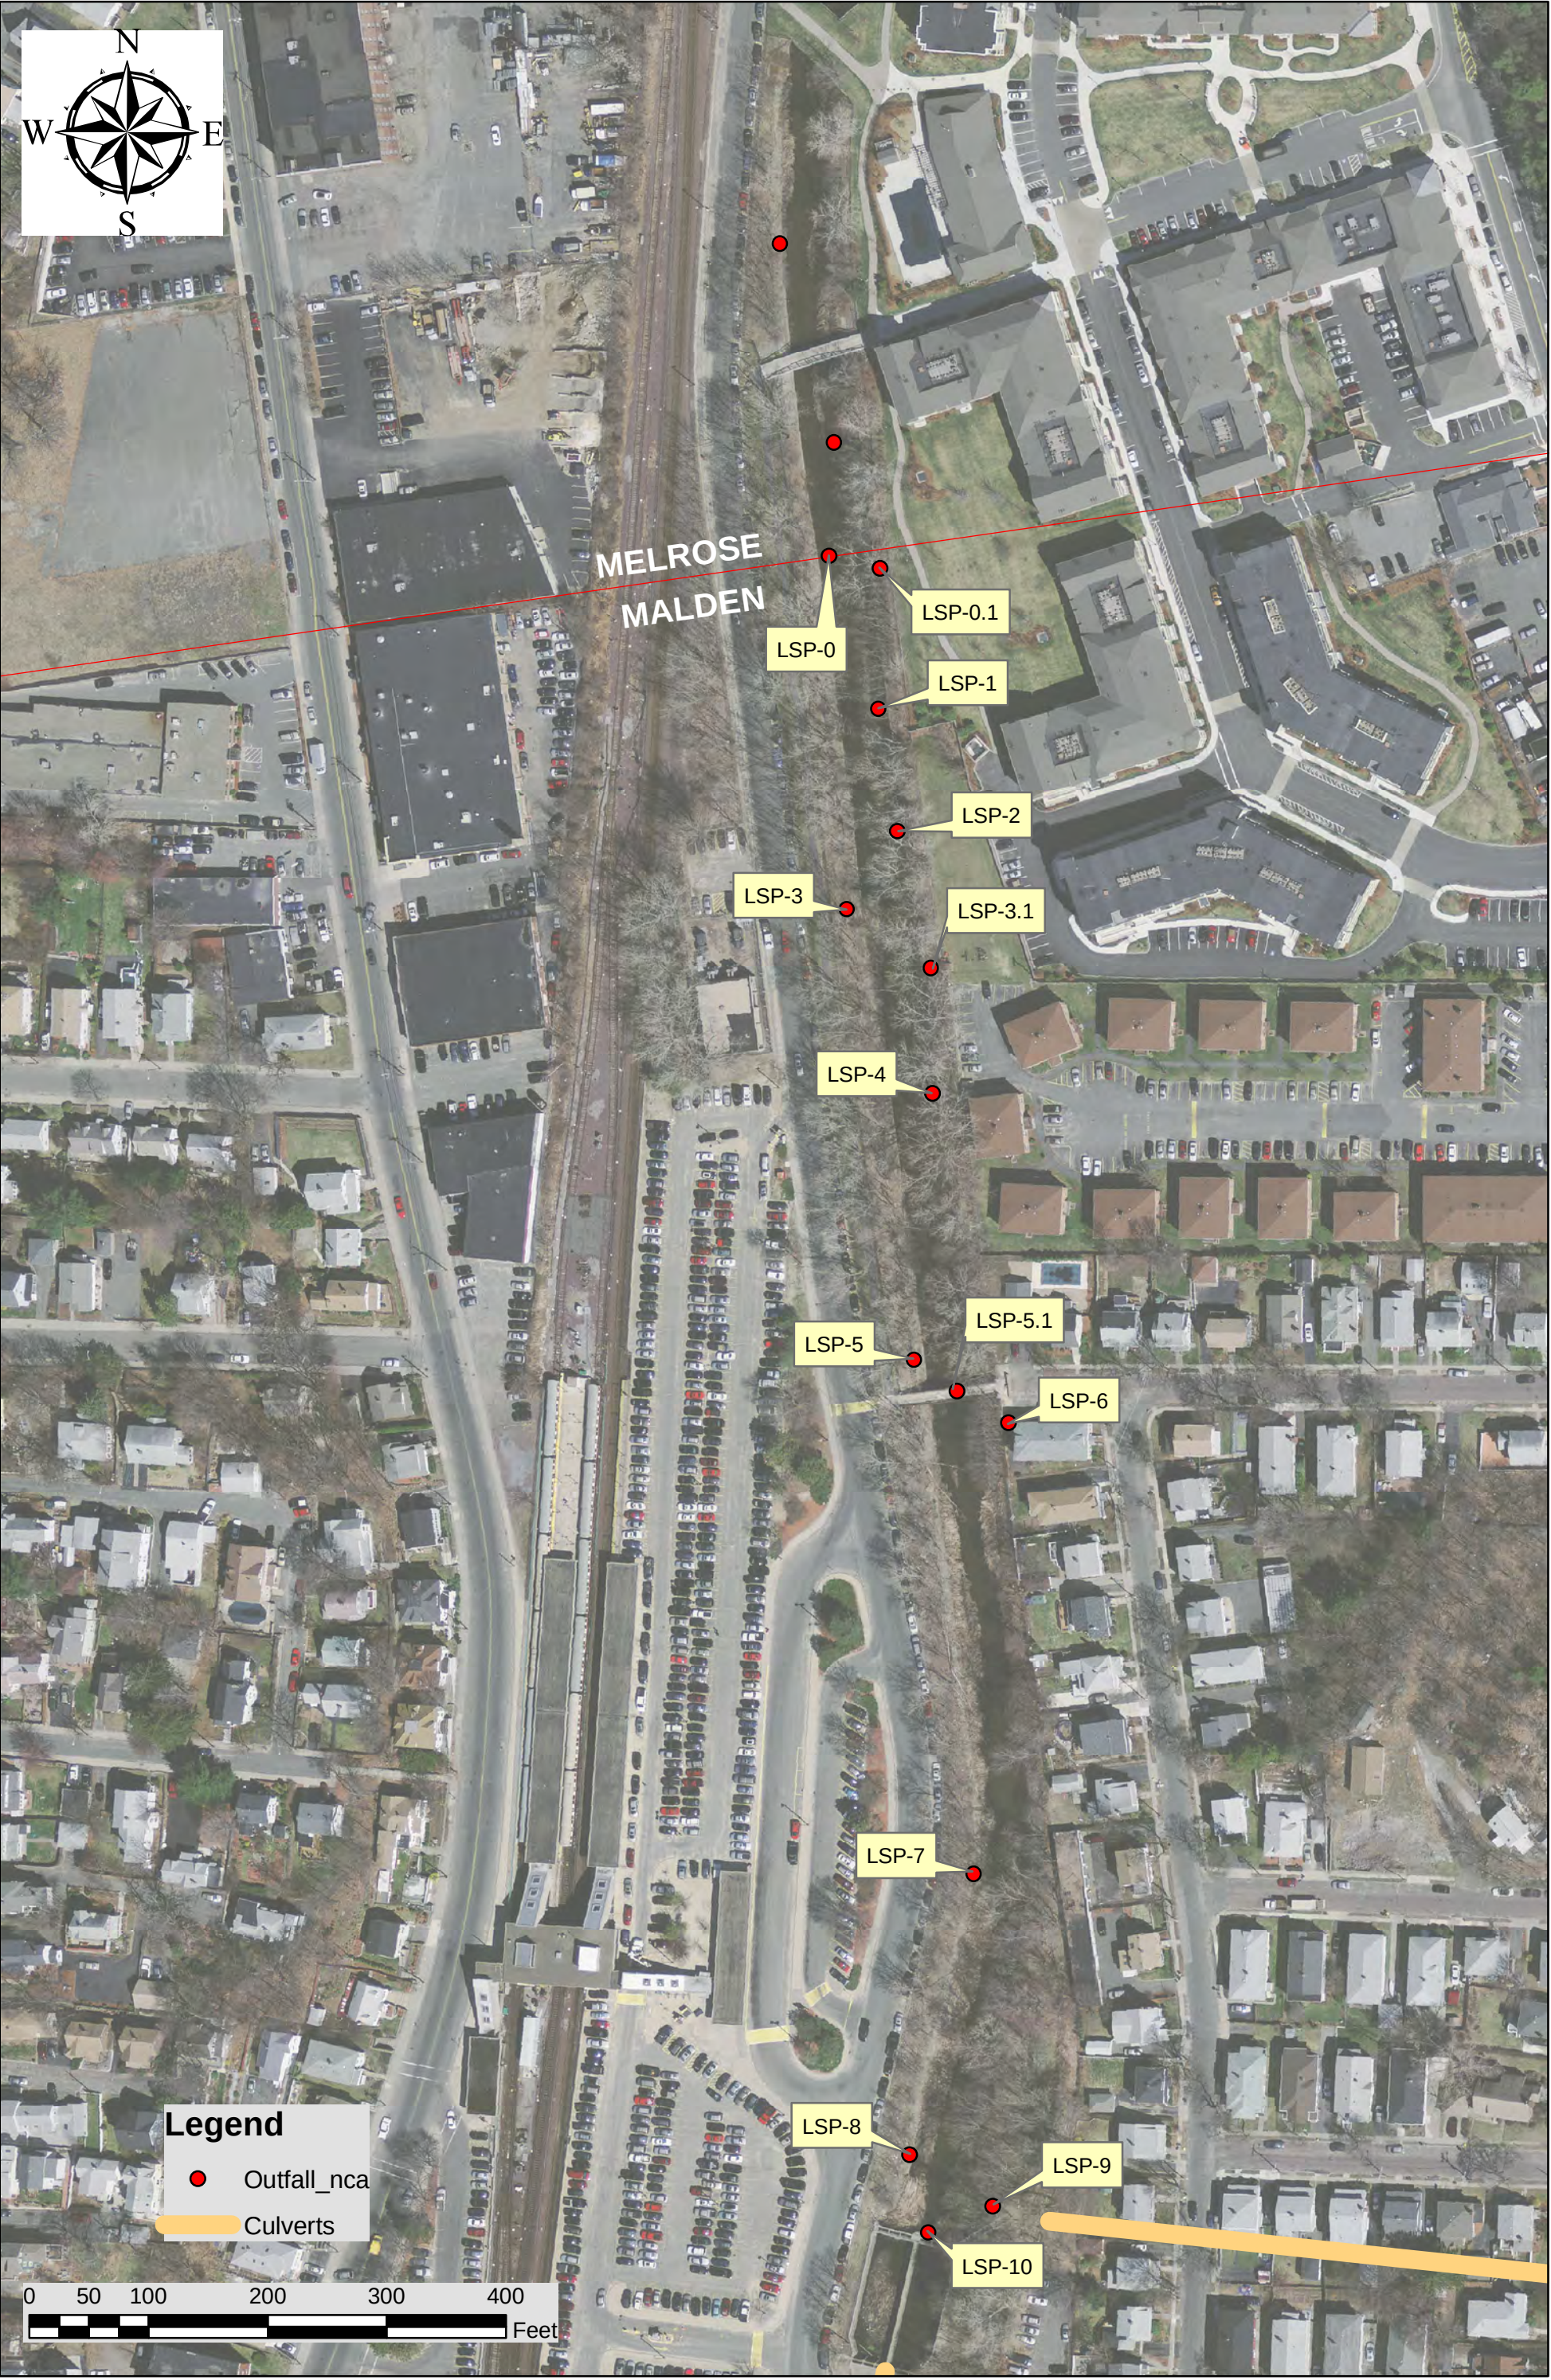
Figure 6 - Lower Spot Pond Brook Outfalls

The Stormwater Compliance Team has conducted numerous dry weather sampling events to investigate the elevated E. coli levels encountered previously at LSP-4, an outfall for the drainage system located within Eldrich Drive (Figure 6). Base flow, as groundwater, is consistently observed within this drainage network and to isolate potential sewage contributions to this base flow, a comprehensive evaluation of the flow conveyance network associated with LSP-4 was completed in February 2012. Given the proximity of the sewer and drain lines to LSP-4, as well as the settlement of the drain line in the area of Buildings 1054 and 1056 Elrich Drive, the focus of assessment activities was directed towards the sewer laterals and nearby drainage line servicing the two apartment buildings. Following dye testing by the Compliance Team, camera surveys performed by representatives of the property owner confirmed that compromises to the laterals servicing two (2) residential building had occurred. Recommendations made by the SCT involved restoring the integrity of the main drainage line to stop the discharges that have been documented at LSP-4.

Working with representatives of the Malden Engineering Department, repairs to the sewer laterals in the area of Building 1054 and 1056 were completed by the property owner in March 2012. Since that time, and as summarized on Table 3.0, dry weather flow samples collected from LSP-4 has decreased significantly relative to concentrations detected in 2012. However, during the 2 July 2014, an *E. coli* concentration of 110,000 MPN/100 ml was detected at LSP-4. An additional sample was collected on 5 November 2014, with an *E. coli* concentration of 3,200 MPN/100 ml detected. Field observations noted at that time by NCA included an increased discharge relative to prior sampling events. According to the City Engineering Department, the Eldrich Drive complex is under new ownership and the City has attempted to contact the property owner numerous times to discuss the sampling results, however the owner has been unresponsive. Accordingly, more formal enforcement measures are under consideration at this time.

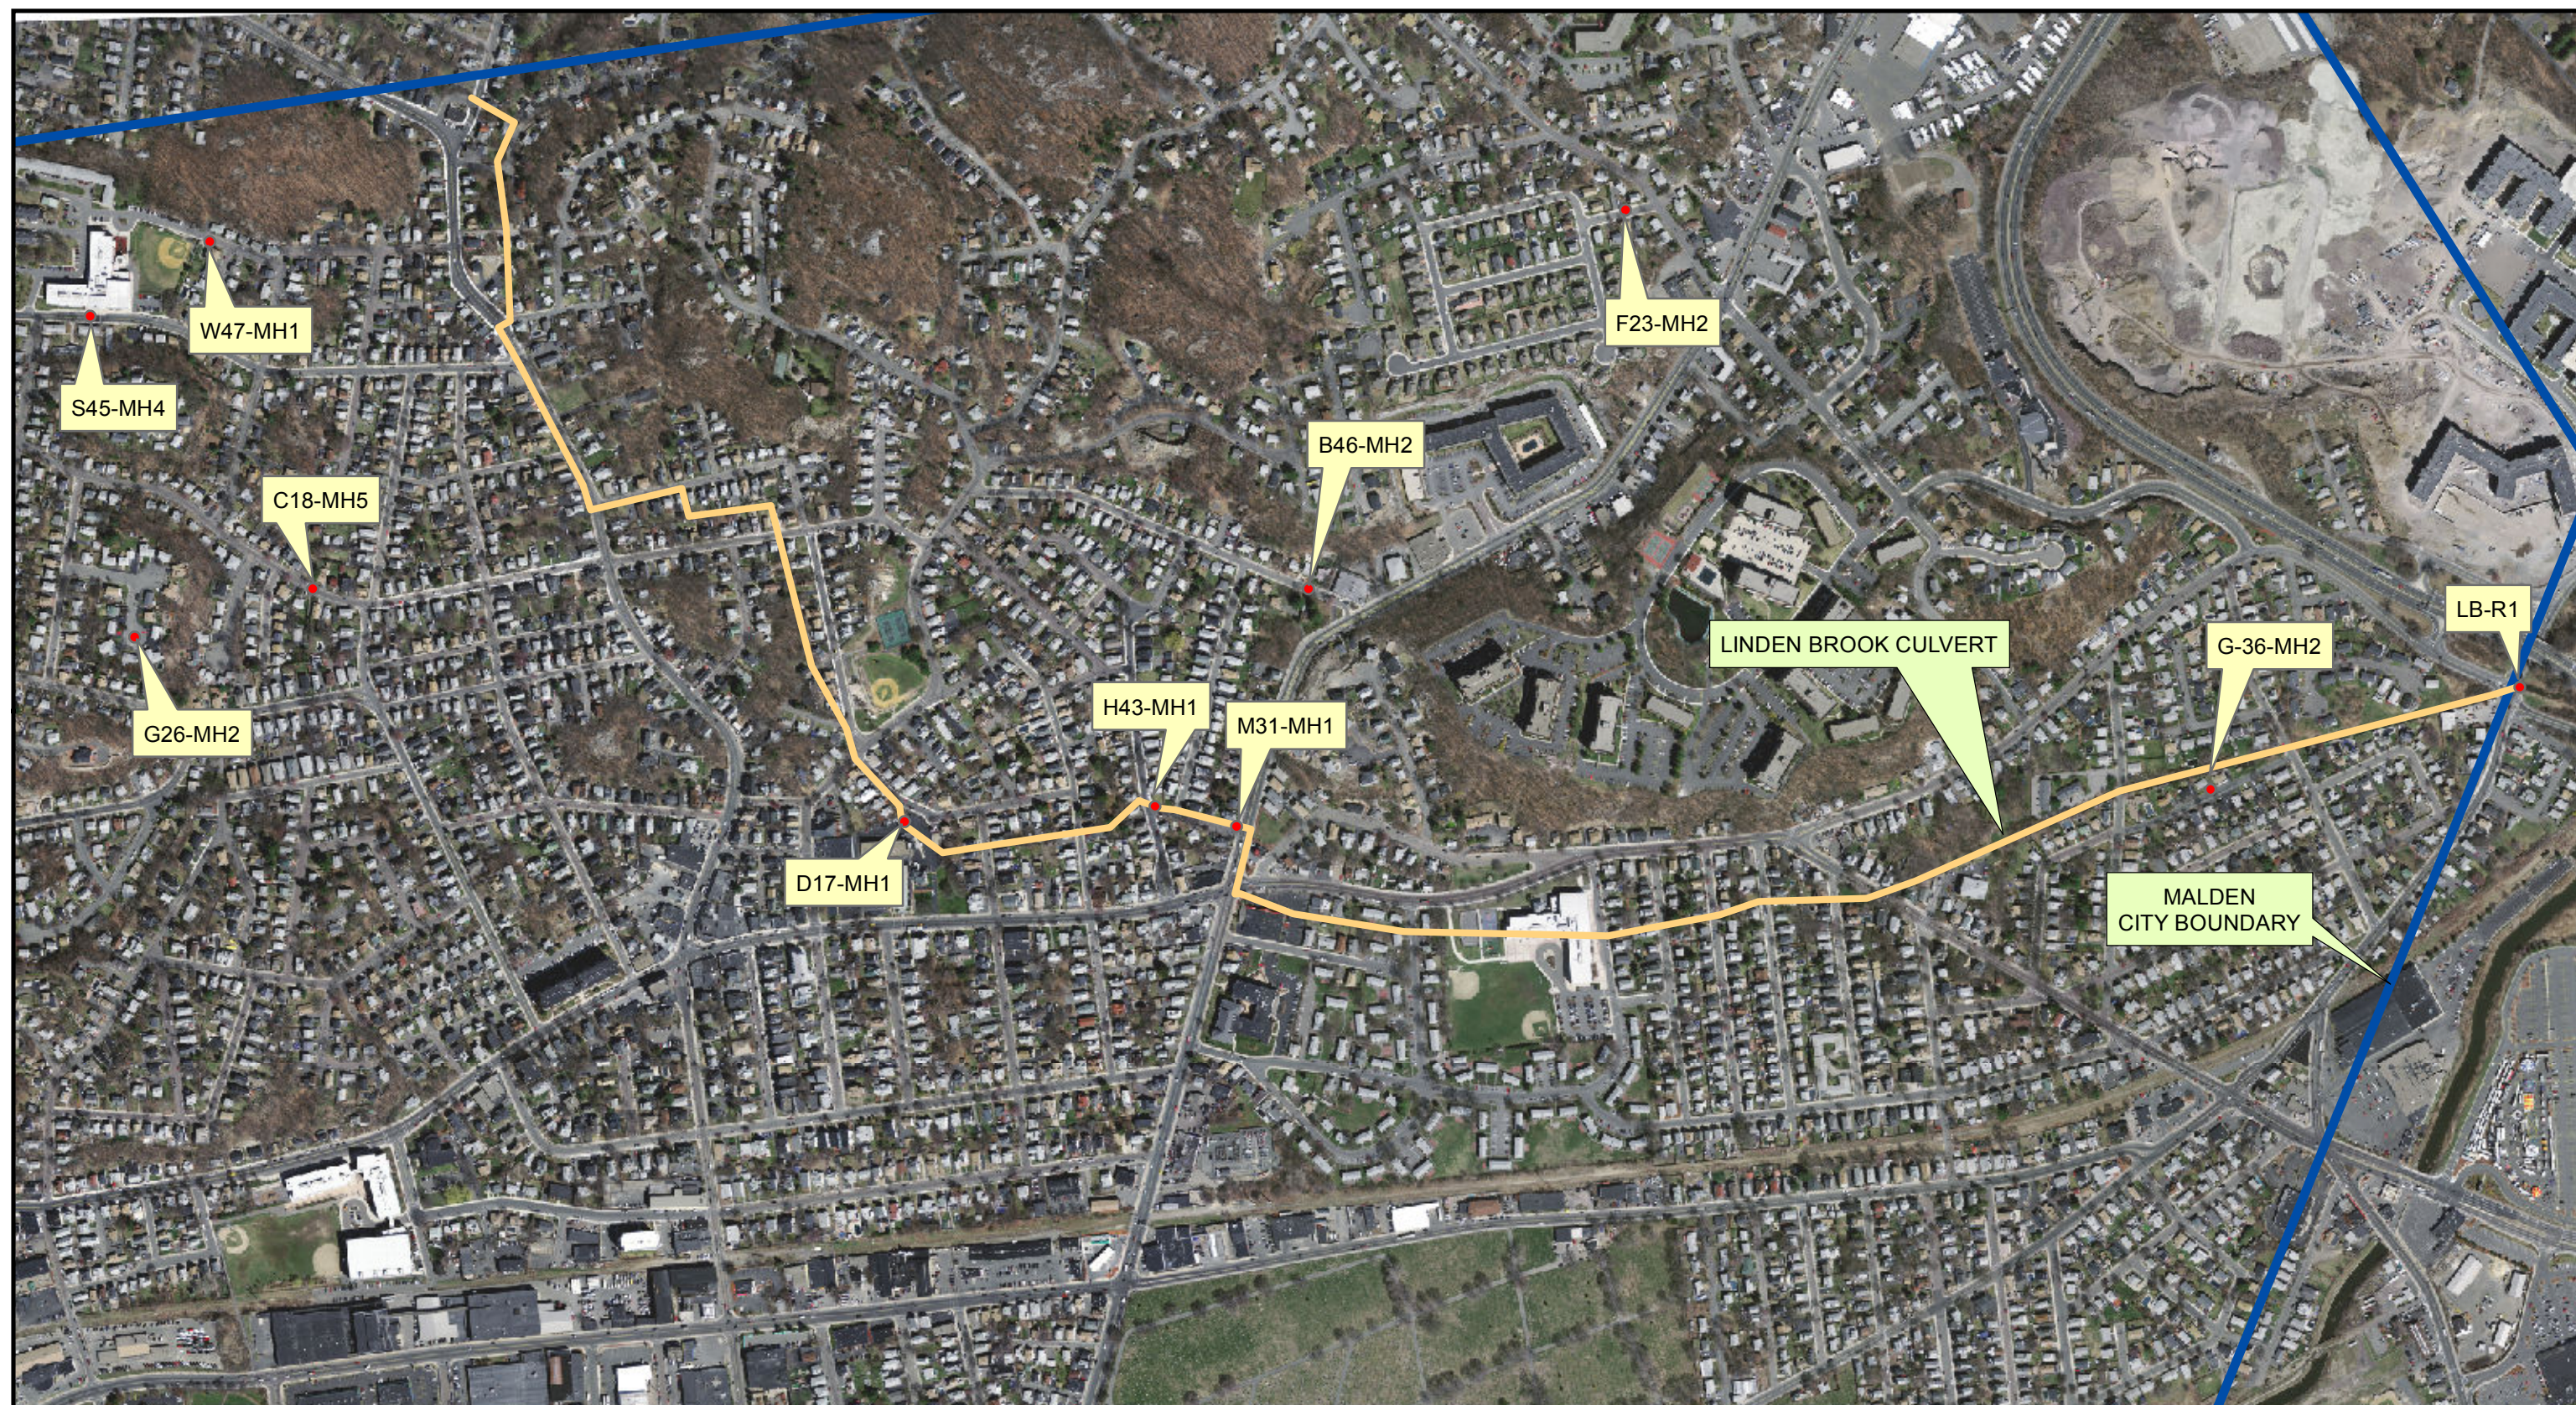
**Figure 8 - Dry Weather Sampling Program-Linden Brook**  
MALDEN, MASSACHUSETTS

During the September 2012 sampling event, conducted with representatives of the USEPA, a water sample was collected from outfall LBR-1 (Figure 8), located in Revere, at which time distinct indications of sewage odors were noted. Consistent with identification of strong sewage odors and immediately apparent from a review of Table 3.0 is the significantly elevated level of *E. coli* (>241,920 MPN/100 ml) detected in sample LBR-1. To assess this condition and as described in prior status reports, the City of Malden contracted with National Water Main Cleaning Company, under the supervision of CDM Smith. As summarized in the following excerpt from an email to the City of Malden from CDM Smith, it is believed that line blockage due to grease build up may have been a crucial factor for the conditions identified at LBR-1, in addition to a “minor” defect in the form of a leaky joint. Although maintenance was routinely performed on this siphon, the extent of grease build up indicates that a higher frequency of cleaning and maintaining is necessary to further understand the condition.
