CASTOR PROJECT

EPA RAIN WORKS GROUP M5

DESIGN GOALS

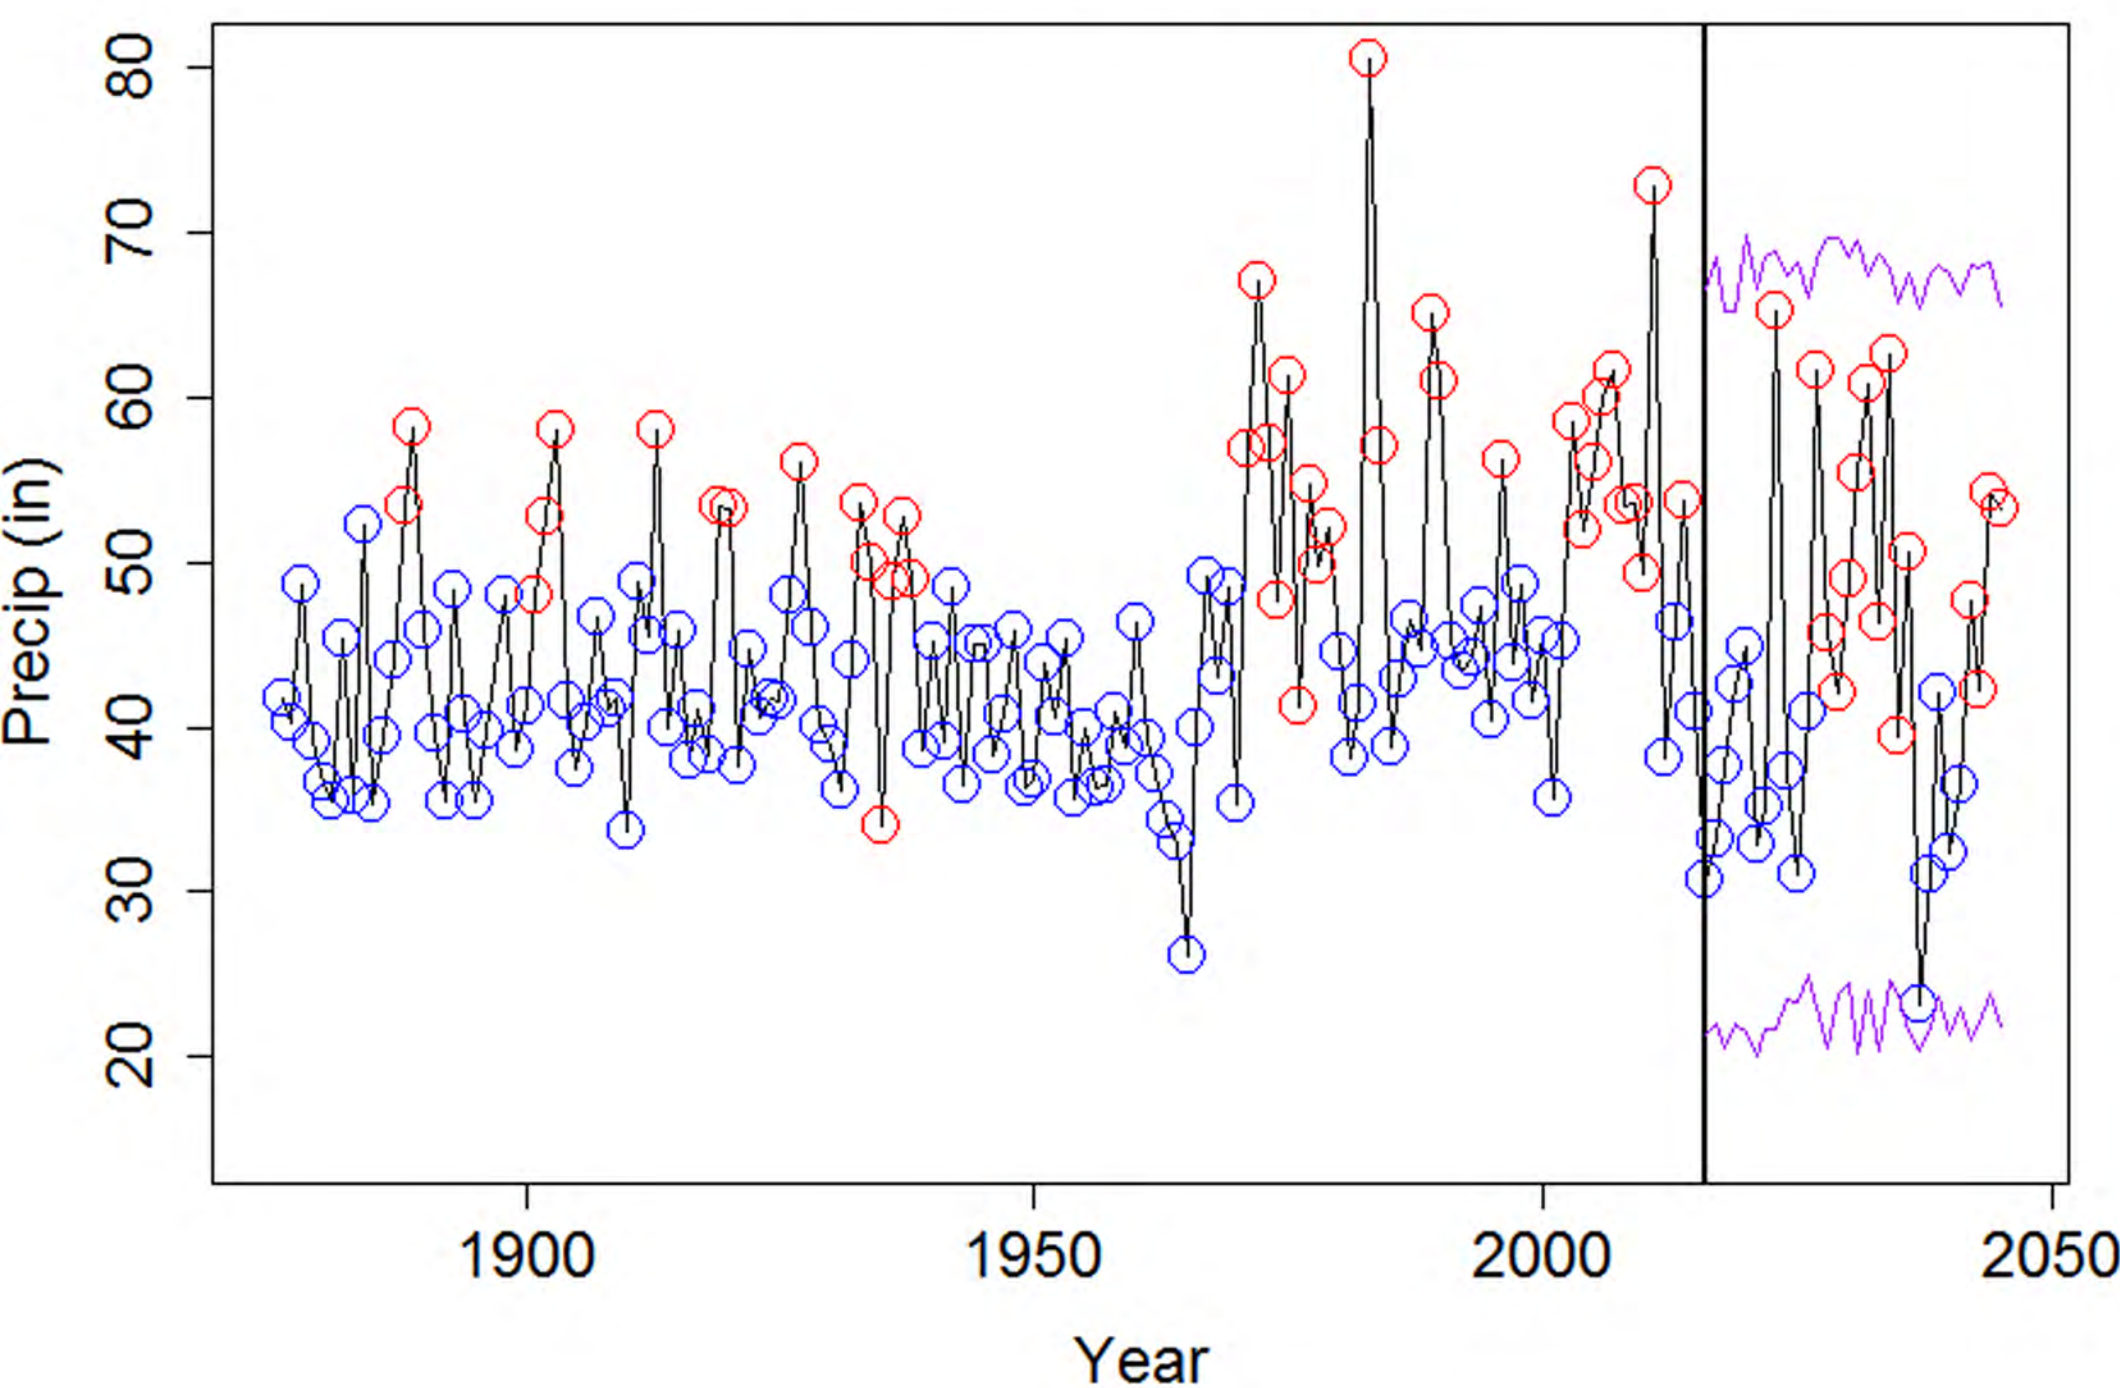
TRENDS IN RAINFALL

THE PRECIPITATION MODEL

An upward trend in the inches of precipitation campus will receive is projected. New infrastructure is required in order to limit the amount of storm water campus contributes to New York City's combined sewage overflow, an issue estimated to cost the city millions annually.

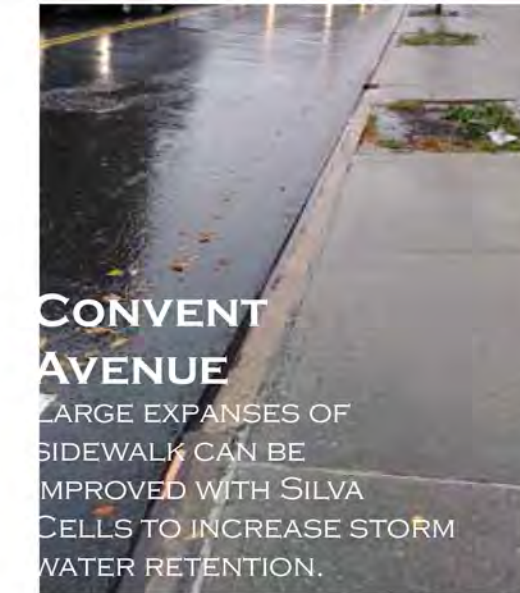
CONVENT AVENUE
LARGE EXPANSIONS OF SIDEWALK CAN BE IMPROVED WITH SILVA CELLS TO INCREASE STORM WATER RETENTION.

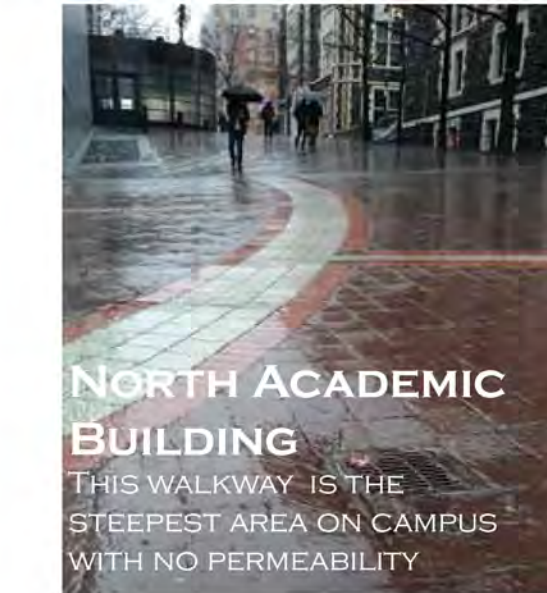
NORTH ACADEMIC BUILDING
THIS WALKWAY IS THE STEEPEST AREA ON CAMPUS WITH NO PERMEABILITY

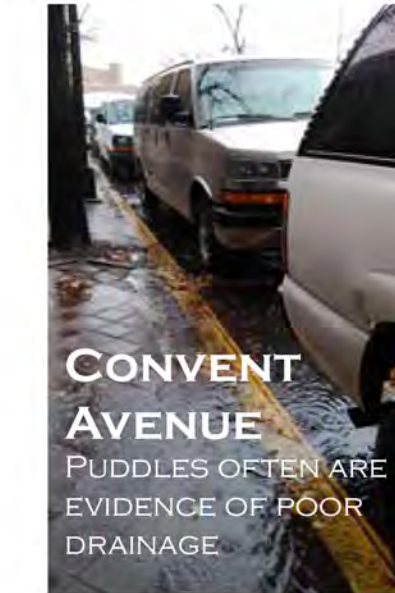
CONVENT AVENUE
PUDDLES OFTEN ARE EVIDENCE OF POOR DRAINAGE.

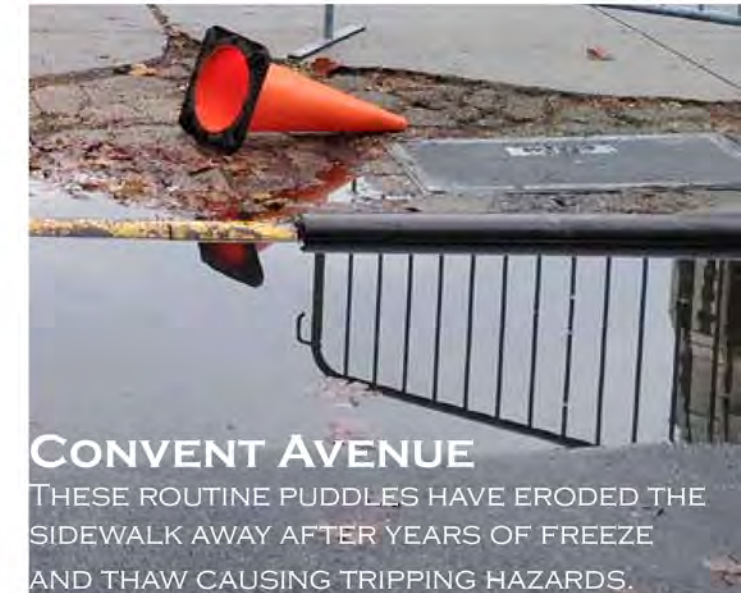
CONVENT AVENUE
THESE ROUTINE PUDDLES HAVE ERODED THE SIDEWALK AWAY AFTER YEARS OF FREEZE AND THAW CAUSING TRIPPING HAZARDS.

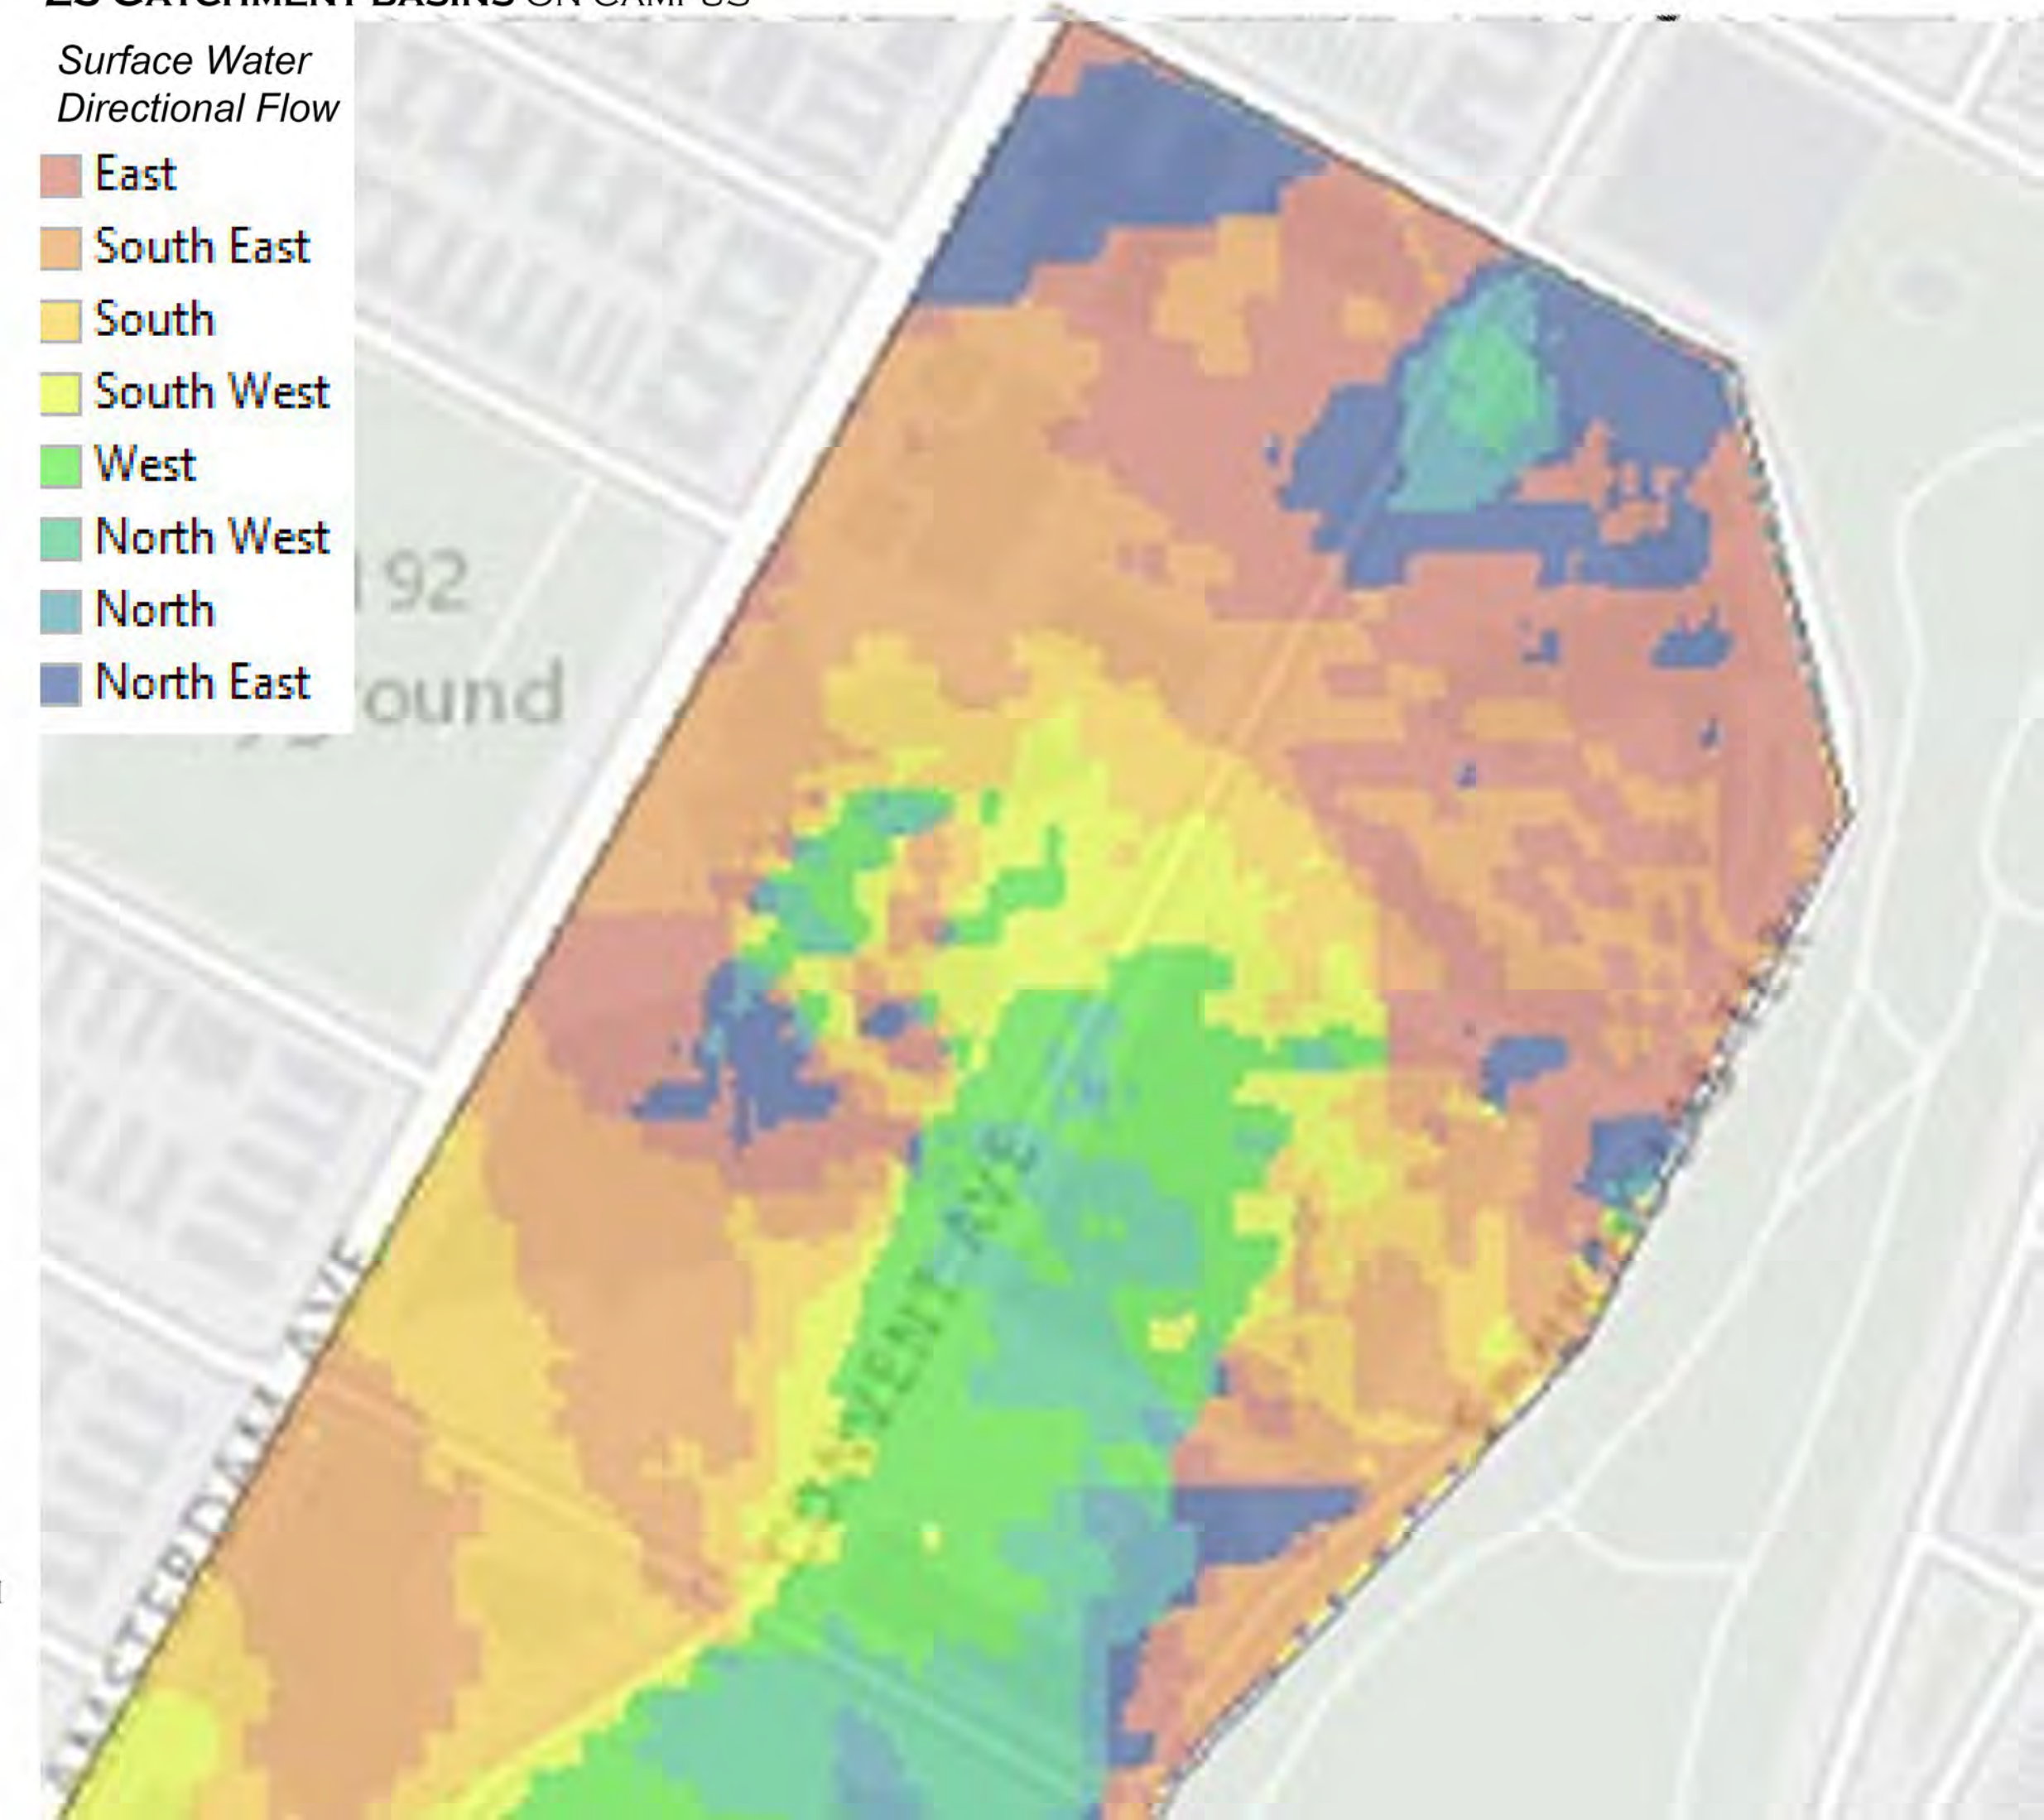
SURFACE WATER FLOW

WATER FLOWS TOWARDS **CONVENT AVENUE**, MAKING IT AN IDEAL LOCATION FOR **BIOSWALES**

UNDERSTANDING THE FLOW OF SURFACE WATER ON CAMPUS AND ANTICIPATING THE AMOUNT OF RAIN ON CAMPUS WAS CRITICAL TO THE DESIGN

25 CATCHMENT BASINS ON CAMPUS

Surface Water Directional Flow

- East
- South East
- South
- South West
- West
- North West
- North
- North East
