**QUANTIFICATION OF THE PHYSICAL HABITAT WITHIN  
GARVINS, HOOKSETT, AND AMOSKEAG POOLS OF THE  
MERRIMACK RIVER**

*Prepared for*  
**PUBLIC SERVICE COMPANY OF NEW HAMPSHIRE**  
**780 North Commercial Street**  
**Manchester, NH 03105**

*Prepared by*  
**NORMANDEAU ASSOCIATES, INC.**  
**25 Nashua Road**  
**Bedford, NH 03110**

**March 2011**

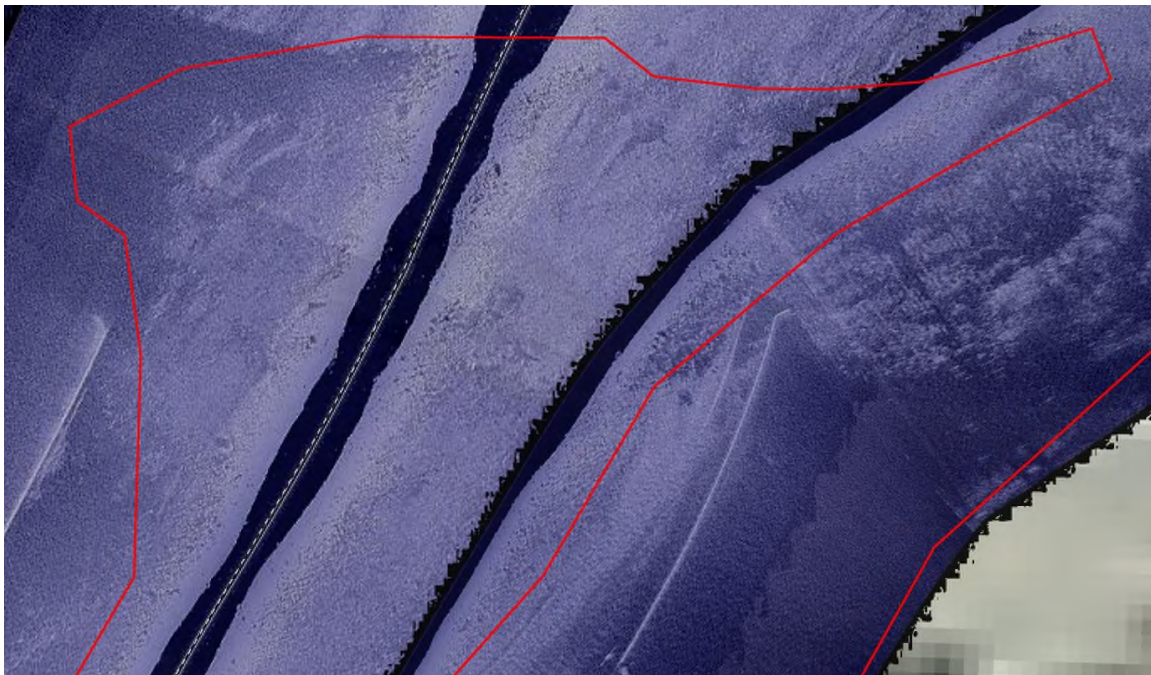
Figure 3-7. Example of gravel/cobble habitat type as classified from sonar imagery for the habitat survey of the Merrimack River, 16 September through 2 November 2010. (Note: gravel/cobble habitat is located within the bounds of the red polygon in the center of the figure).

A total of six substrate types were identified at the resolution of 2-4 inches in imagery from the Humminbird unit; sand/silt/clay, gravel/cobble, boulder, rip-rap, ledge, and woody debris. Figures 3-6 through 3-11 provide examples for the six habitat types classified from the sonar imagery. The habitat types were delimited with a predetermined precision of  $\pm 100$  sq ft (0.0023 acres). However, in most cases habitats smaller than this area or habitat borders were discernable at a greater resolution and were mapped at a higher precision. The total area (acres) for the six habitat types found in each of the three surveyed pools was quantified. Areas of aquatic vegetation were identified separately as an individual vegetation bed can occur over more than one substrate type. An example of submerged aquatic vegetation as identified by sonar imagery can be found in Figure 3-12.
