THE NEPONSET RIVER WATERSHED

1994 RESOURCE ASSESSMENT REPORT

COMMONWEALTH OF MASSACHUSETTS
EXECUTIVE OFFICE OF ENVIRONMENTAL AFFAIRS
MASSACHUSETTS DEPARTMENT OF ENVIRONMENTAL PROTECTION
OFFICE OF WATERSHED MANAGEMENT

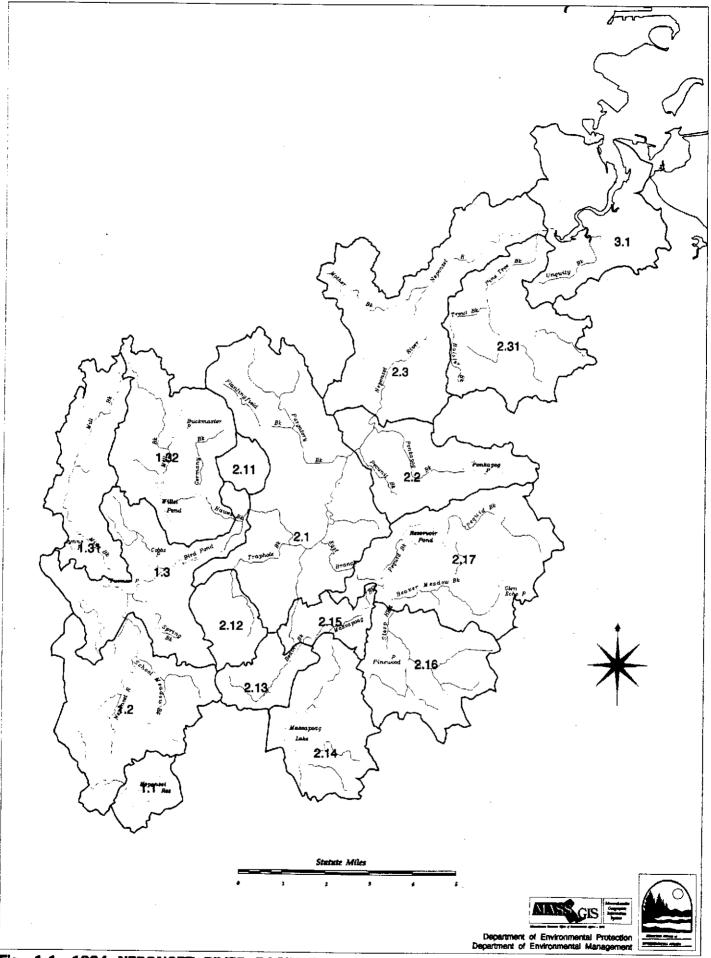
Fig. 1.1. 1994 NEPONSET RIVER BASIN SURVEY. Subwatershed boundaries in the Neponset River Basin.

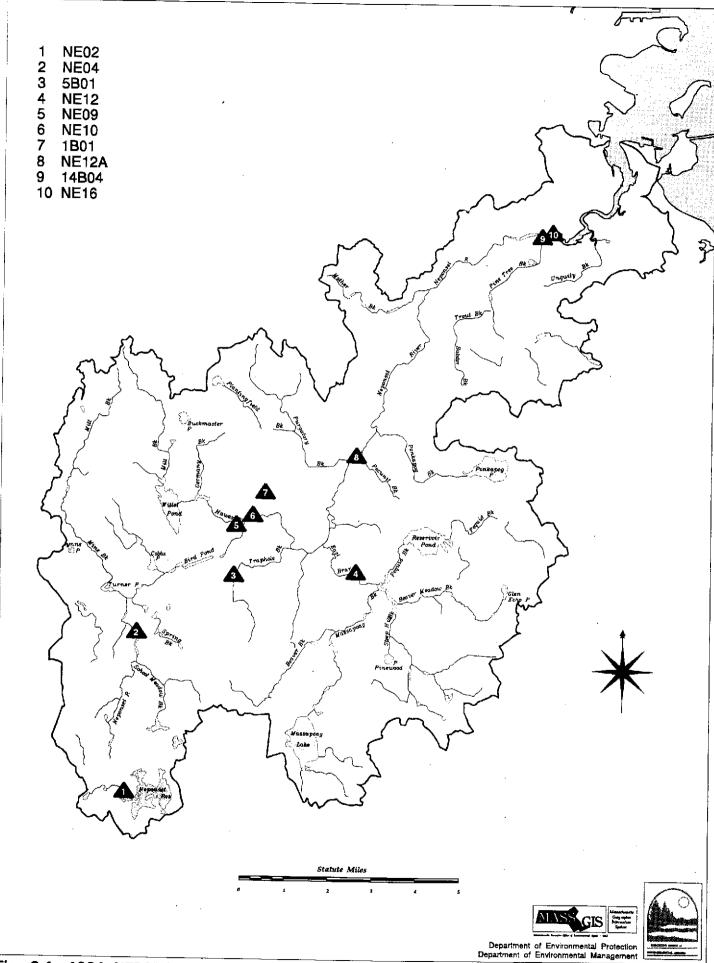
Fig. 2.1. 1994 NEPONSET RIVER BASIN SURVEY. Water quality monitoring station locations.

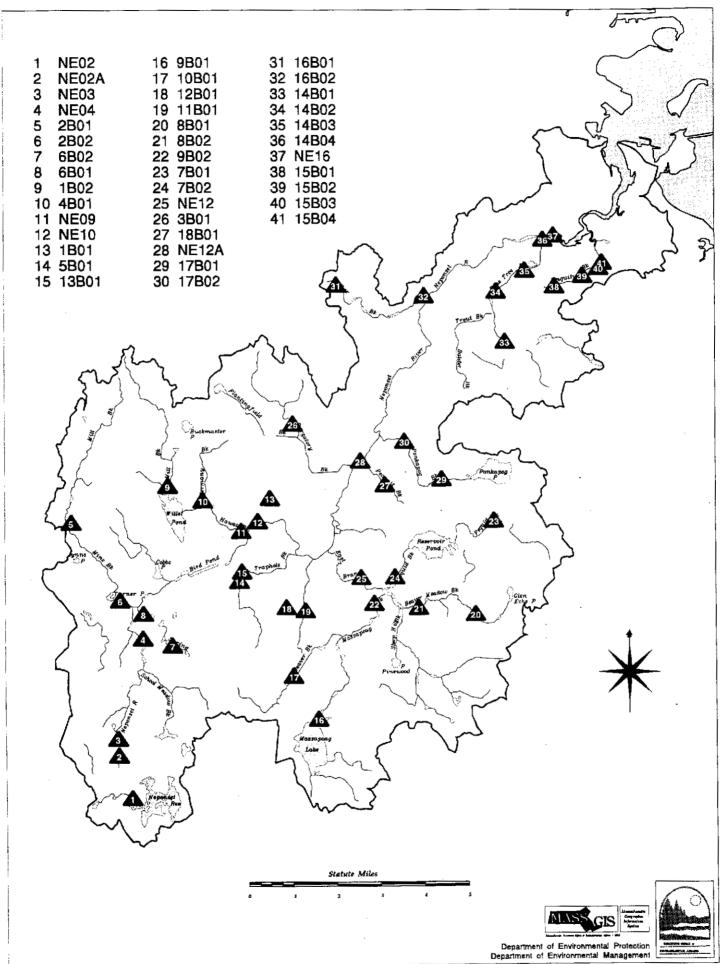
Fig. 2.2. 1994 NEPONSET RIVER BASIN SURVEY. Bacteriological monitoring station locations.

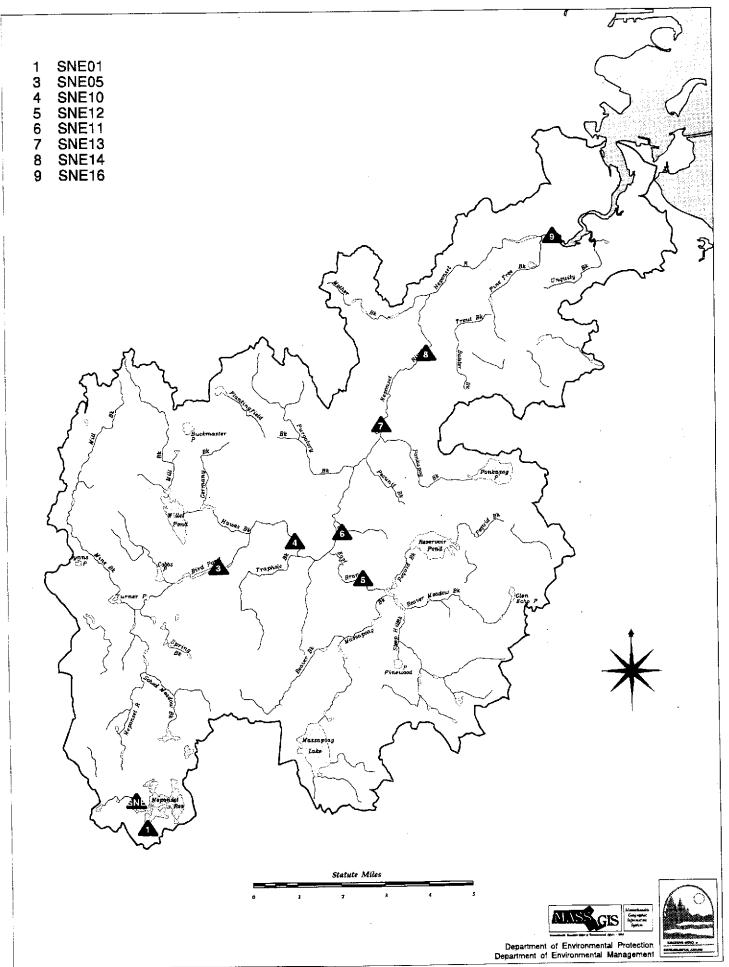
Fig. 3.1. 1994 NEPONSET RIVER BASIN SURVEY. Sediment quality monitoring station locations.

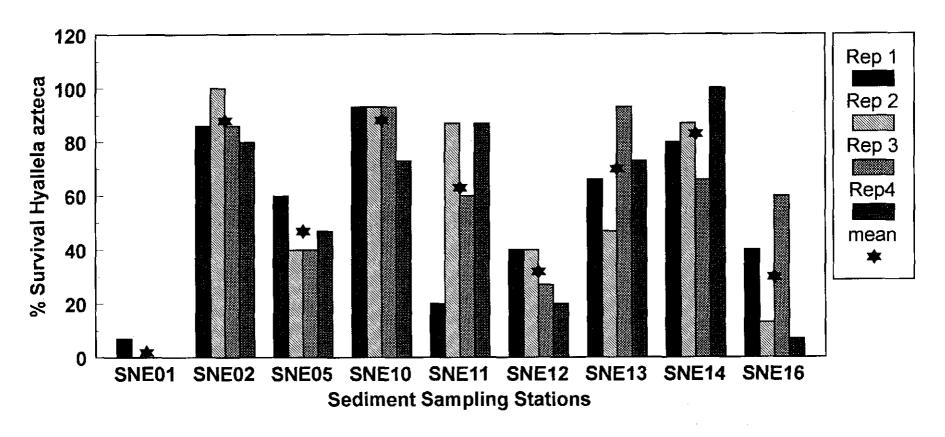
Fig. 3.2. 1994 NEPONSET RIVER BASIN SURVEY. Percent survival of *Hyallela azteca* after a 10-day exposure period in sediment collected from the following stations in the Neponset River Basin: Neponset Reservoir (SNE01), Crackrock Pond (SNE02), Neponset River, Bird Pond (SNE05), Neponset River, Pleasant Street Bridge (SNE10), Neponset River, Neponset Street, MWRA Construction Yard, Canton (SNE11), East Branch Neponset River, Factory Pond (SNE12), Neponset River, Green Lodge Street, Canton/Norwood (SNE13), Neponset River, upstream of Truman Highway, Hyde Park/Milton (SNE14) and Neponset River, Baker Dam, Milton (SNE16). Mean survival calculation based on 4 replicates of 15 organisms per test chamber. Survival of *Hyallela azteca* in reference sediment from Saw Mill Brook, Concord was 100%.

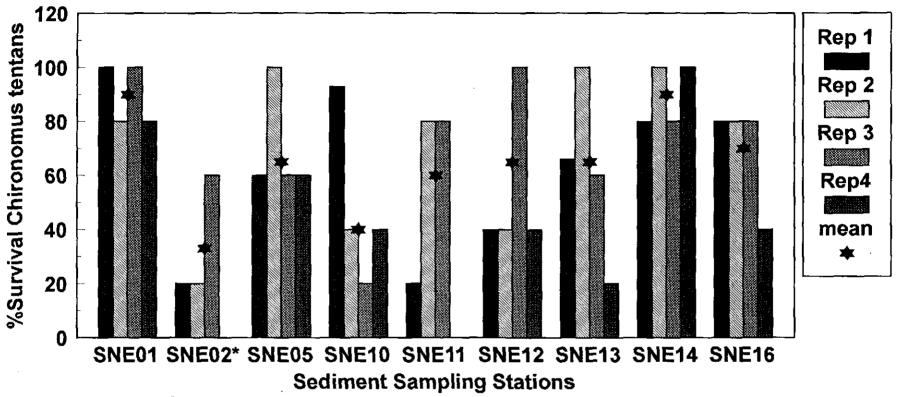
^{*} Three replicates at SNE02 rather than four.

Fig. 3.3. 1994 NEPONSET RIVER BASIN SURVEY. Percent survival of *Chironomus tentans* after a 10-day exposure period in sediment collected from the following stations in the Neponset River Basin: Neponset Reservoir (SNE01), Crackrock Pond (SNE02), Neponset River, Bird Pond (SNE05), Neponset River, Pleasant Street Bridge (SNE10), Neponset River, Neponset Street, MWRA Construction Yard, Canton (SNE11), East Branch Neponset River, Factory Pond (SNE12), Neponset River, Green Lodge Street, Canton/Norwood (SNE13), Neponset River, upstream of Truman Highway, Hyde Park/Milton (SNE14) and Neponset River, Baker Dam, Milton (SNE16). Mean survival calculation based on 4 replicates of 5 organisms per test chamber. Survival of *Chironomus tentans* in reference sediment of Saw Mill Brook, Concord was 100%.

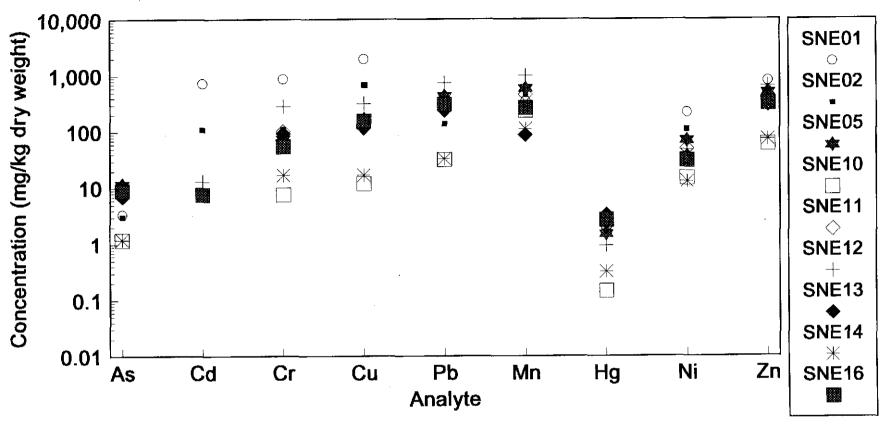
Fig. 3.4. 1994 NEPONSET RIVER BASIN SURVEY. Concentration of selected elements in sediment collected from the following stations in the Neponset River Basin: Neponset Reservoir (SNE01), Crackrock Pond (SNE02), Neponset River, Bird Pond (SNE05), Neponset River, Pleasant Street Bridge (SNE10), Neponset River, Neponset Street, MWRA Construction Yard, Canton (SNE11), East Branch Neponset River, Factory Pond (SNE12), Neponset River, Green Lodge Street, Canton/Norwood (SNE13), Neponset River, upstream of Truman Highway, Hyde Park/Milton (SNE14) and Neponset River, Baker Dam, Milton (SNE16). The ranges (min., max., mean) of heavy metals in the sediments of Massachusetts lakes and ponds (Rojko 1990) noted below for comparison.

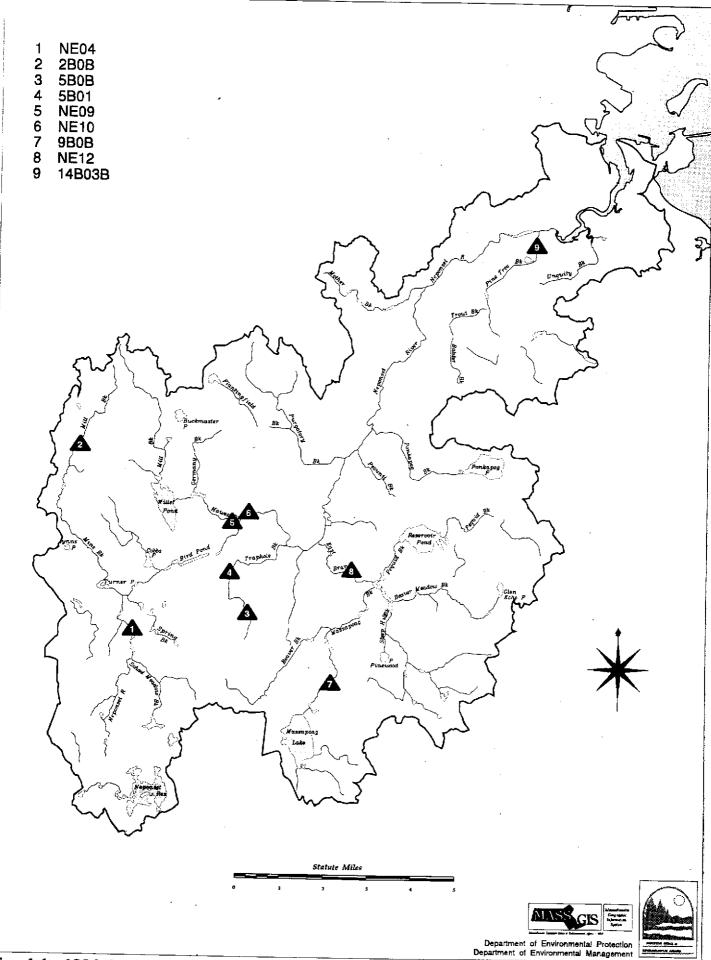
Fig. 4.1. 1994 NEPONSET RIVER BASIN SURVEY. Location of biological monitoring stations.

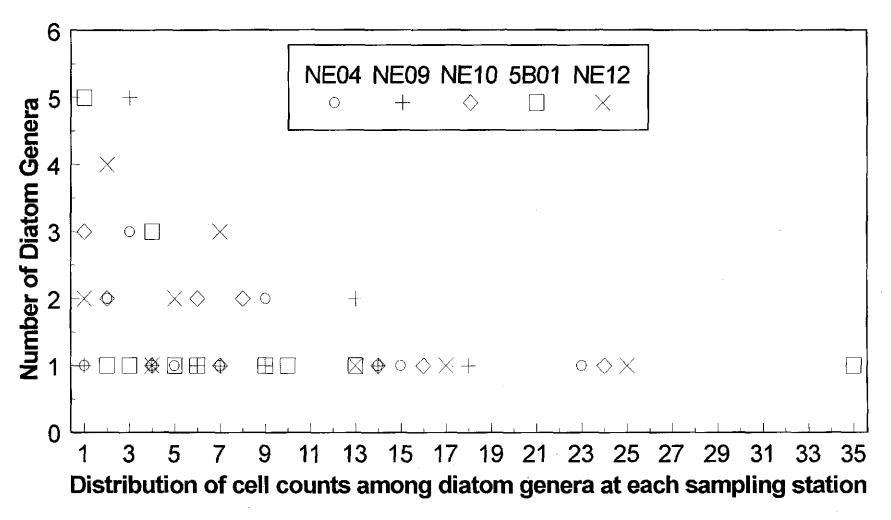
Fig. 4.2. 1994 NEPONSET RIVER BASIN SURVEY. Distribution of cell counts among attached diatom genera recorded for the following stations in the Neponset River Basin: Neponset River, South Street, Walpole (NE04), Hawes Brook, Washington Street, Norwood (NE09), Neponset River, Pleasant Street Bridge, Norwood (NE10), East Branch Neponset River, Neponset Street, Canton (NE12), Traphole Brook, Cooney Street, Walpole (5B01). This graphic presentation is based on 100 cell counts from attached diatom samples collected at each station.

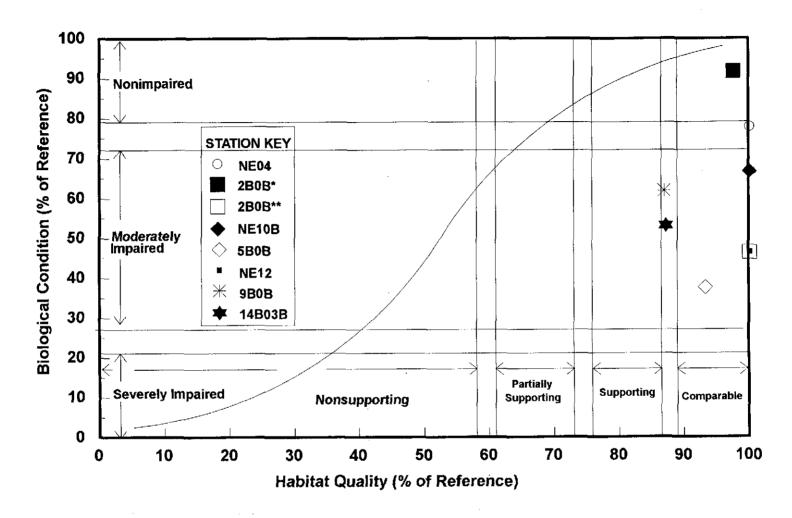
Fig. 4.3. 1994 NEPONSET RIVER BASIN SURVEY. Habitat quality and condition of benthos at the following stations in the Neponset River Basin: Neponset River, South Street, Walpole (NE04), Mill Brook, Route 109, Medfield (2B0B), Neponset River, downstream Pleasant Street Bridge, Norwood (NE10B), Traphole Brook, High Plain Street, Sharon (5B0B), East Branch Neponset River, Neponset Street, Canton (NE12), Massapoag Brook, Deb Sampson Street, Sharon (9B0B) and Pine Tree Brook, Ruggles Lane/School Street, Milton (14B03B).

Note: * reference station NE09, ** reference station 5B01

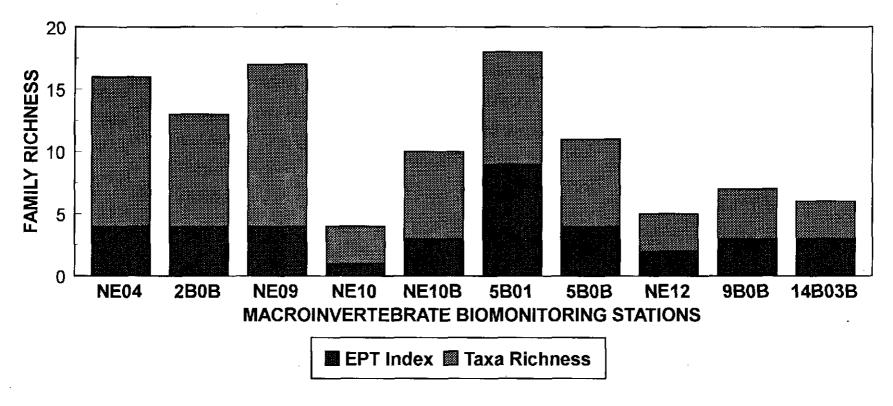
Fig. 4.4. 1994 Neponset River Survey. Results of EPT Index (number of Ephemeroptera, Plecoptera and Trichoptera families) and Taxa Richness (total number of families) of the benthos at the following locations in the Neponset River Basin: Neponset River, South Street, Walpole (NE04), Mill Brook, Route 109, Medfield (2B0B), Hawes Brook, Washington Street, Norwood (NE09), Neponset River, Pleasant Street Bridge, Norwood (NE10), Neponset River, downstream Pleasant Street Bridge, Norwood (NE10B), Traphole Brook, Cooney Street, Walpole (5B01), Traphole Brook, High Plain Street, Sharon (5B0B), East Branch Neponset River, Neponset Street, Canton (NE12), Massapoag Brook, Deb Sampson Street, Sharon (9B0B) and Pine Tree Brook, Ruggles Lane/School Street, Milton (14B03B).

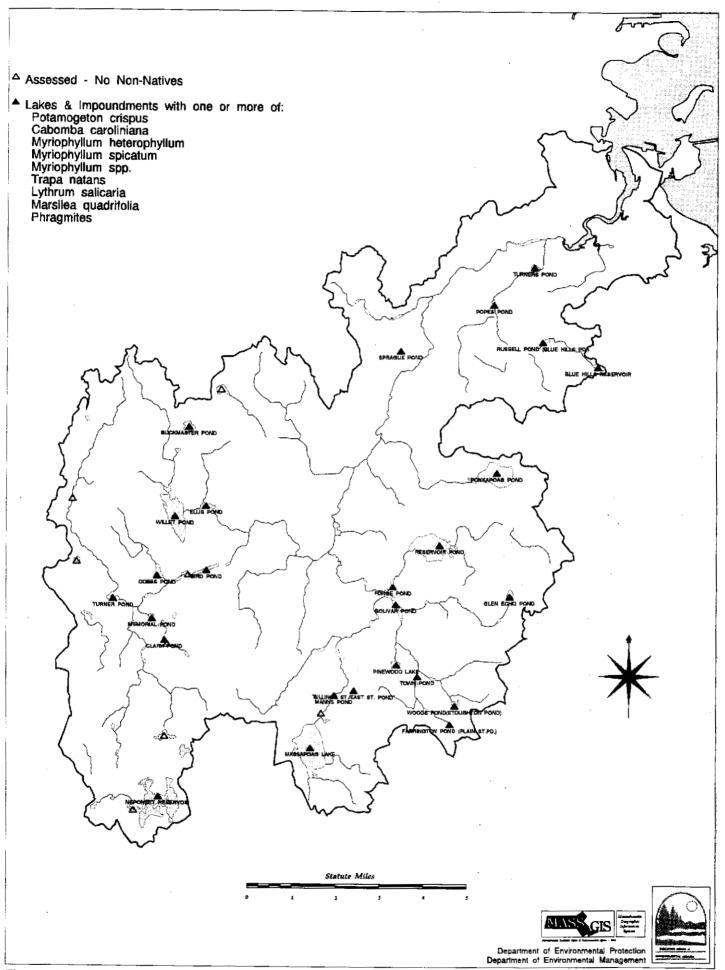
Fig. 5.1. 1994 NEPONSET RIVER BASIN SURVEY. Distribution of non-native aquatic and wetland plants in Neponset River Basin lakes and impoundments.

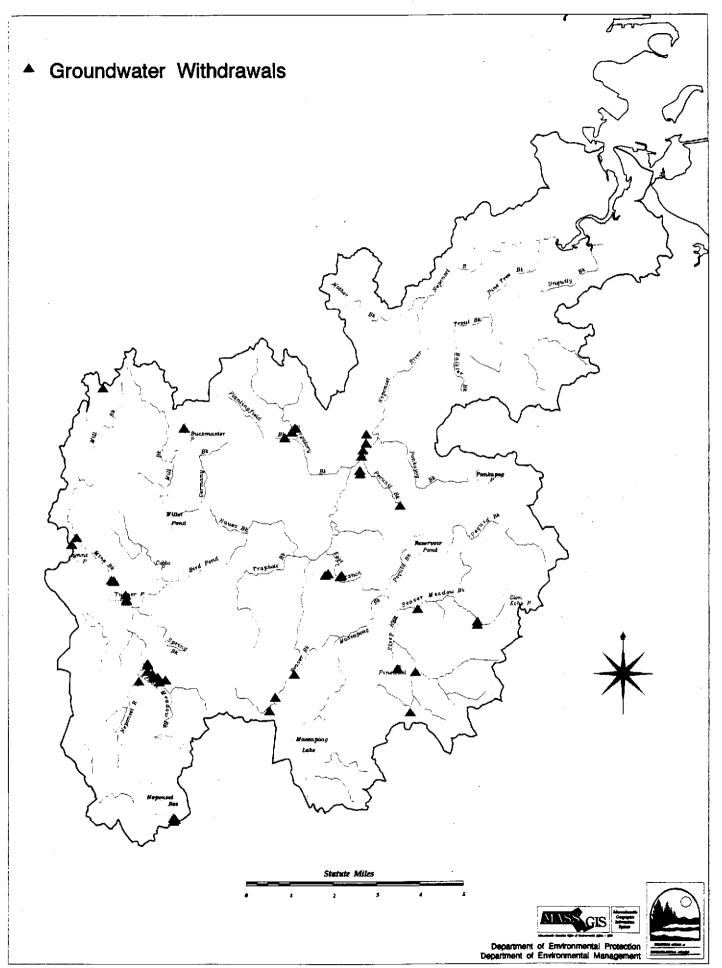
Fig. 6.1. 1994 NEPONSET RIVER BASIN SURVEY. Registered and permitted public water supply withdrawals in the Neponset River Basin.

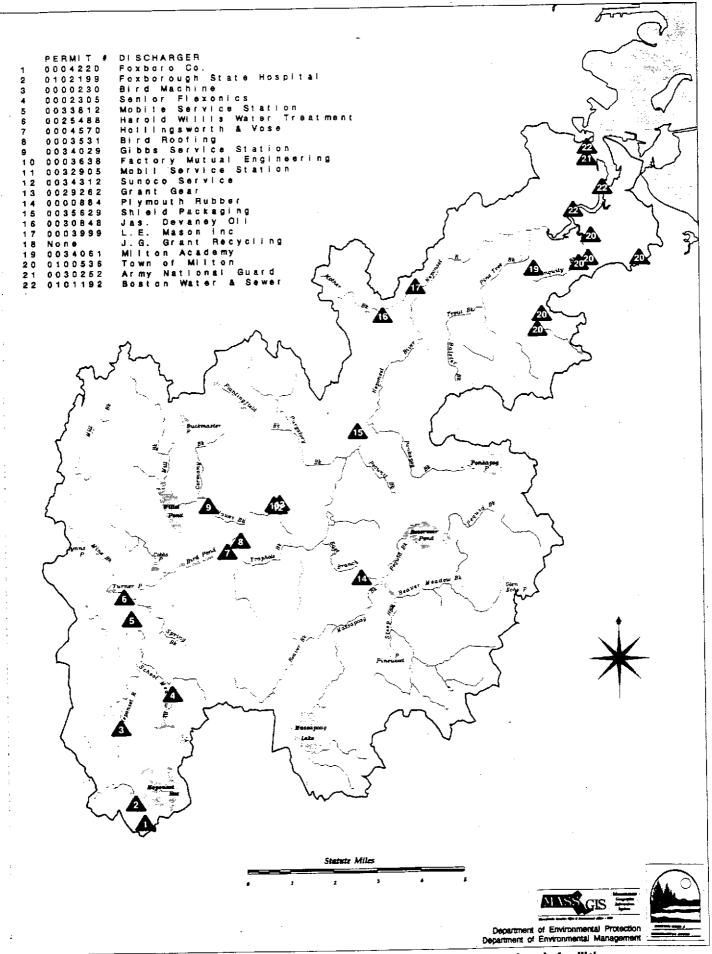
Fig. 7.1. 1994 NEPONSET RIVER BASIN SURVEY. Location of permitted facilities discharging wastewater to the Neponset River Basin.

At the headwaters of the basin, the Foxboro Company's (Number 1, Figure 7.1) past and present activities are a major concern in the watershed. Currently, all process and sanitary wastewater from the company is discharged to the Mansfield WWTP and cooling water is recirculated via a closed-loop system. Only storm water is discharged to the Neponset Reservoir from the property via Gudgeon Brook. During low flow periods, concentrations of volatile organic compounds (VOCs) in excess of drinking water standards have been detected in Gudgeon Brook; the company is investigating the source(s) of these VOCs. While these investigations continue, Foxboro Company is treating Gudgeon brook with air stripping. In addition, high concentrations of cadmium and other heavy metals in the Neponset Reservoir sediments, as well as high nutrient levels, have been linked to the company's past activities. Pickerel Cove, into which the company previously discharged wastewater, has been identified as a 21E

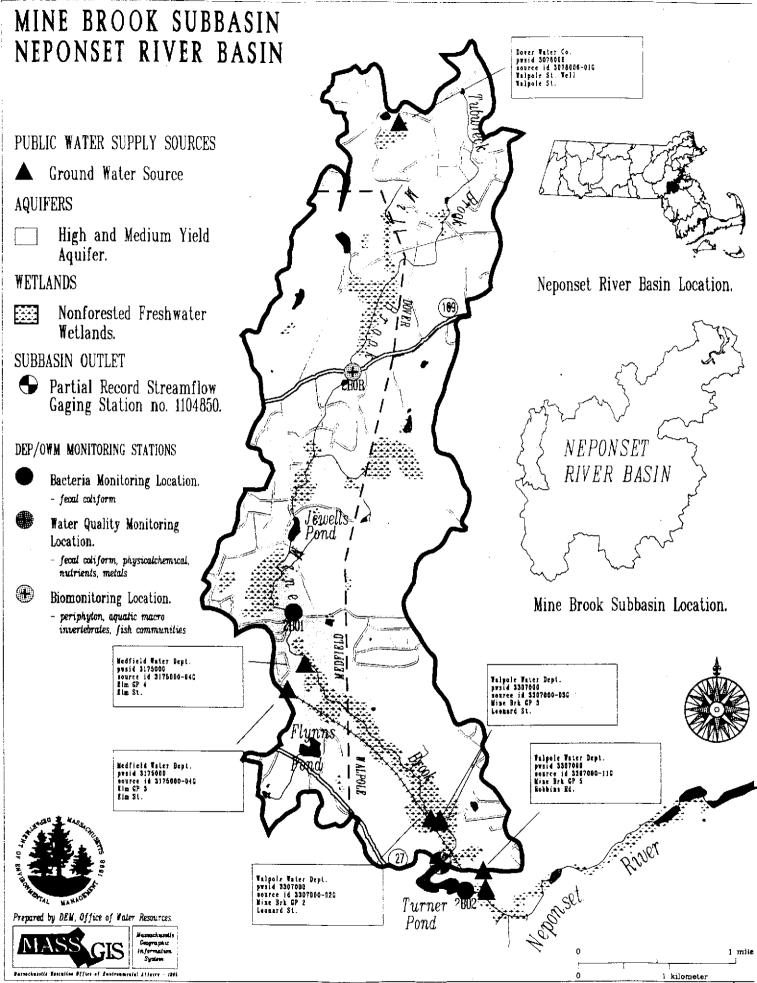
FIG. 9.1. 1994 NEPONSET RIVER BASIN SURVEY. Overview of the Mine Brook subwatershed: water supplies, aquifers, wetlands and monitoring locations.

The Mine Brook Subbasin is located in the northwest portion of the Neponset River Watershed (Figure 9.1). Mine Brook is composed of Tubwreck Brook in Dover which joins and flows into Mill Brook and then continues down to Jewells Pond in Medfield. Mine Brook flows from the outlet of Jewells Pond to Turner Pond. The total stream length of these brooks is approximately 6 miles. The total drainage area of the subbasin which terminates at the inlet to Turner Pond is 5.98 square miles while the stratified drift area in the subbasin is 3.64 square miles. Land use consists mainly of light to medium density residential and forest land.

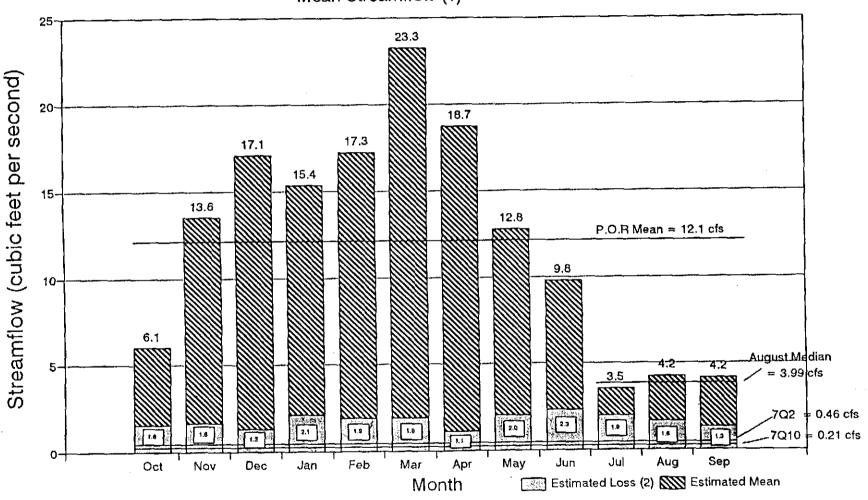
Mine Brook, Turner Pond Inlet, Walpole Estimated Natural Monthly Mean Streamflow (1)

- (1) Estimated by drainage area ratio method using Old Swamp River, South Weymouth, gage no. 01105600, Period of Record = 1966 1993.
- (2) Monthly average day estimated transfer of water out of subbasin. Loss = water supply withdrawals volume returned by septic disposal.

Fig. 9.2. 1994 Neponset River Basin Survey. Relationship between stream hydrology and water use in the Nine Brook subwatershed.

Flows in Mine Brook are reduced by a significant amount through water supply withdrawal by the towns of Dover, Walpole, and Medfield. A small percentage of that water is returned to the subbasin through onsite septic systems and the filter backwash water from the Harold E. Willis WTF. Partial flow data collected on Mine Brook (Turner Pond inlet) makes it possible to employ several different methodologies to calculate both regulated and unregulated values; however, different methodologies may yield different results. Figure 9.2 illustrates the relationship between the stream hydrology (estimated natural monthly mean streamflow using the drainage area ratio method with Old Swamp River, South Weymouth, gage no. 01105600, period of record = 1966-1993), and the monthly average estimates of water transferred out of the subbasin. Well illustrated is the relationship between the critical low flow period (July through October) and the water supply usage (where 26 - 56 % of the streamflow is transferred out of basin to the MWRA sewer system) -- assuming a direct relationship between water withdrawal and streamflow. Although this assumption is extremely conservative, environmental impacts due to reduced flow and changes in water quality (elevated temperatures) from water supply well withdrawal, combined with increases in residential developments, may be manifested in changes in the aquatic environment (loss of wild trout fisheries, impacts on significant wetlands). These changes in the aquatic biota due to reduced flow and water quality need further investigation, which in a general way are addressed in the biological assessment section of this report.
