RE: Town of Rockport  
NPDES Phase II Annual Report

**National Pollutant Discharge  
Elimination System (NPDES)  
Phase II Stormwater Management Plan  
2006 Annual Report – Year 3  
Rockport, Massachusetts**

Earth Tech, Inc.  
196 Baker Avenue  
Concord, Massachusetts 01742

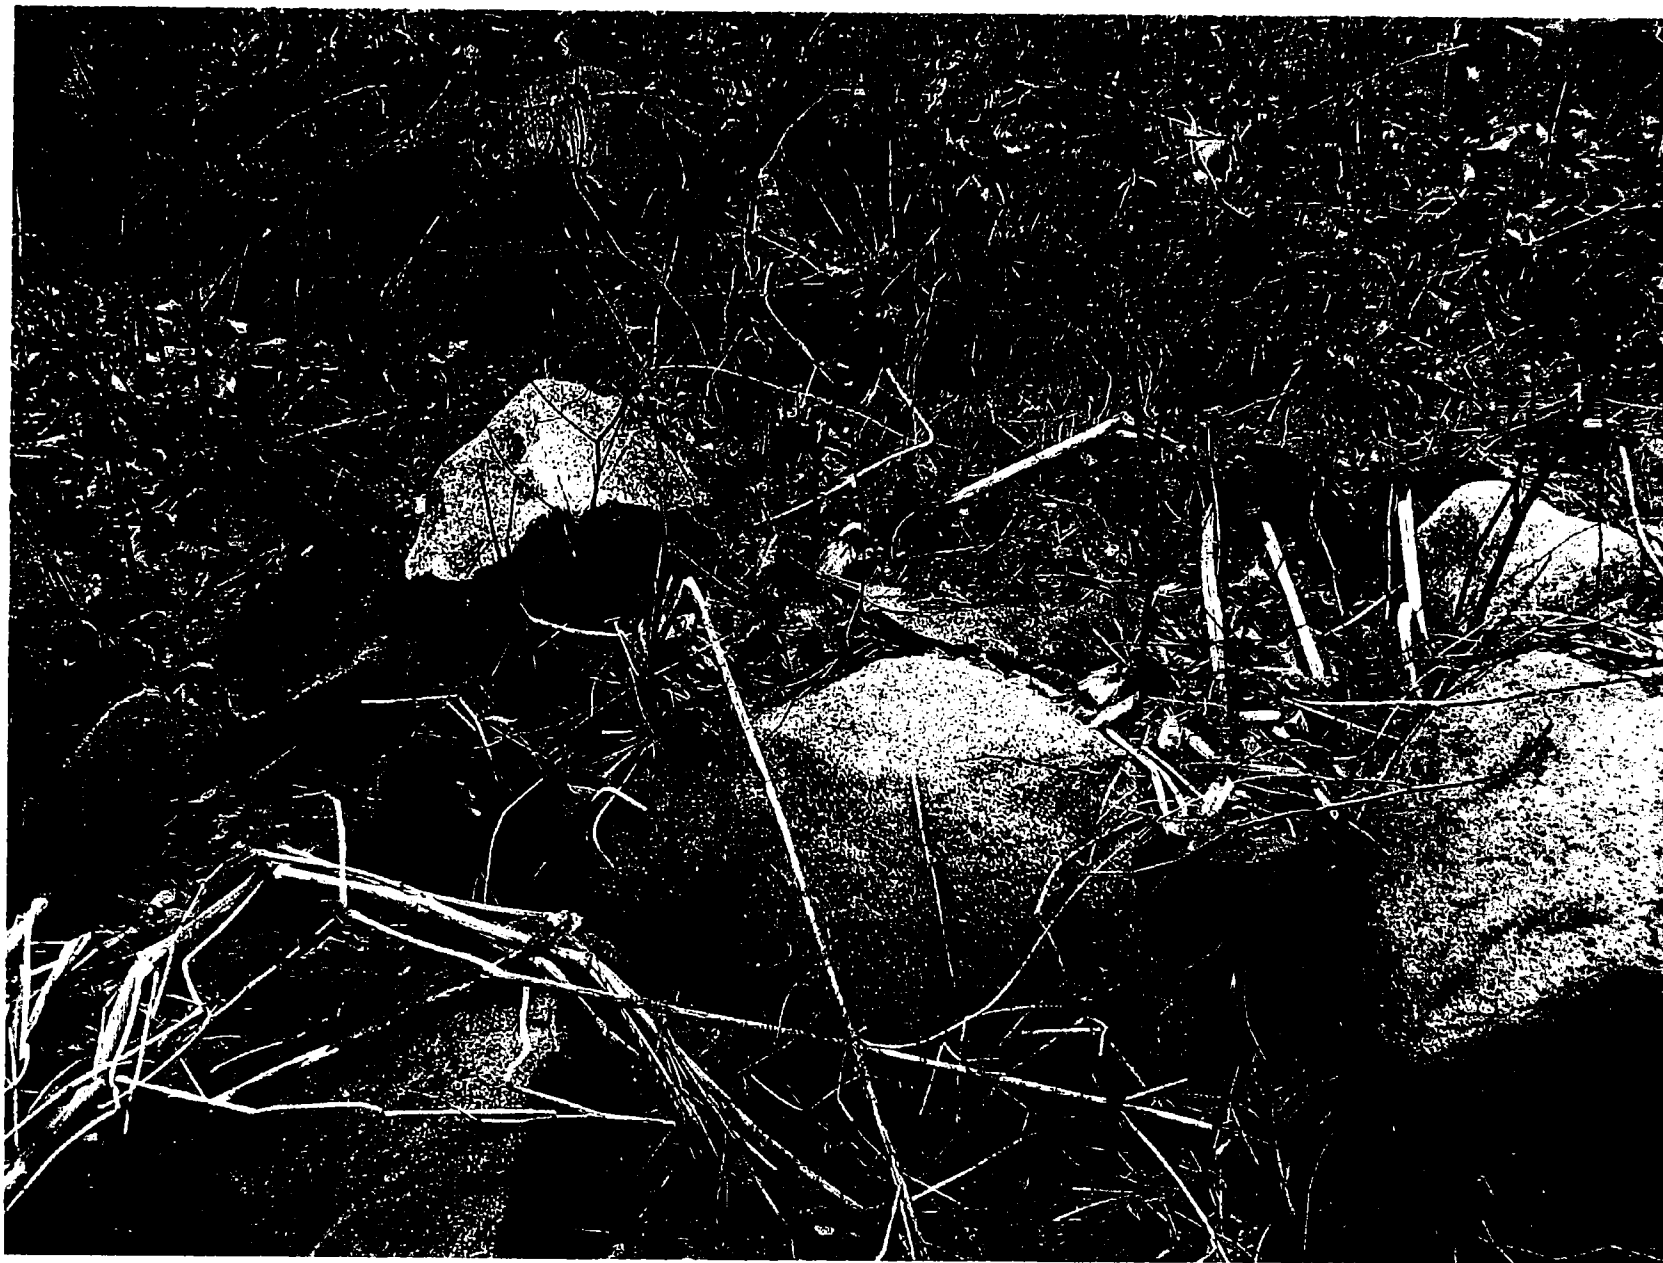
**Figure B-5: Outfall #6**

| Figure No. | Outfall I No. | W&C Report | Location/ Description | Size (in.) | Material | Notes |
|---|---|---|---|---|---|---|
| B-5 | 6 | * | 50' upstream of meadow headwall; source east side. | 2 | PVC | Has been observed w/ dry weather discharge; Observed 11/28/04 w/ strong discharge. |

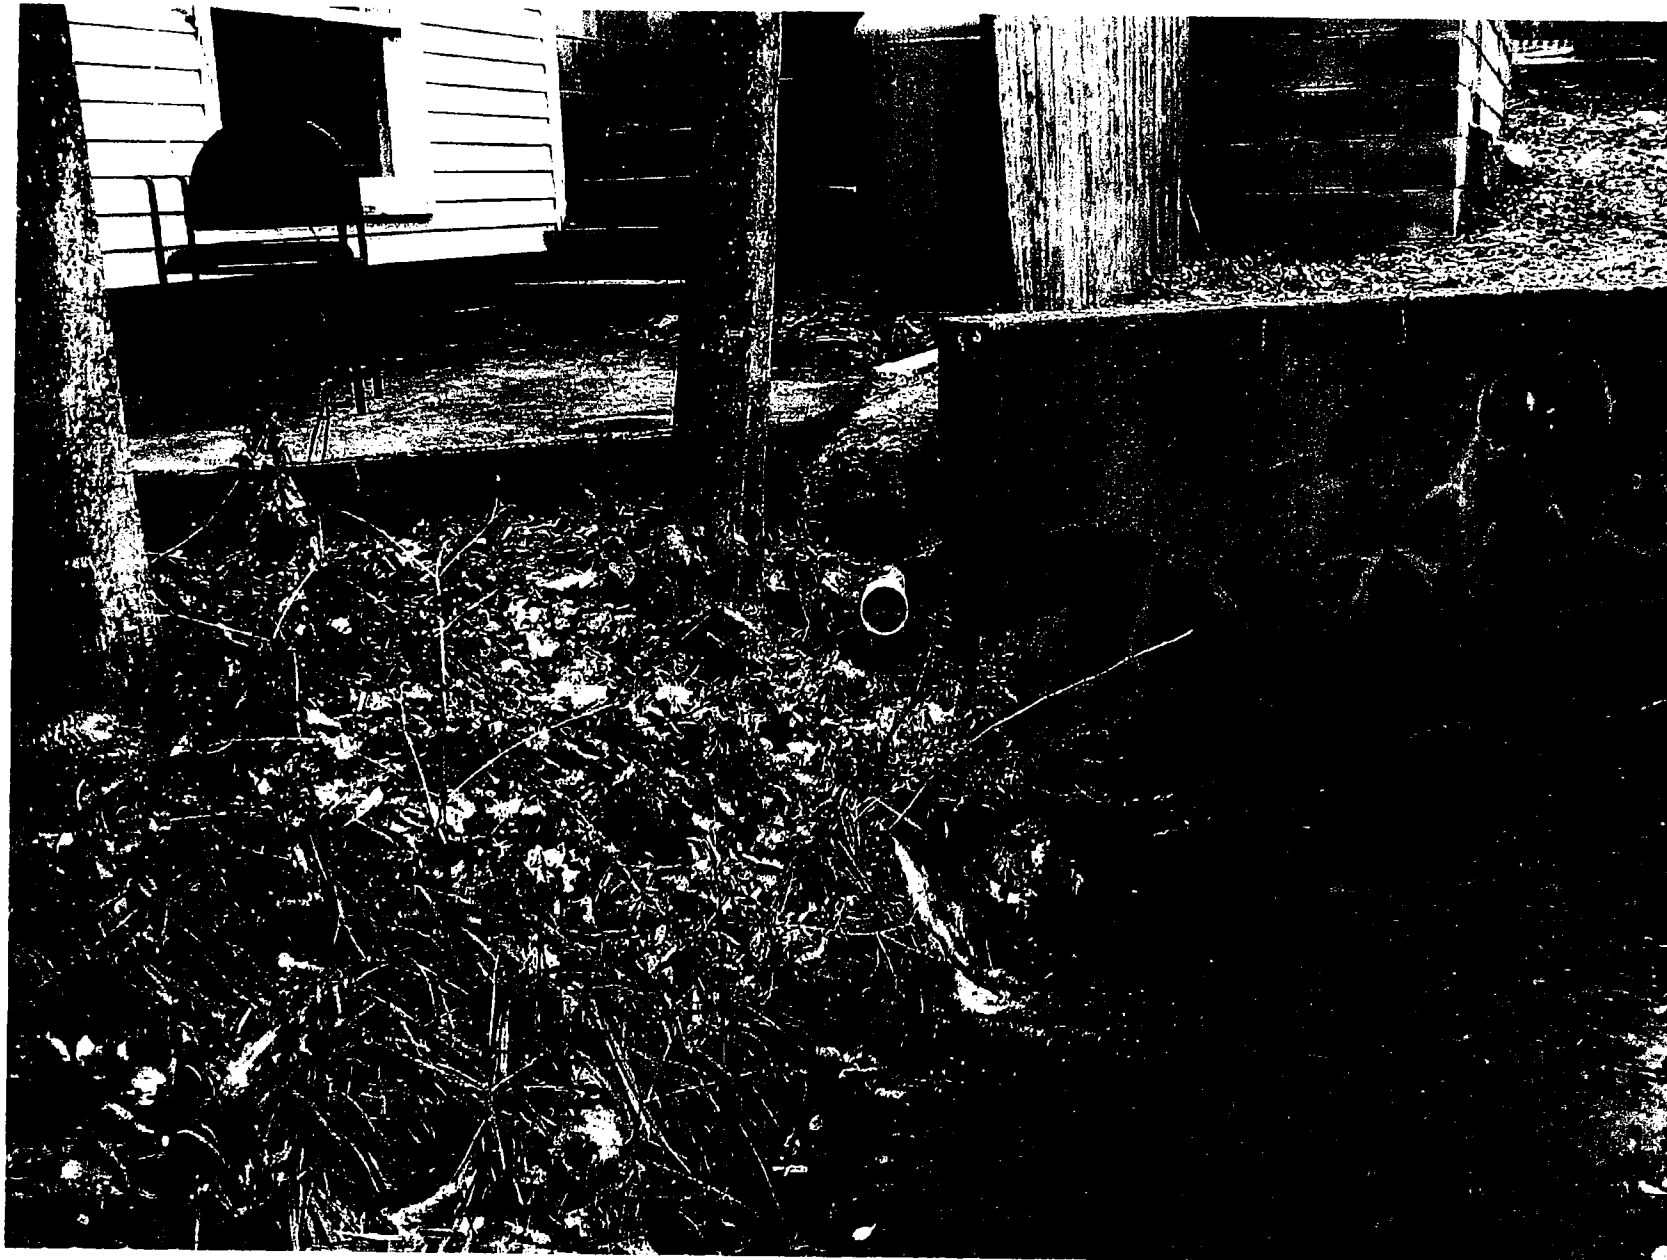
**Figure B-14: Outfall #20 and #21**

| Figure No. | Outfall I No. | W&C Report | Location/ Description | Size (in.) | Material | Notes |
|---|---|---|---|---|---|---|
| B-14 | 20 | 5 | 46' up from upstream headwall at RR Ave.; source west side. | 2 | Corrogated plastic hose | Coming from restaurant? |

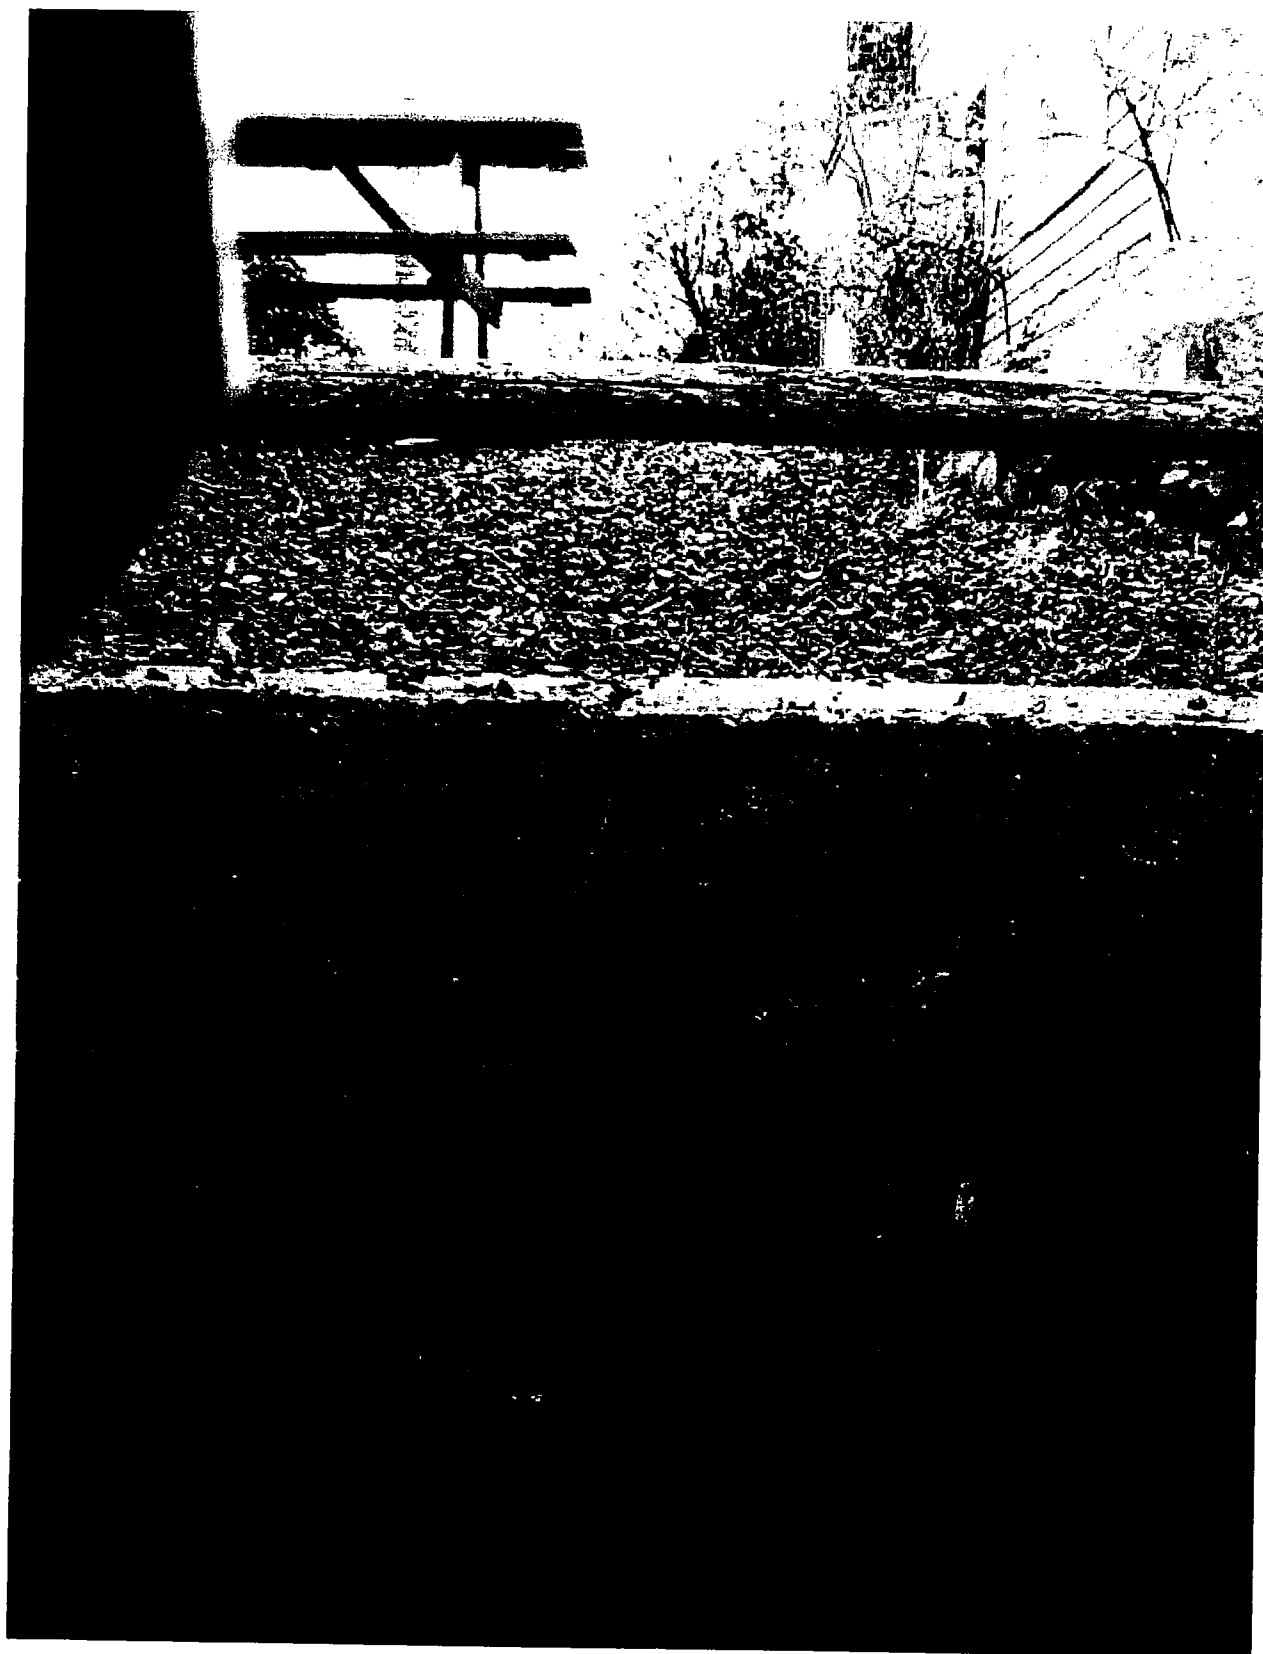
**Figure B-20: Outfall #27**

| Figure No. | Outfall I No. | W&C Report | Location/ Description | Size (in.) | Material | Notes |
|---|---|---|---|---|---|---|
| B-20 | 27 | 9 | 142' up from upstream headwall at RR Ave.; source east side. | 12 | Corrogated metal | In concrete wall of channel 8' upstream from #26 |

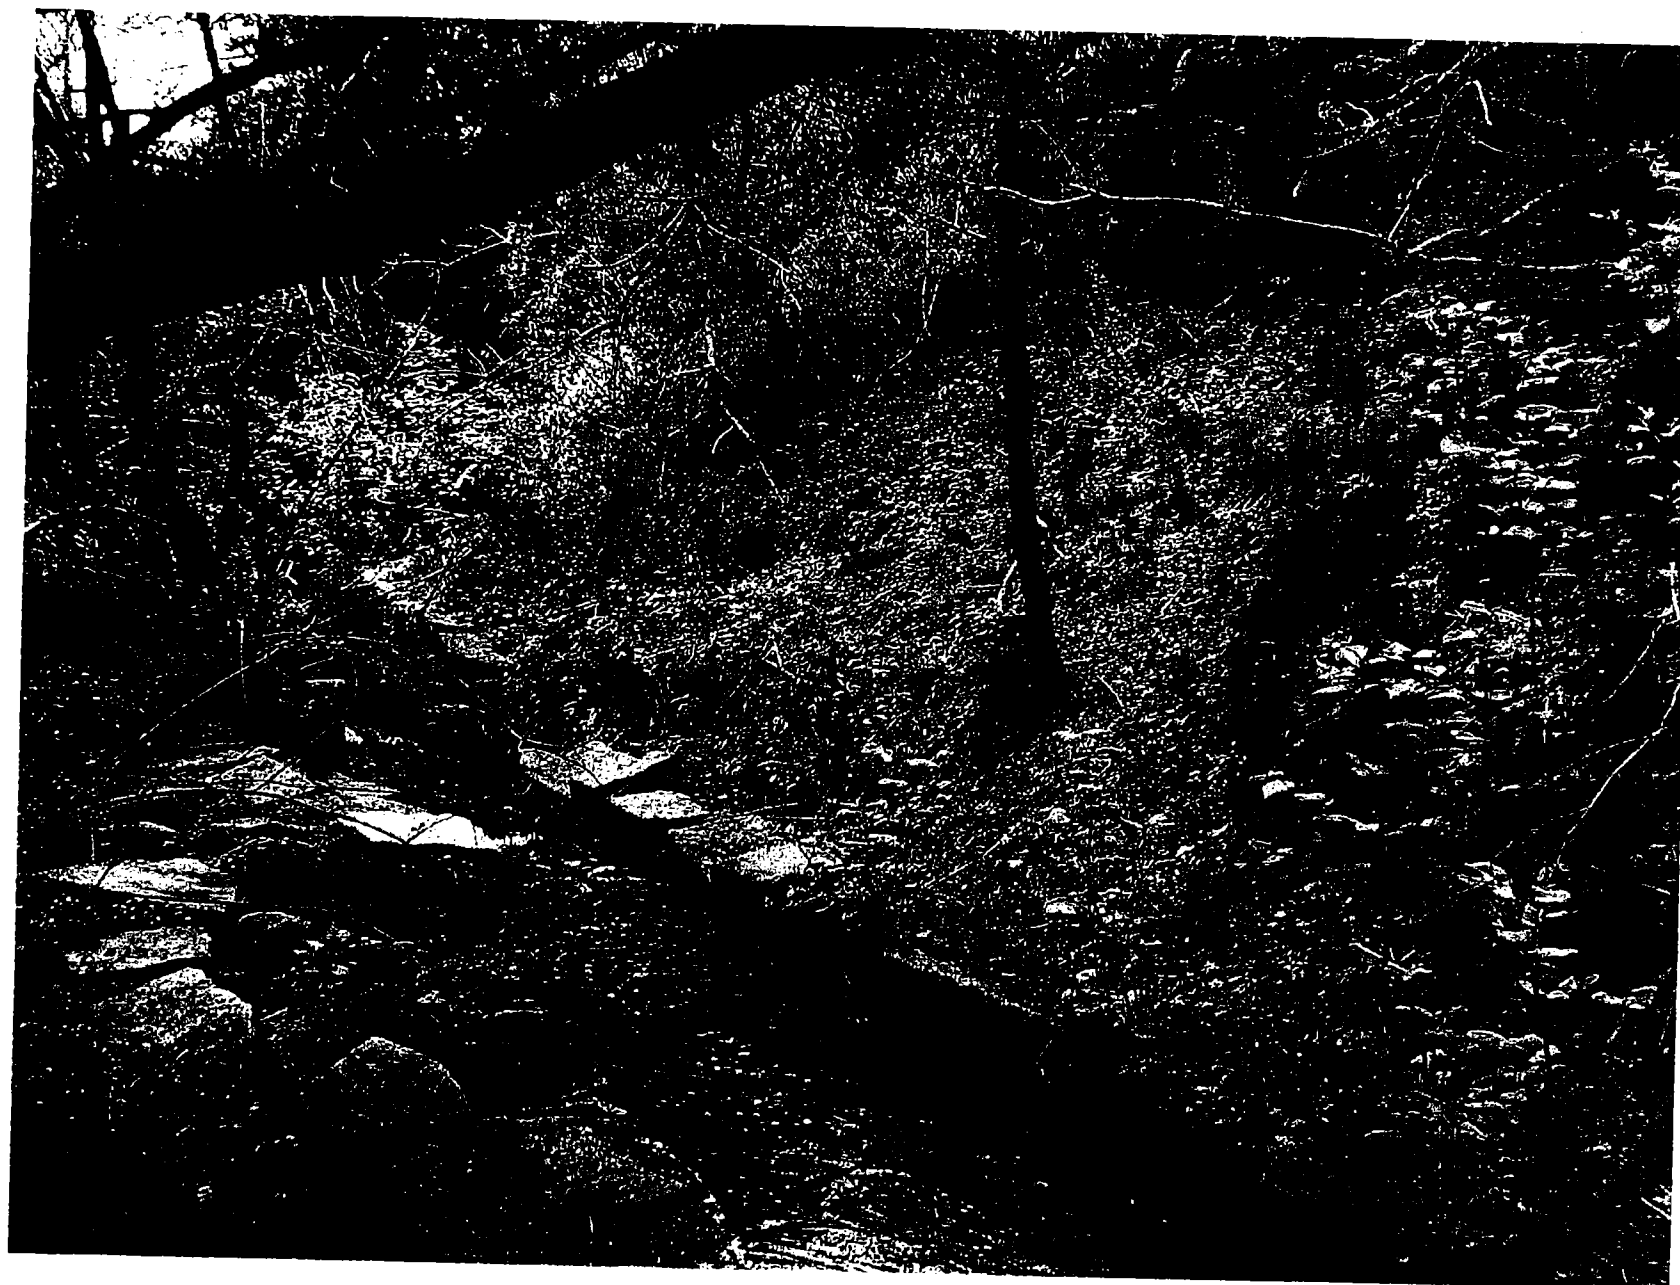
1. A discharge to the bank above the stream approximately 100-feet upstream of Beach Street in Millbrook Meadow was noted by Woodard & Curran in the *Illicit Discharge Detection Summary Report*. This site was visited several times during the course of the study. No significant increase of erosion was observed. (Appendix C, Figure C-1).

**Figure C-1: Some erosion of bank behind King St. residence**

1. Encourage the King Street property owner who is directing runoff from his or her property to the bank above Mill Brook in Mill Brook Meadow to use a dry well, vegetated swale or other means of infiltration rather than promoting erosion and overland flow on a steep bank leading to a stream. The Rockport Conservation Commission may be able to accomplish this through contacting the property owner and educating them about the possible impacts of the discharge and alternative techniques of addressing their runoff issues. Adopting a stormwater management by-law may help reduce the incidences of such discharges in the future.

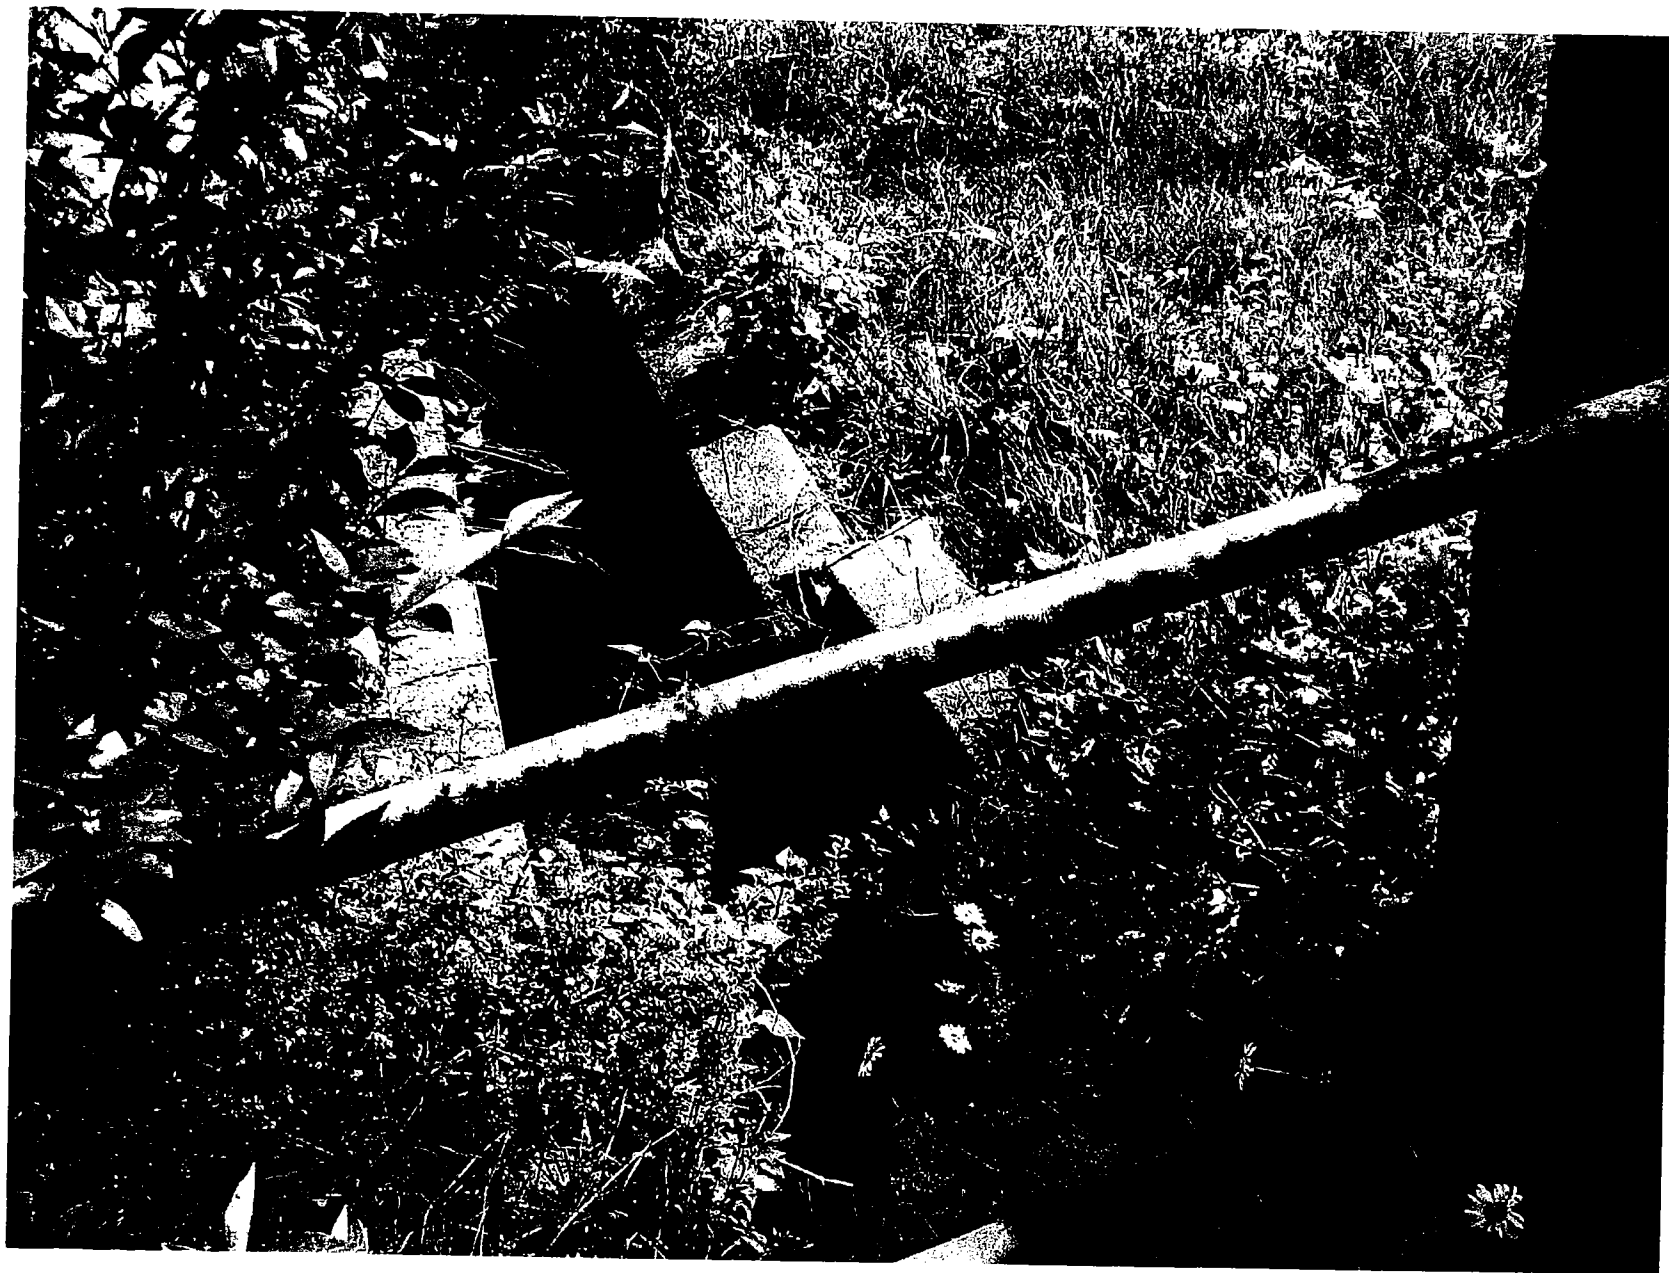
4. A cement retaining wall serving as the south side of an open culvert for the Squam Brook tributary just after it passes under the base of Summit Avenue (at sampling station K) is beginning to cave in toward the stream. This retaining wall is likely privately owned. If it were to collapse at some point in the future, it would cause a significant release of sediment into the stream. Since this location is upstream of Mill Pond, if it were to collapse it is likely that this would be another large dose of sediment added to the already sediment-choked pond. (Appendix C, Figure C-2).

**Figure C-2: Collapsing retaining wall at base of Summit Ave.**

4. Proactively address the collapsing retaining wall on the channelized portion of Squam Brook at the base of Summit Avenue. The town should investigate ownership of the retaining wall that separates the adjacent residential property from the stream channel at this location to determine if any easements exist. The town should work with the property owner through whatever means are available to repair or replace the retaining wall to prevent the cumulative sedimentation that is currently taking place and to prevent an all-out collapse that could release a huge load of sediment to the brook and create a significant flooding event in this area.

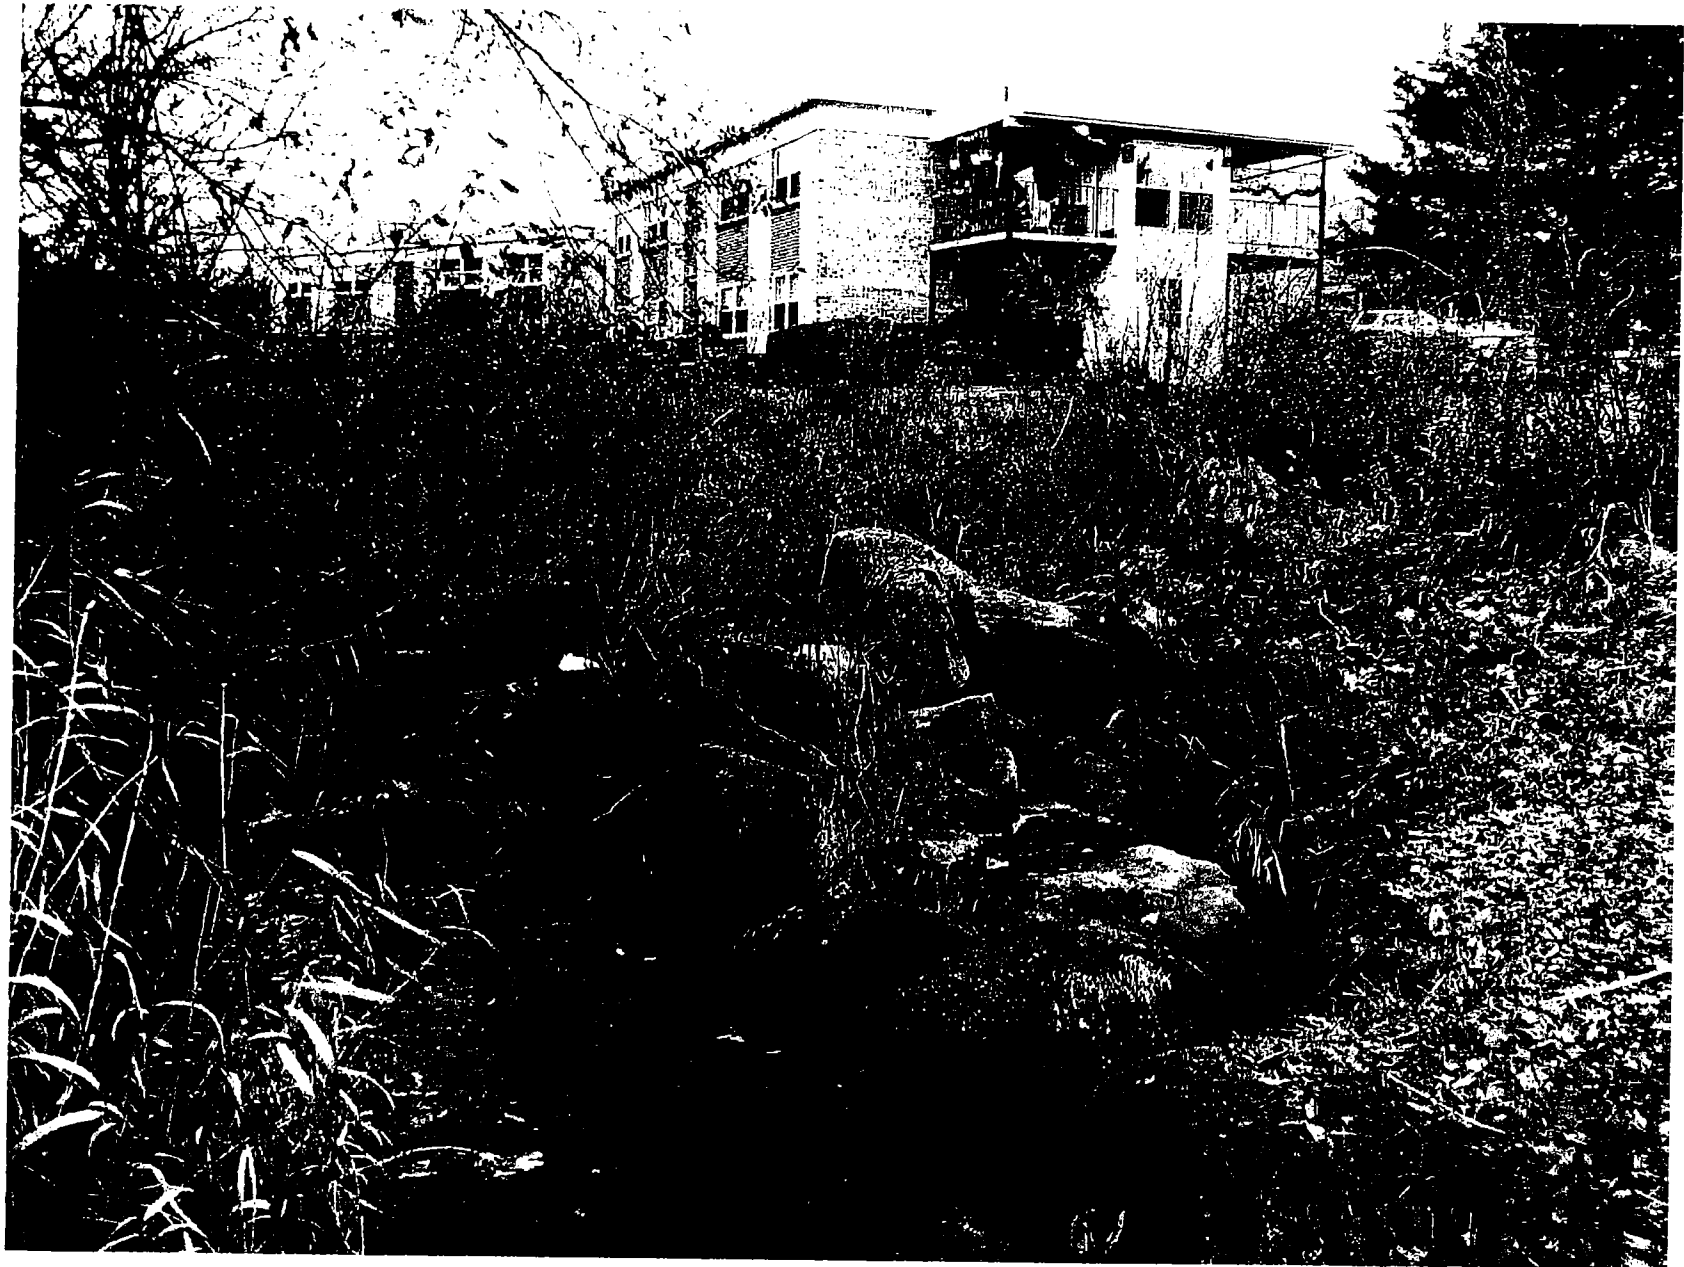
**Figure C-4: Eroding stream bank adjacent to Mill Brook Park**

**3. Erosion control should be implemented as needed from Pooles Lane to Railroad Avenue.** Mill Brook's natural stream banks have eroded at one location in this area in particular adjacent to the Rockport Housing Authority Mill Brook Park housing complex. (See also description under Section 2-5(6) under Monitoring Erosion and Sedimentation.) W&C recommends using "soil bioengineering" techniques, such as BioLog® or BioD-Roll™. These natural biodegradable products could be used to provide the needed protection until establishment of mature vegetation, which will resist erosion forces. These methods not only provide strong, sustainable, aesthetically pleasing water edges, but also provide habitats for aquatic & terrestrial wildlife and filter run off water. The cost in materials would be approximately \$350 per 30 foot section of stabilized stream bank.

6. Address eroding banks on section of stream adjacent to Rockport Housing Authority property. This erosion appears to be caused or exacerbated by a berm erected across the stream channel. The Rockport Conservation Commission should work with the Rockport Housing Authority which manages the land to remove any structures that are causing or worsening erosion of stream banks. The town should work with the Housing Authority to stabilize the banks to prevent further sedimentation of Mill Brook. See also Structural BMP recommendations letter by W&C for stream bank stabilization techniques.
