*Department of Conservation and Recreation  
NPDES Storm Water Management Program  
Permit Year 11 Annual Report*

## **Department of Conservation and Recreation NPDES PII Small MS4 General Permit Annual Report**

**Permit Year 11 Annual Report**

# Illicit Discharge Detection Report

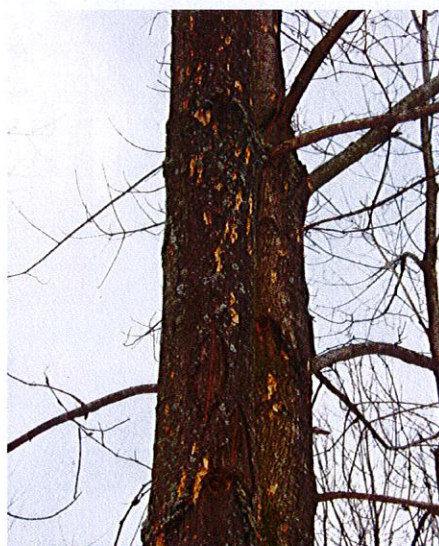
This picture shows bark damage to an Ash tree that has been seriously harmed by the Emerald Ash Borer. The tree will now become weakened, misshapen and vulnerable to fatal disease.

The damage EAB inflicts includes distinct 'S'-shaped tunnels formed beneath the bark from larval feeding, with vertical splits in the bark caused by callus tissue forming in response to larval feeding. Adult emergence leaves 'D'-shaped exit holes (3-4 mm in diameter) in the bark. Eventually, the upper third of the tree dies back and numerous shoots arise below the dead portion of the trunk, leaving the tree misshapen, weak, and vulnerable to disease and other natural challenges.

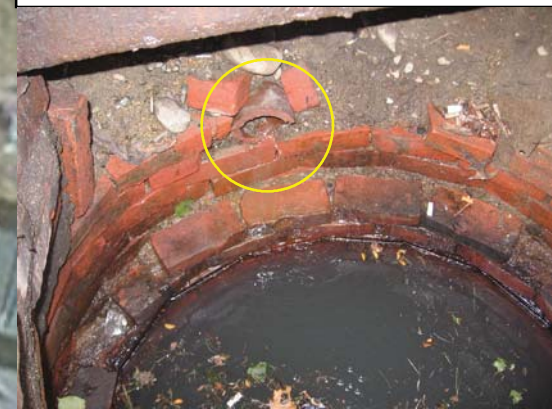
**Figure 3-4**

**Catchbasin 467**

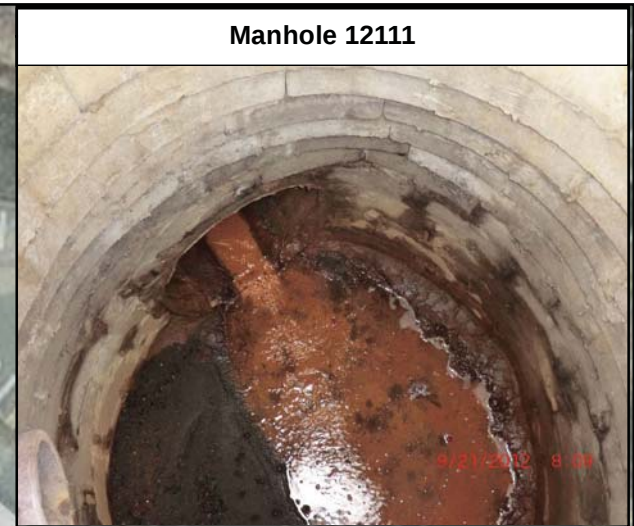
Flow was observed coming from an 18" pipe off of DCR property on the Lynnway in Lynn. The flow was coming from the direction of a business parking lot off of the Lynnway. There was a period of rain during the sample window that may have contributed to the flow. Test results indicate that the flow had chemical characteristics similar to washwater.
