**Municipality/Organization:** City of Malden  
**EPA NPDES Permit Number:** MA041046  
**MADEP Transmittal Number:** 041088  
**Annual Report Number  
& Reporting Period:** No. 10: April 1, 2012-March 31, 2013

## NPDES PII Small MS4 General Permit Annual Report

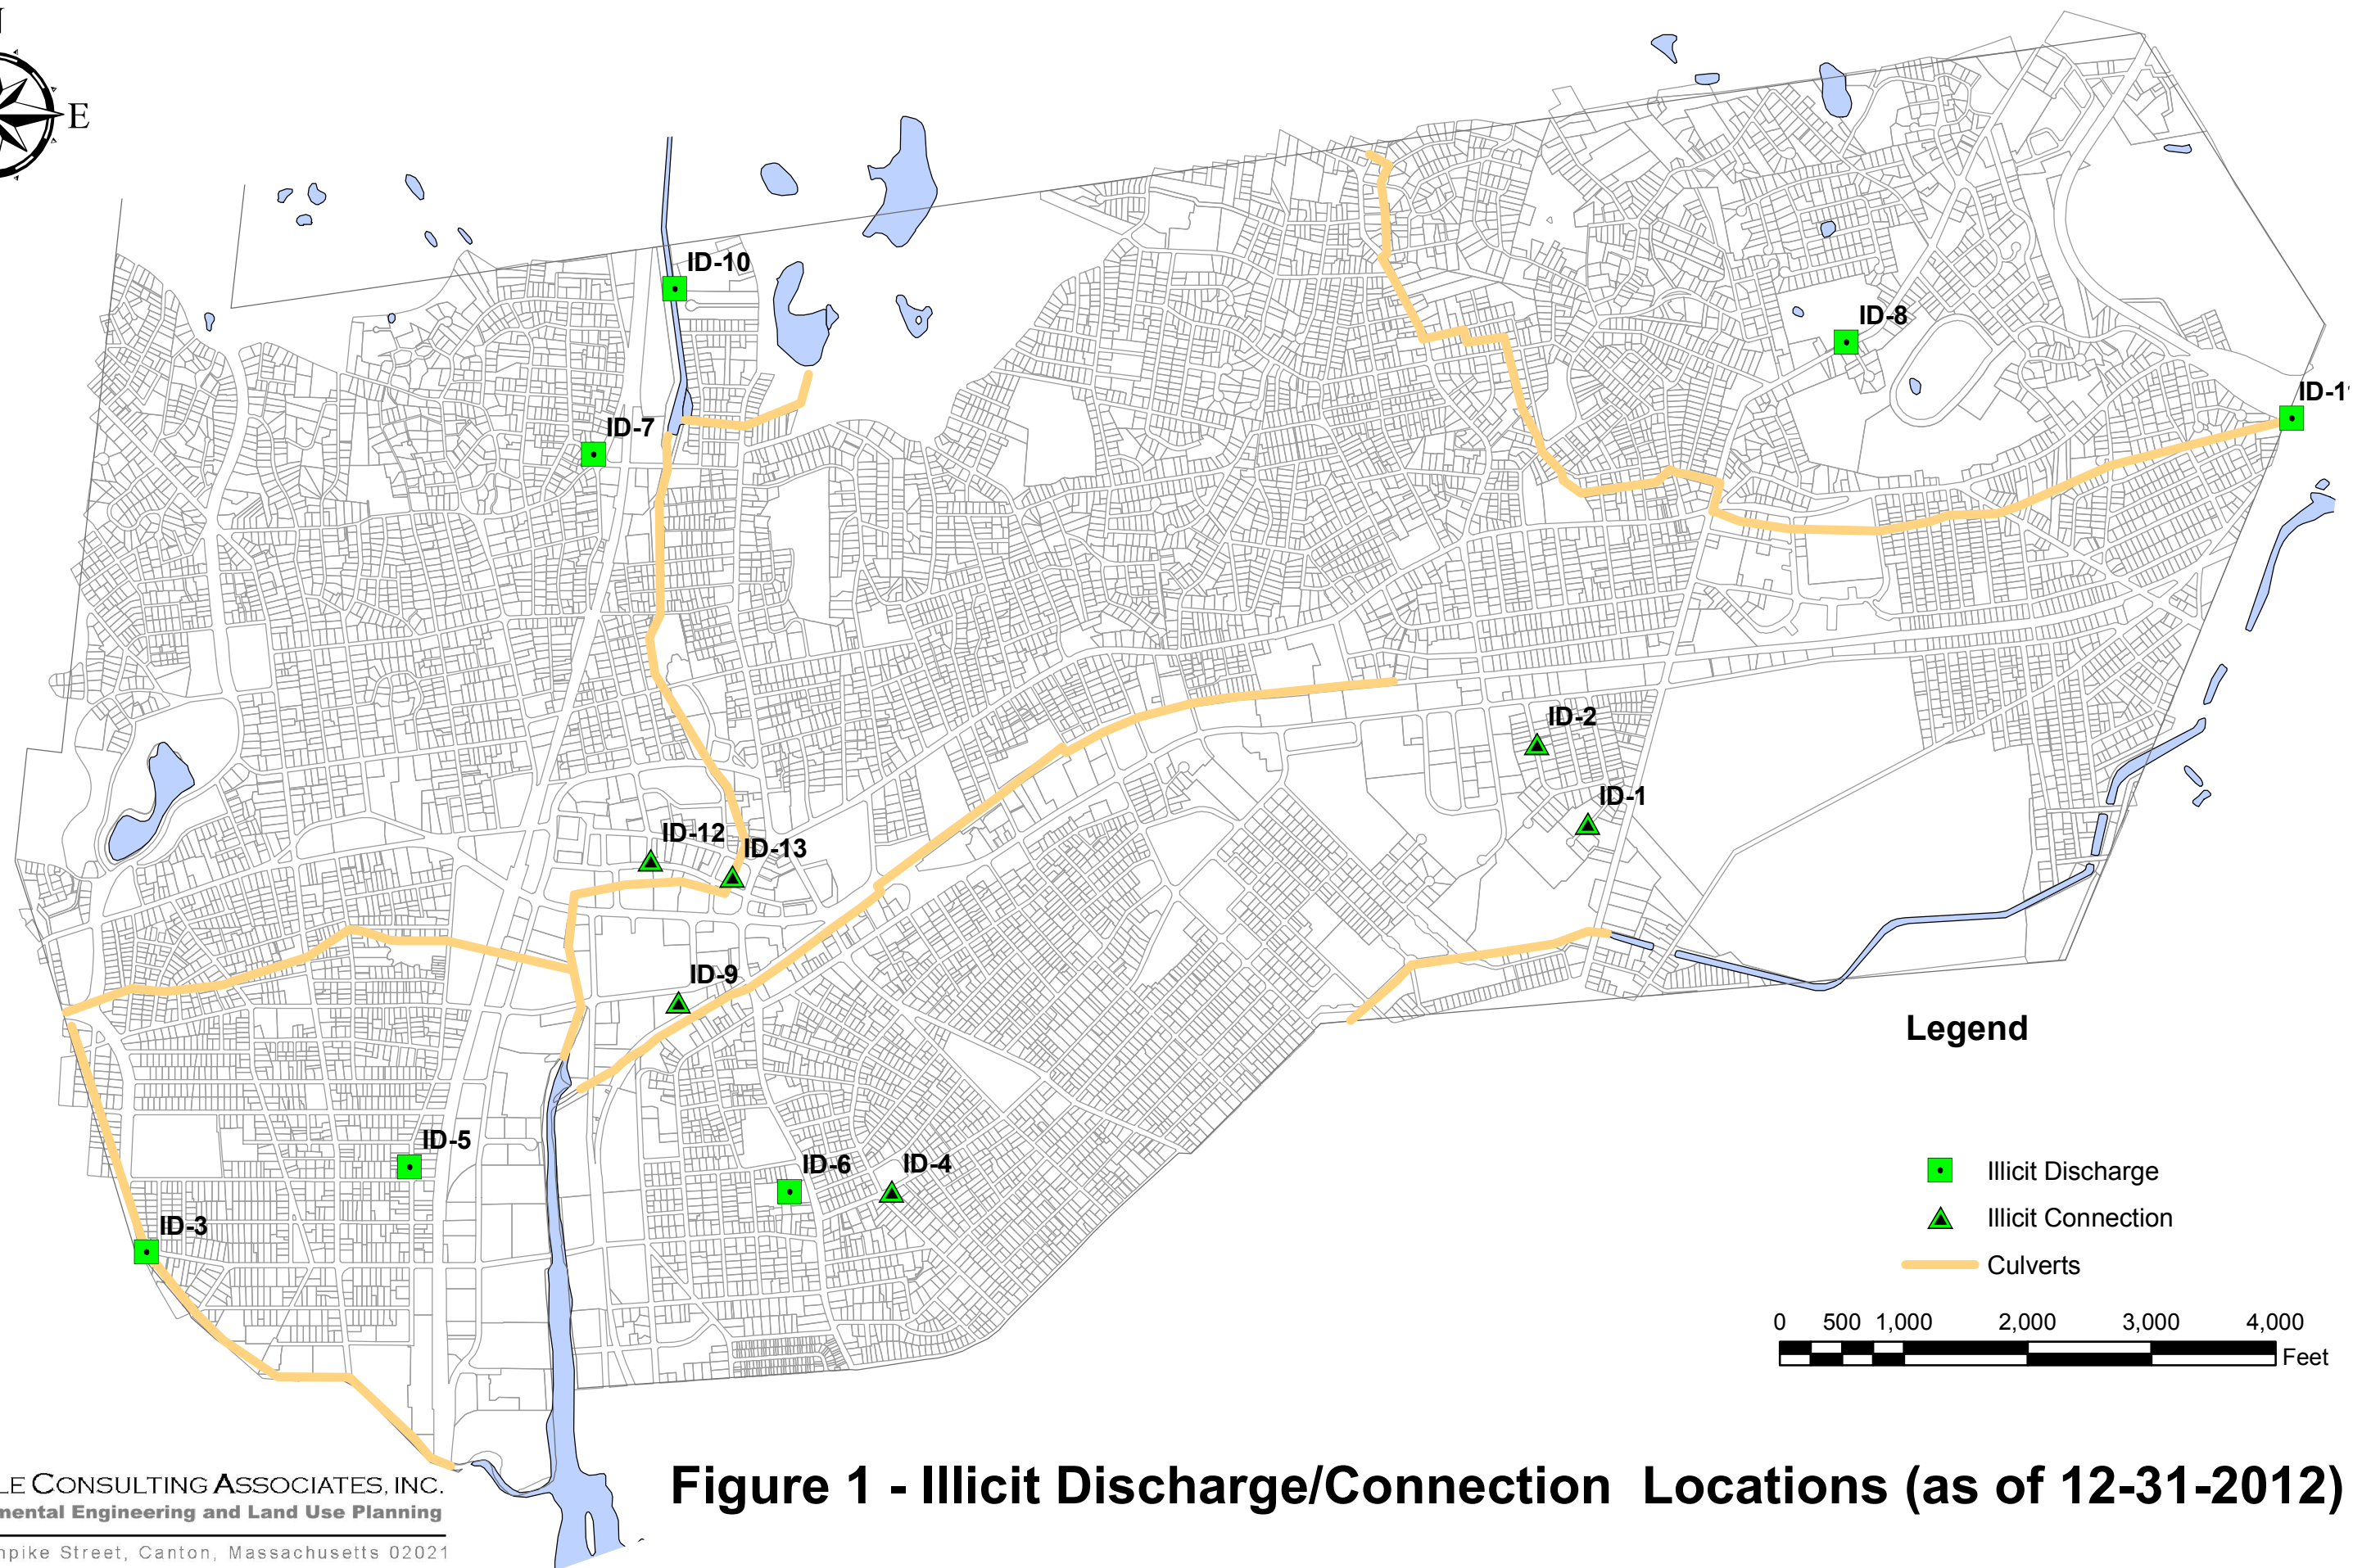
**Figure 1 - Illicit Discharge/Connection Locations (as of 12-31-2012)**

During this reporting period, one illicit discharge in the form of a compromise to sewer lateral connections for a residential complex was identified. A summary of the illicit discharges/connections identified to date is presented on Figure 1 and Table 1.0.

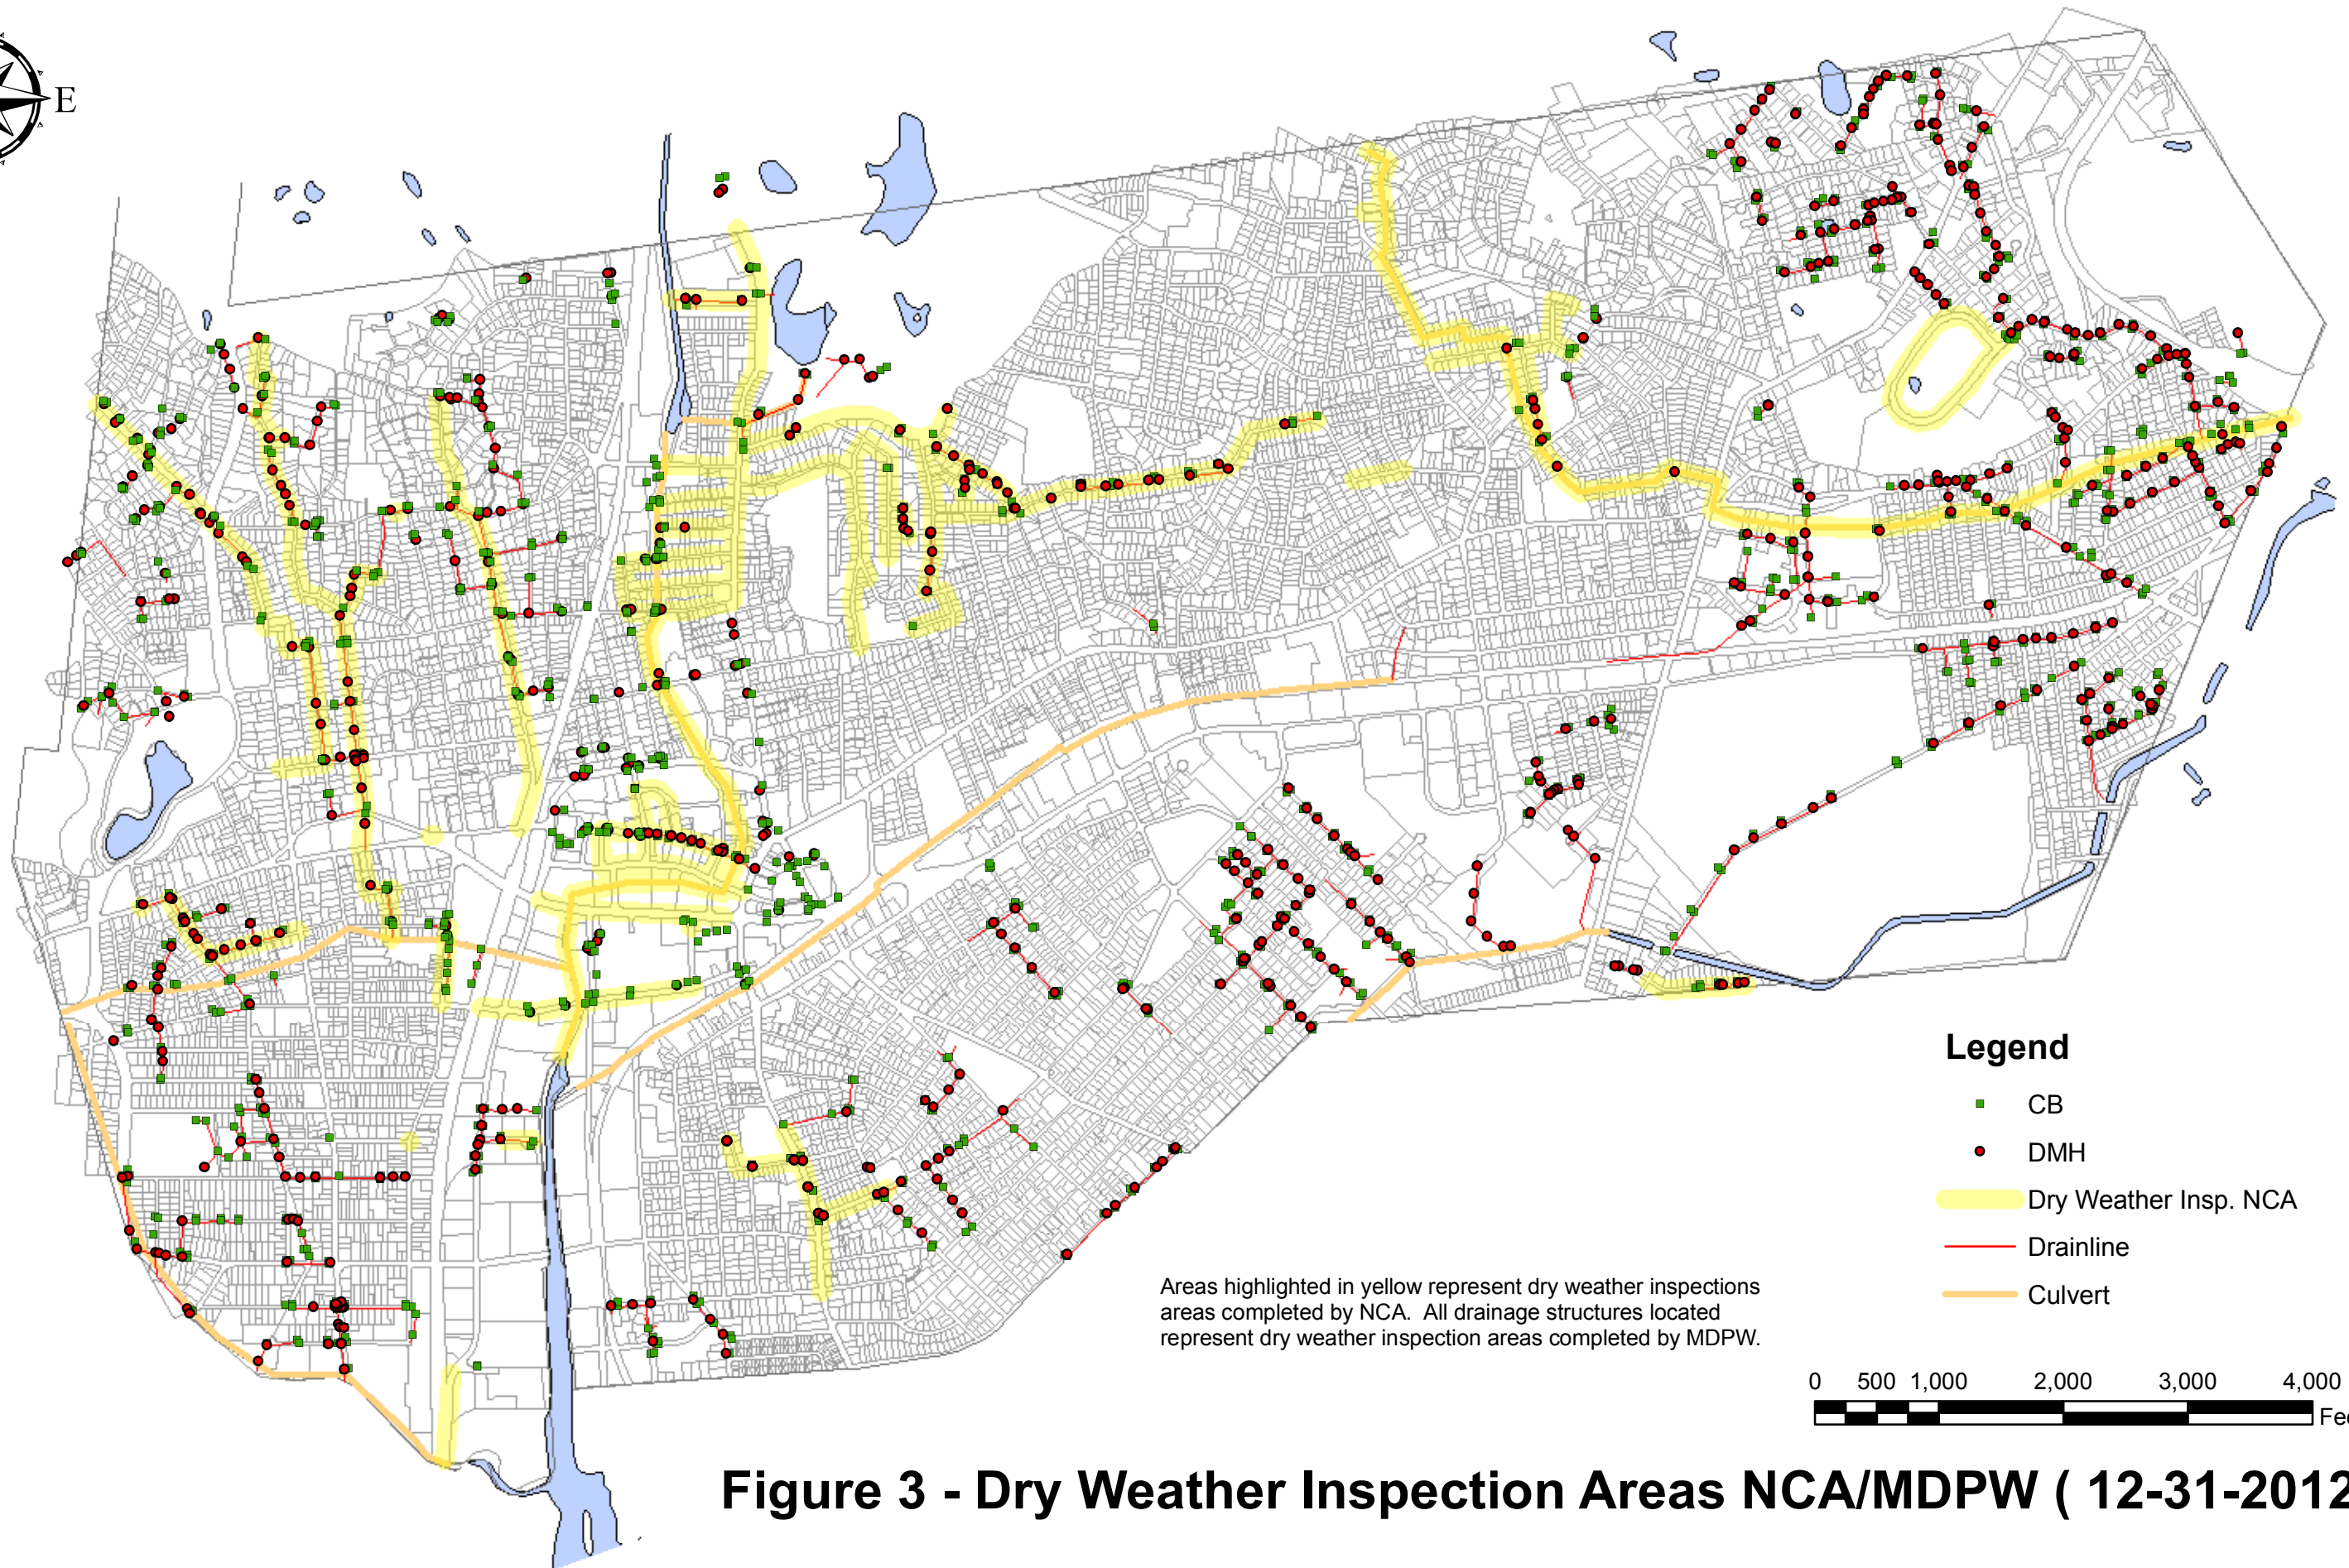
**Figure 3 - Dry Weather Inspection Areas NCA/MDPW ( 12-31-2012)**

Areas highlighted in yellow represent dry weather inspections areas completed by NCA. All drainage structures located represent dry weather inspection areas completed by MDPW.

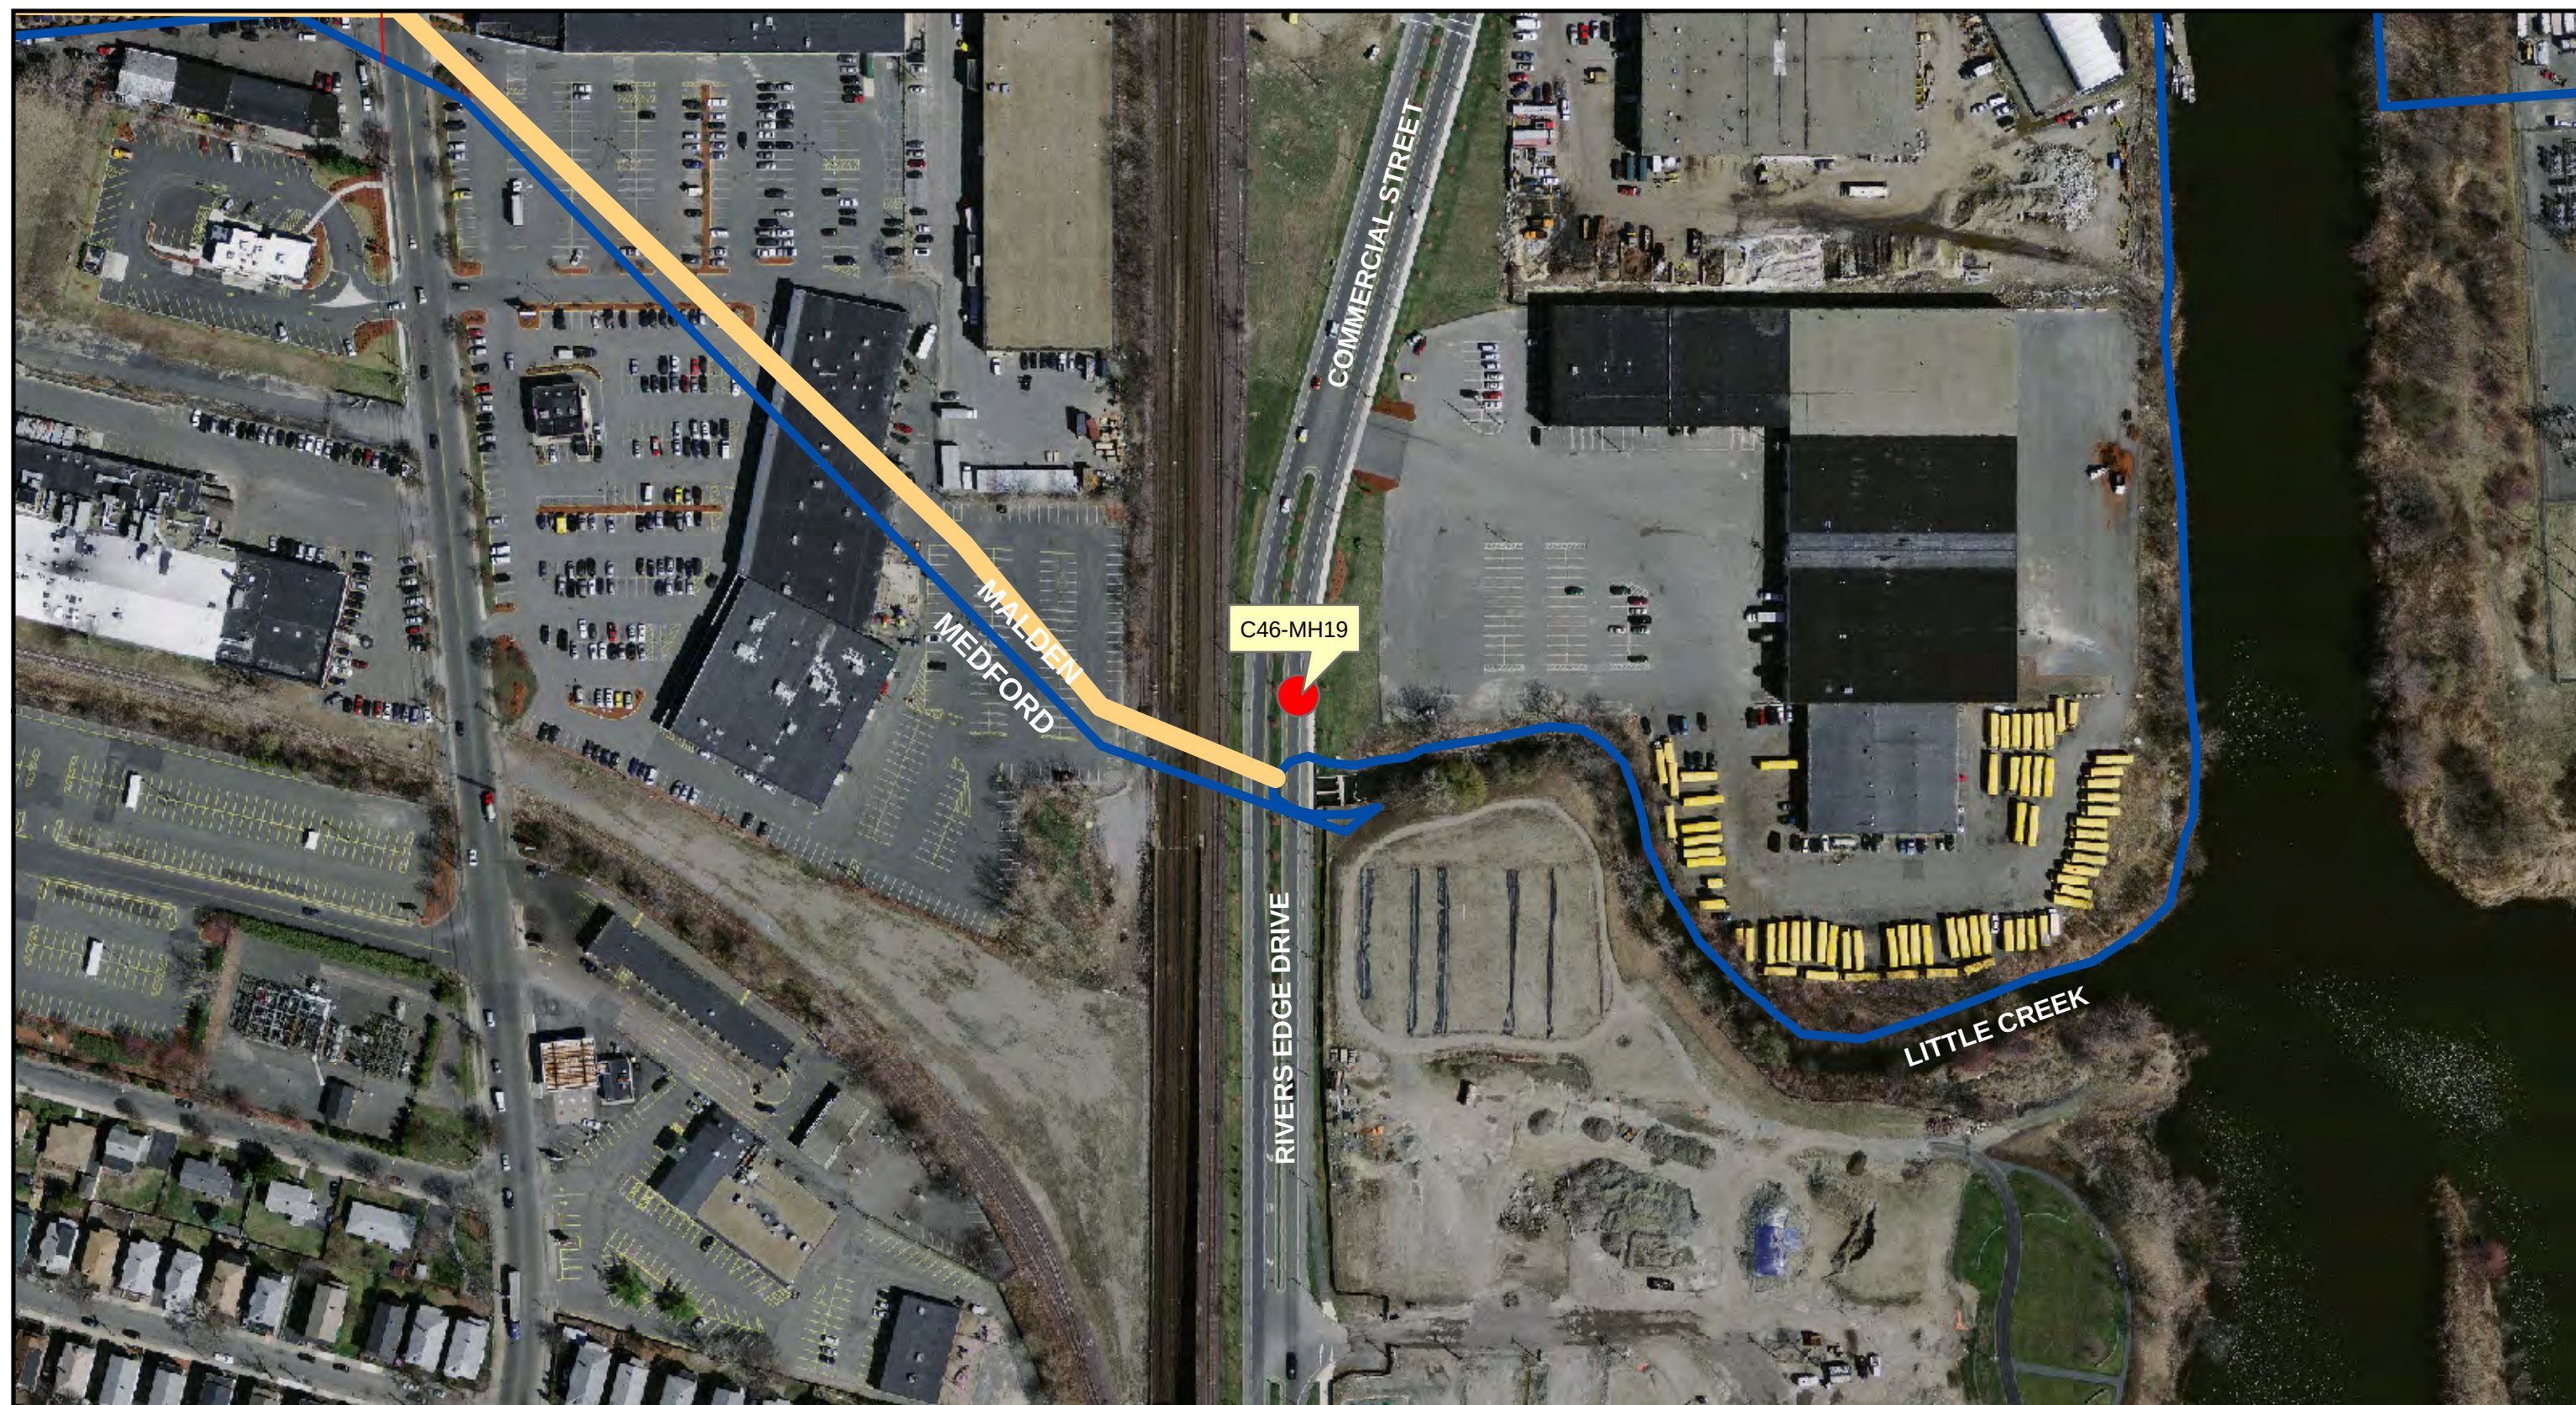
**Figure 8 - September 2012 Dry Weather Sampling Program**  
COMMERCIAL STREET - MALDEN, MASSACHUSETTS

Previous dry weather inspections have identified dry weather flows within a segment of the drainage system at the manhole identified as C46-MH19 (Figure 8), which is located immediately to the north of Little Creek. Reference to Table 2.0 reveals that moderate levels of both bacteria and sewage flow contributions were detected during the September 2012 sampling event. Of further note however, was the detection of surfactants, chlorine and ammonia nitrogen levels.

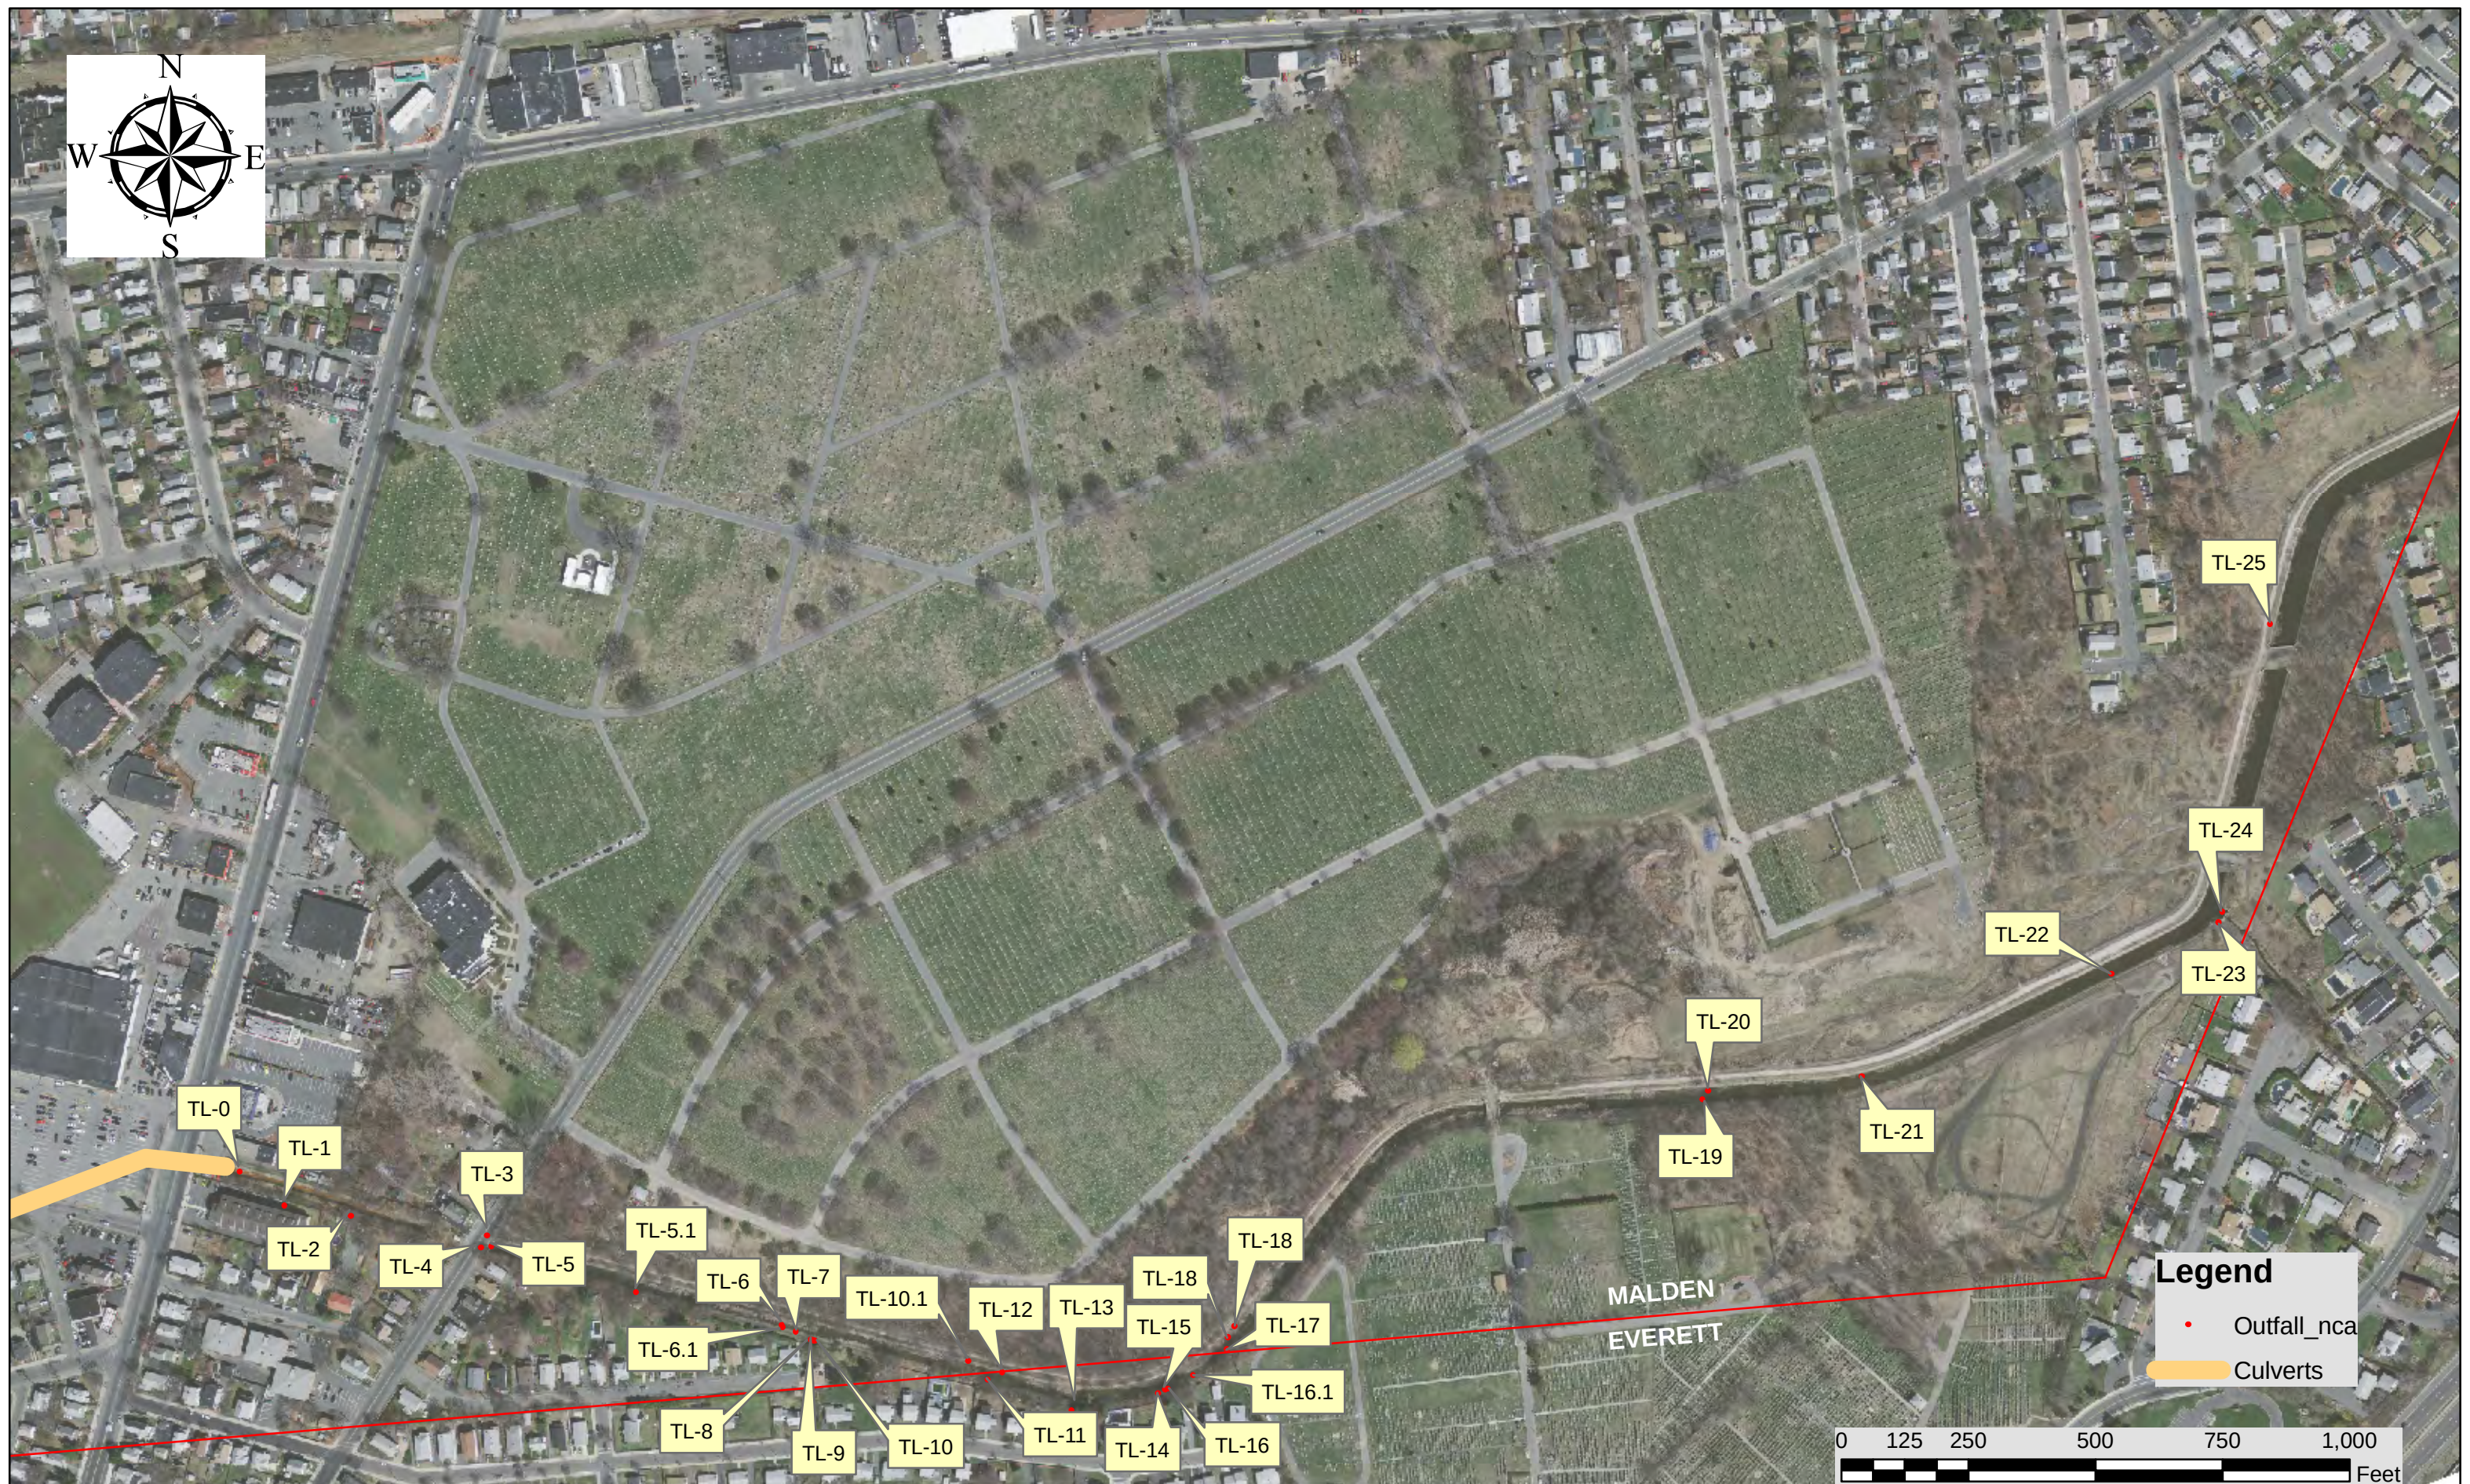
**Figure 10 - Town Line Brook Outfalls**

Town Line Brook in Malden begins at the Malden and Everett city boundary and is culverted until it daylights into an open concrete lined trapezoidal channel at Broadway. Significant tidal influences exist in the form of an approximate 2-3 foot change in surface water elevation between Broadway and the remaining length of the culvert to the Revere City line. As shown on Figure 10, a total of 29 outfalls to Town Line Brook in Malden have been identified. The historic monitoring data of Town Line Brook has revealed relatively uniform bacteria levels during dry weather sampling events. Several outfall locations have consistently exhibited bacteria loadings during dry weather sampling events, including S3-MH12, TL-0, TL-9 and Trifone Brook (TL-24). Manhole sample point S3-MH12 is the upstream sampling point for this section of the Brook as it enters the Malden system from Everett, while TL-0 is located at Broadway, where Town Line Brook daylights. TL-9 is located proximate to the terminus of Hadley Street in Malden and receives dry weather flows from the City of Everett, with Trifone Brook (TL-24), also flowing from Everett prior to discharging into Town Line Brook.

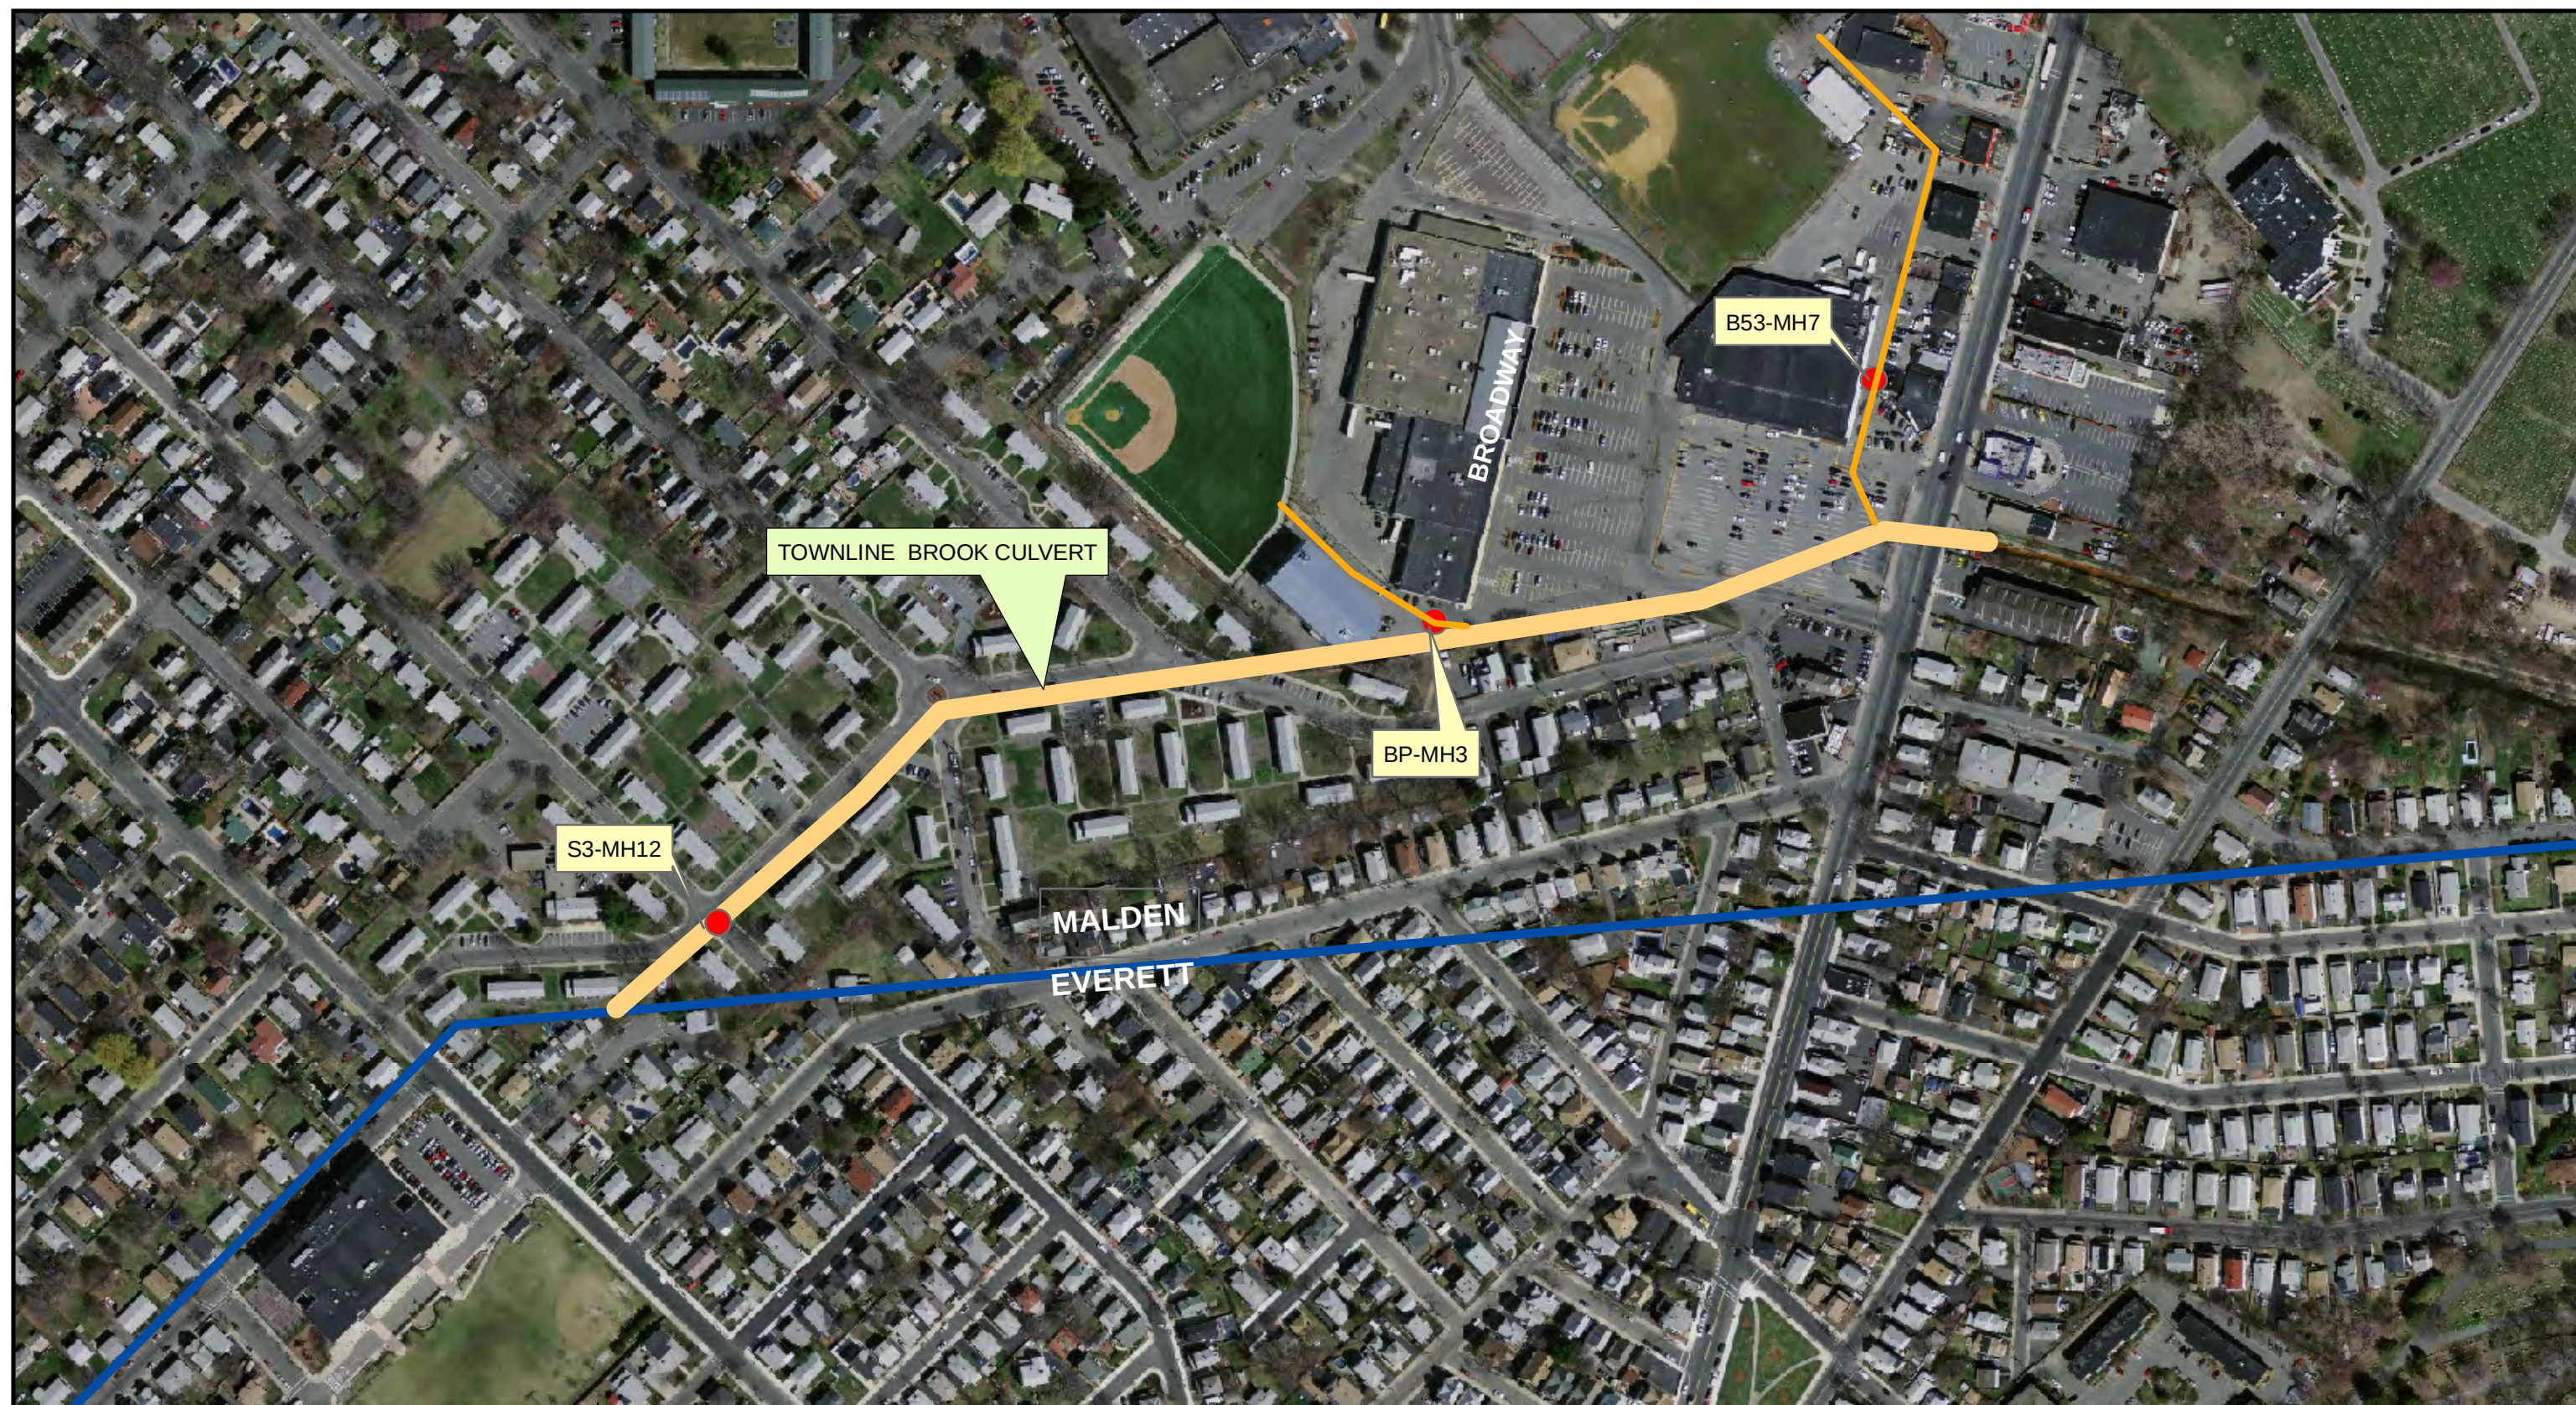
**Figure 11 - September 2012 Dry Weather Sampling Program**  
TOWNLINE BROOK CULVERT - MALDEN, MASSACHUSETTS

While a single stream dry weather flow condition exists at TL-9, there are several primary contributions to the outfall at Broadway (TL-0) and a Sketch Plan of Site depicting the sampling locations designed to isolate these flow contributions is depicted as Figure 11. As referenced previously, S3-MH12 is the upstream sampling point for this section of the Brook as it enters the Malden system from Everett. As summarized on Table 2.0, a sample from S3-MH12 and a duplicate sample both revealed consistent bacteria contributions entering into the Malden infrastructure. In addition, several indicators of human sewage contributions were also identified. As illustrated on Figure 11, there are two (2) culverted flows within the Malden drainage infrastructure that discharge at TL-0. While much lower bacteria levels were identified at sampling points BP-MH3 and B53-MH7, pharmaceuticals and detectable caffeine levels were also identified. These sampling points will be added to the coverall dry weather sampling program and in addition to re-sampling at these locations, upstream flows will also be investigated to isolate potential area of contribution.
