**Municipality/Organization:** City of Malden  
**EPA NPDES Permit Number:** MA041046  
**MADEP Transmittal Number:** 041088  
**Annual Report Number  
& Reporting Period:** No. 10: April 1, 2012-March 31, 2013

## NPDES PII Small MS4 General Permit Annual Report

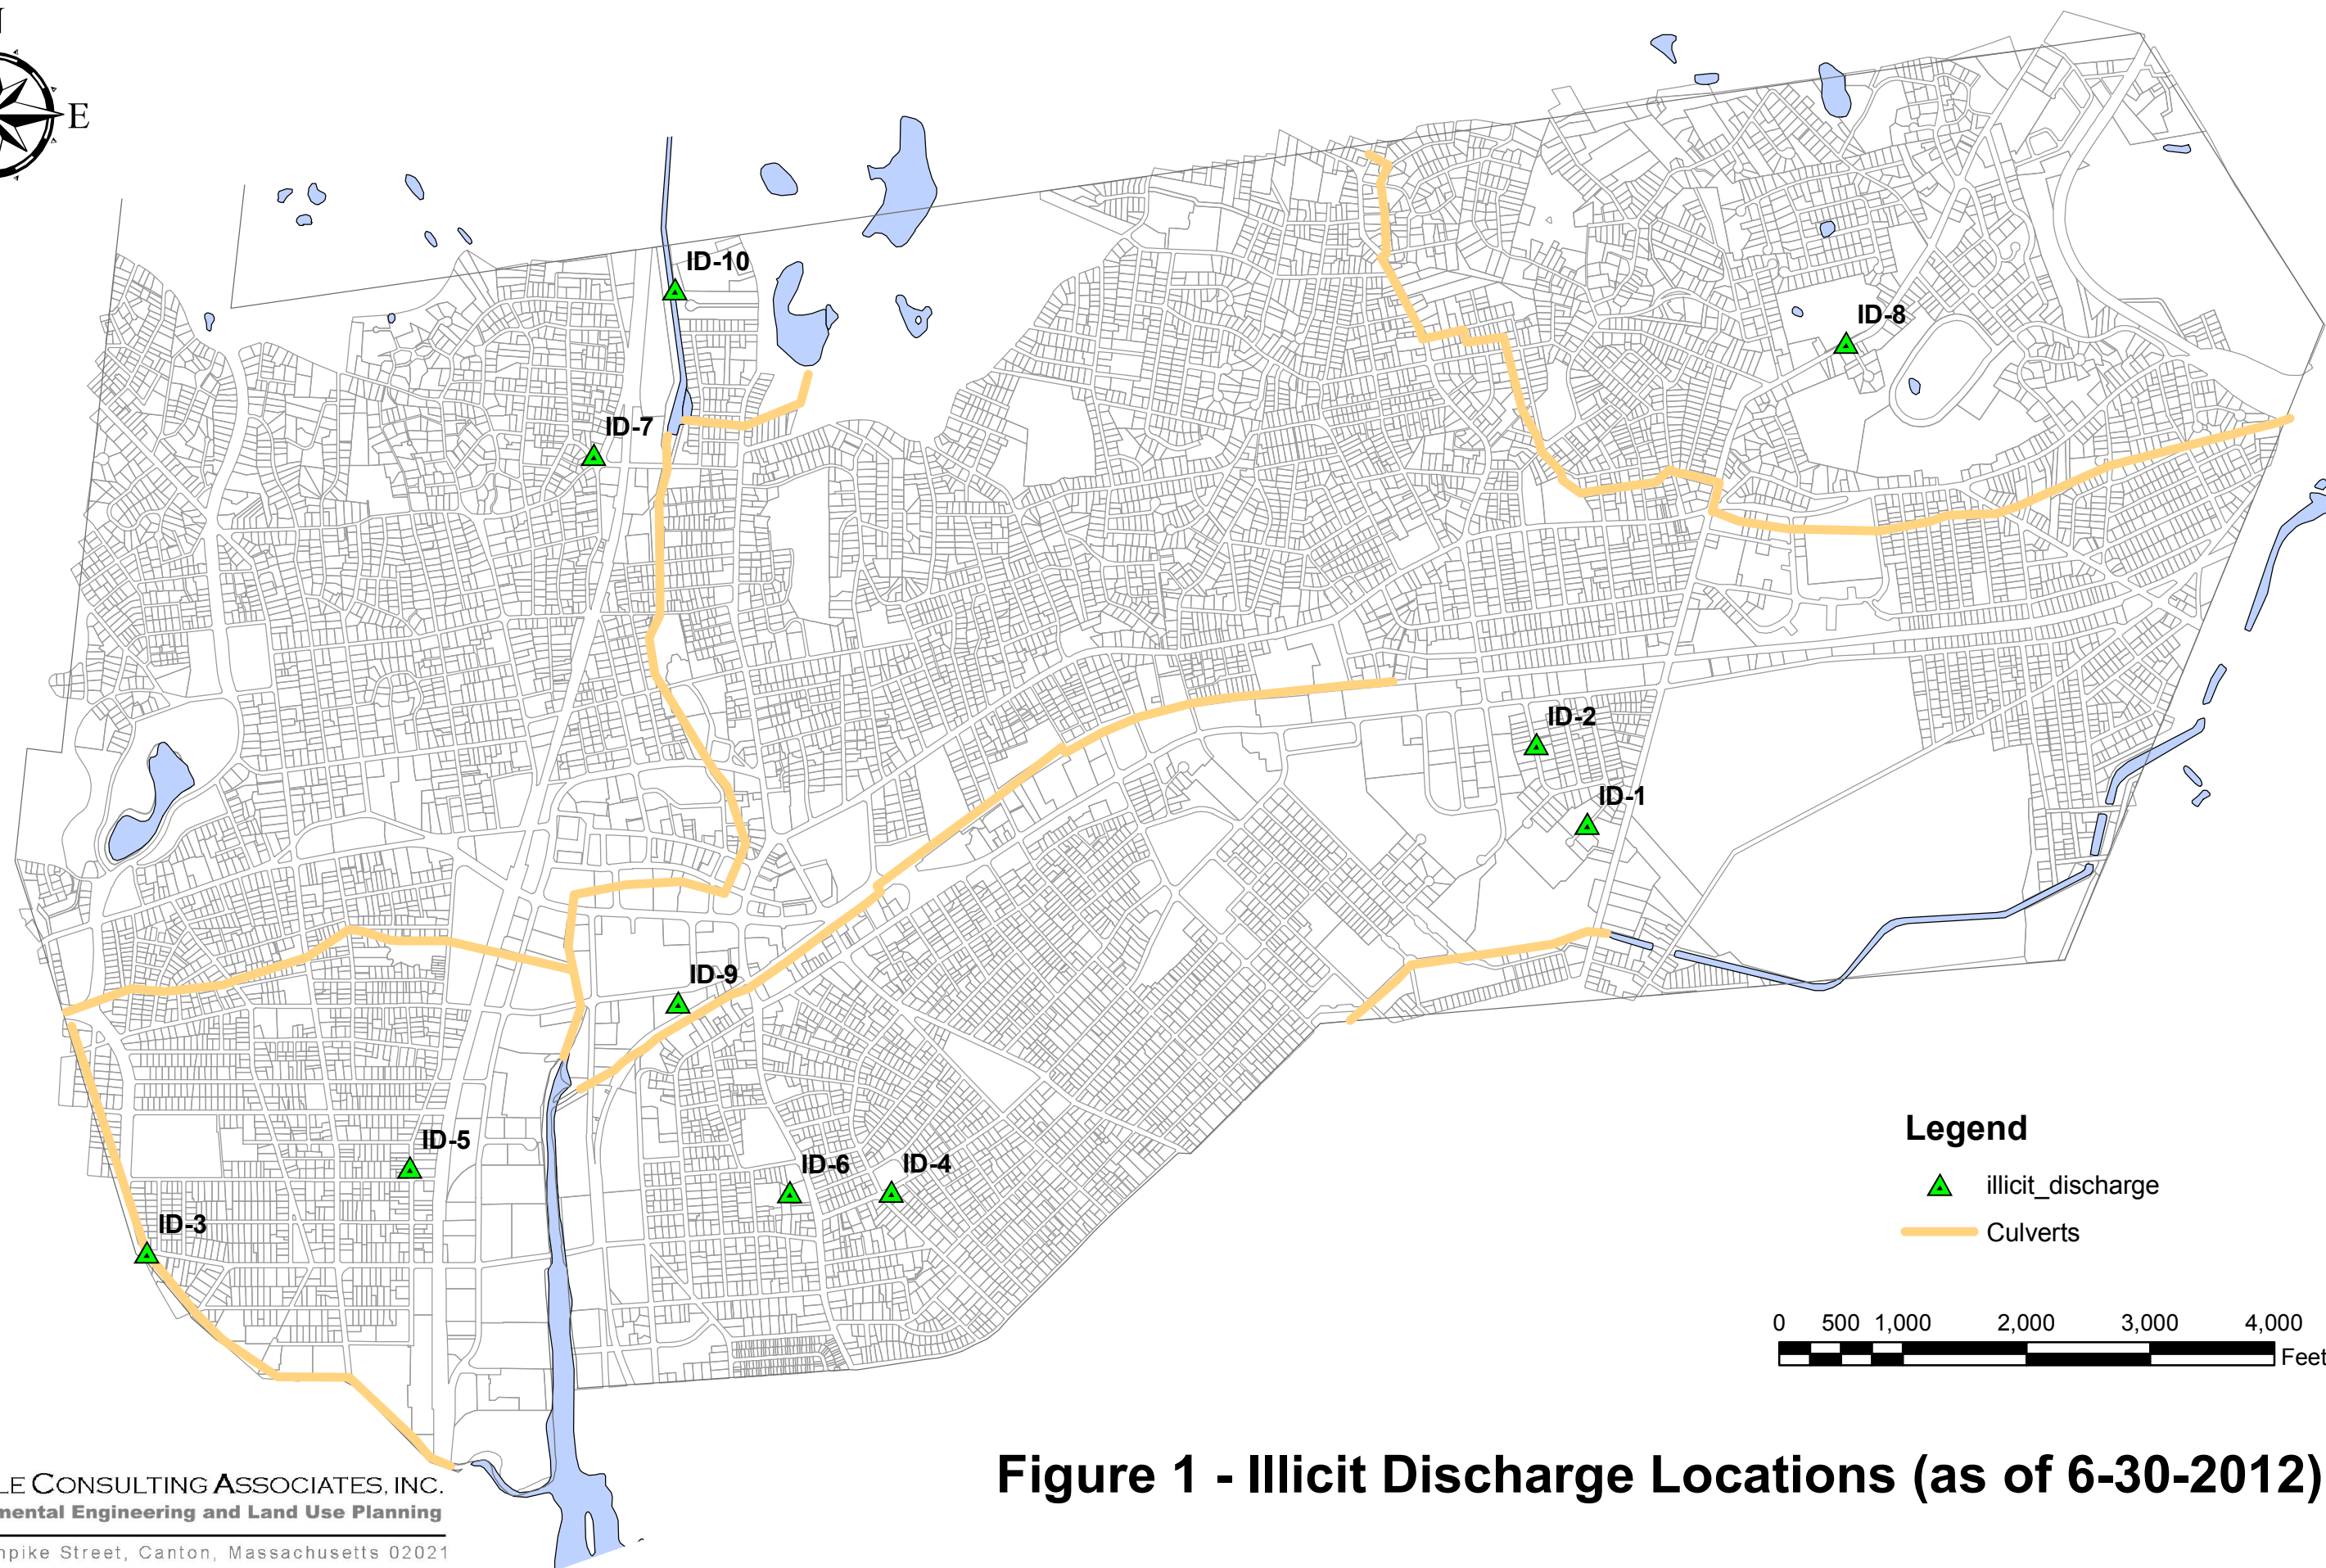
**Figure 1 - Illicit Discharge Locations (as of 6-30-2012)**

During this reporting period, one illicit discharge in the form of a compromise to sewer lateral connections for a residential complex was identified. A summary of the illicit discharges/connections identified to date is presented on Figure 1 and Table 1.0.

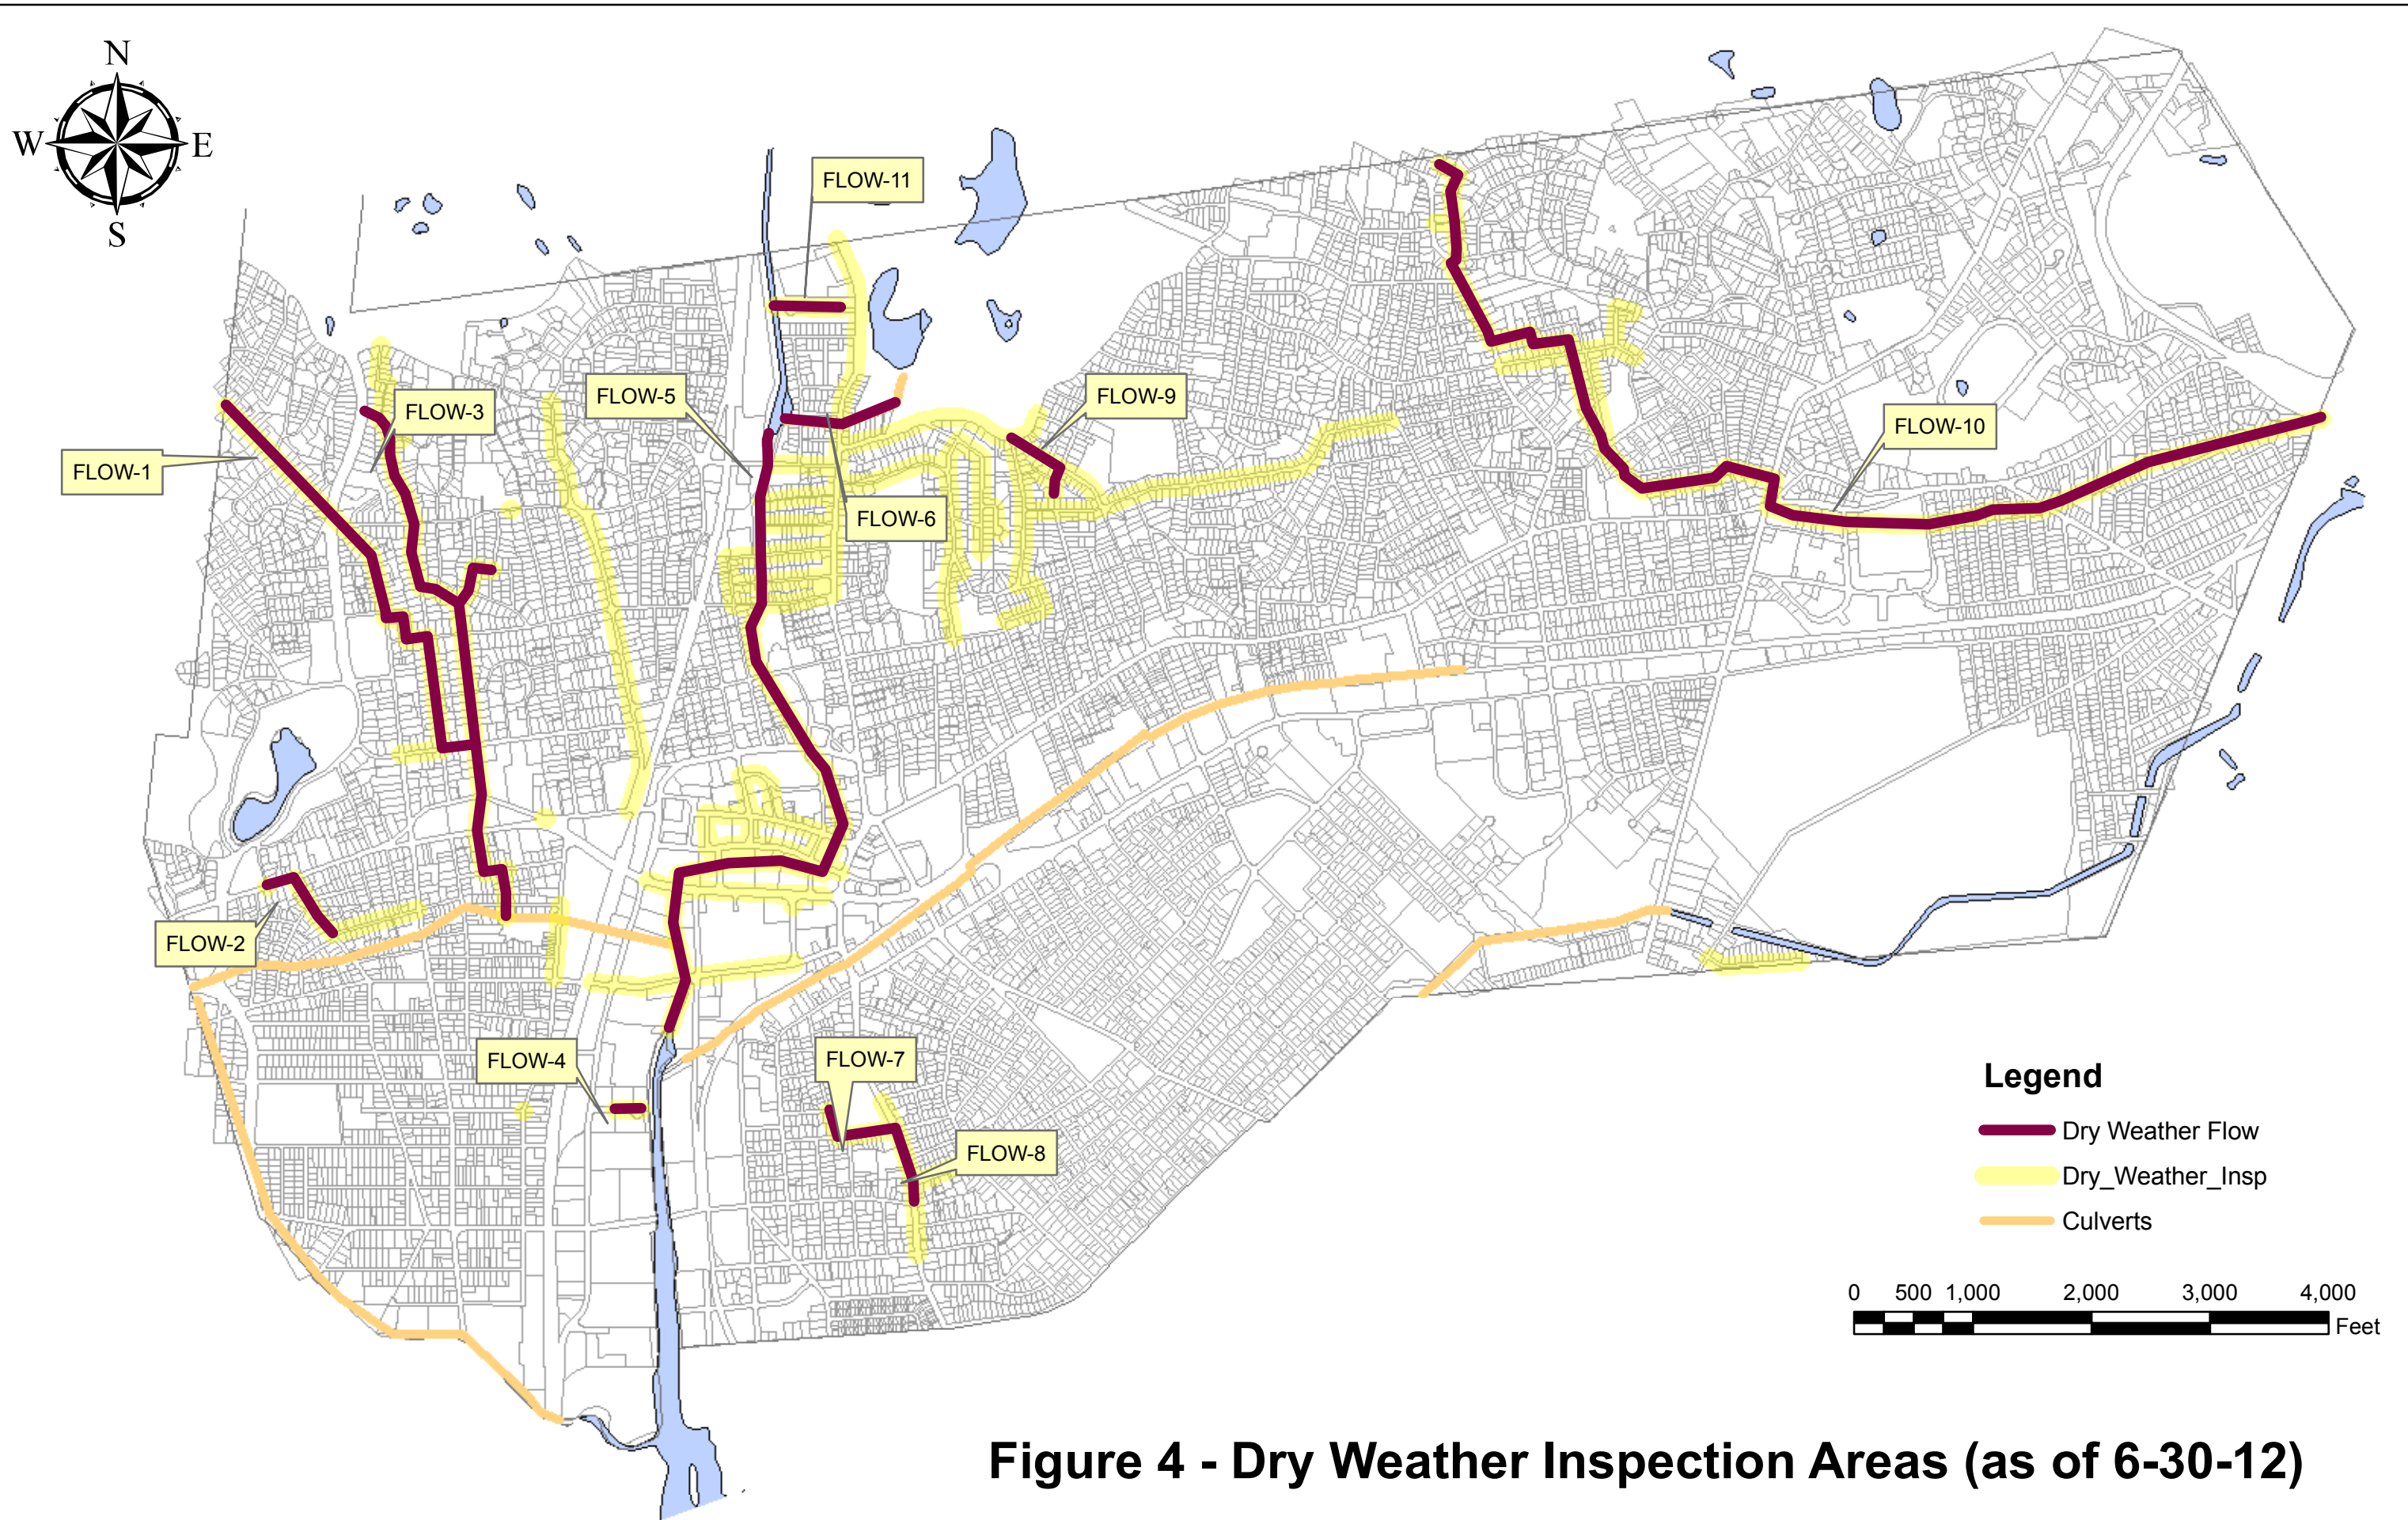
**Figure 4 - Dry Weather Inspection Areas (as of 6-30-12)**

As stated above, during the course of the dry weather inspections, a number of dry weather flows, consisting primarily of waterline leaks and culverted surface waters have been identified. A summary of these flows within the municipal system that have been identified to date are shown on Figure 4, and are described as follows.
