**Municipality/Organization:** City of Malden  
**EPA NPDES Permit Number:** MA041046  
**MADEP Transmittal Number:** 041088  
**Annual Report Number  
& Reporting Period:** No. 11: April 1, 2013-March 31, 2014

## NPDES PII Small MS4 General Permit Annual Report

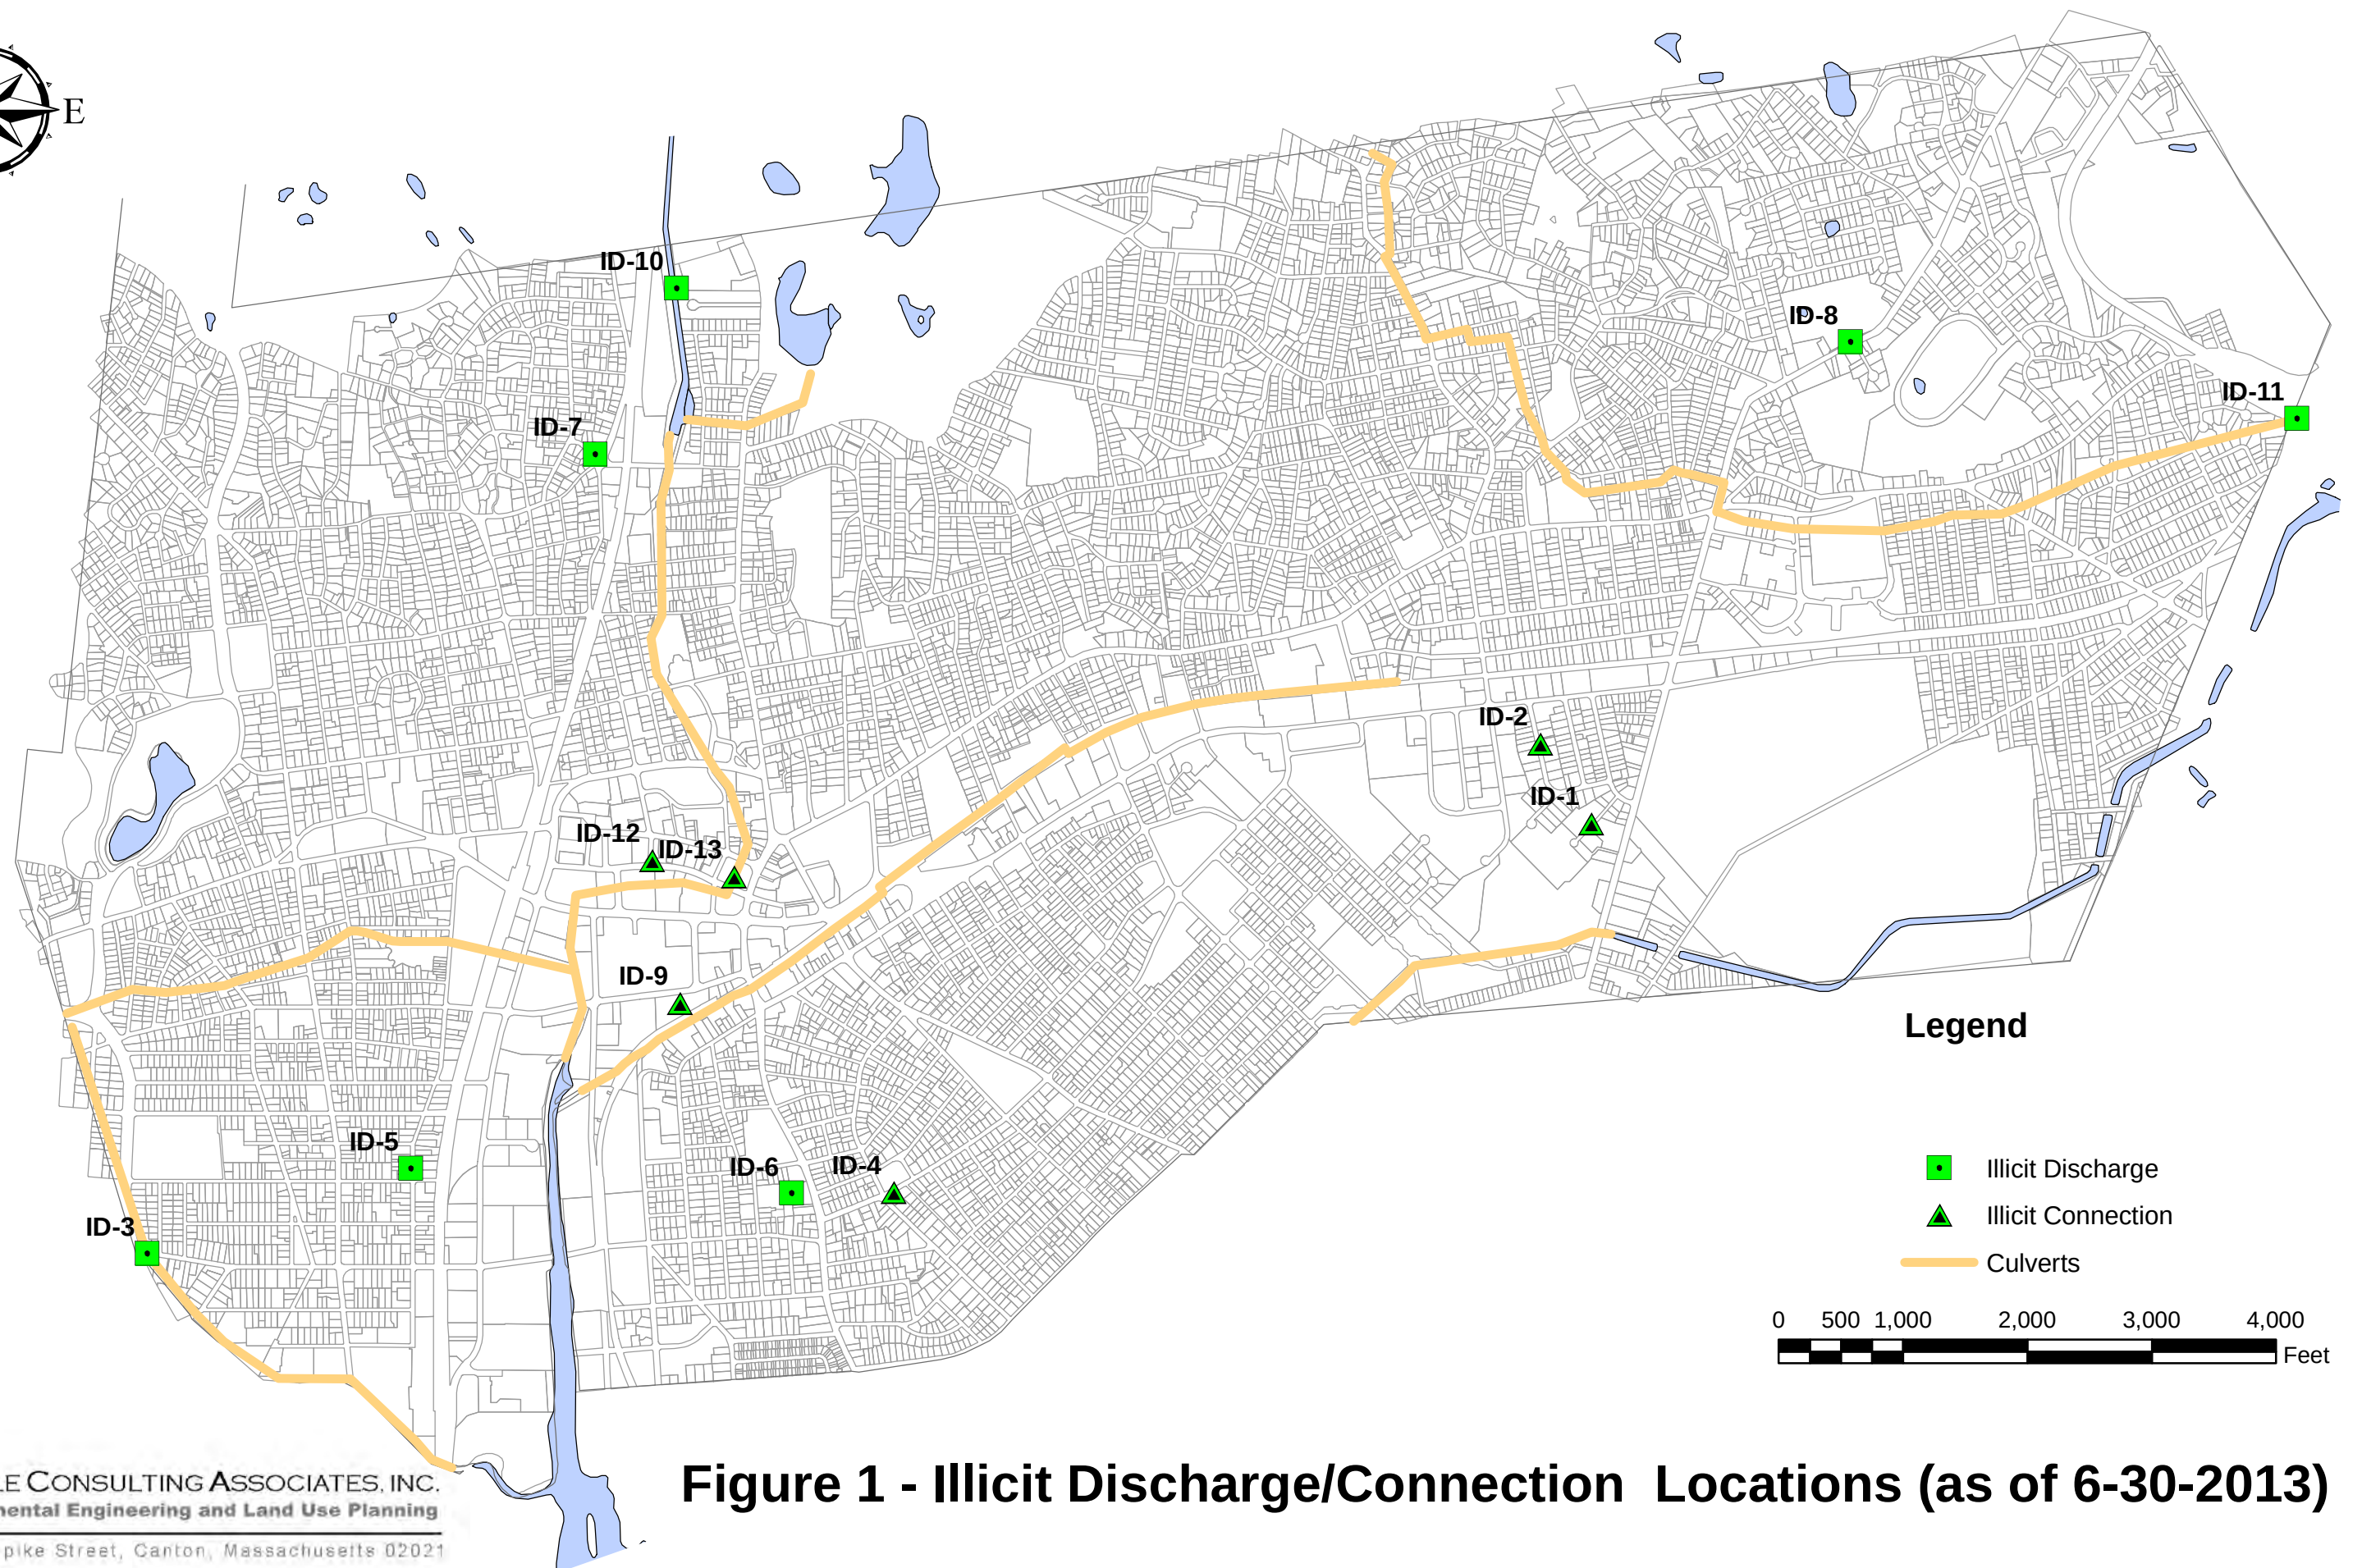
**Figure 1 - Illicit Discharge/Connection Locations (as of 6-30-2013)**

During this reporting period, no illicit discharges were identified. However, last reporting period; one (1) potential illicit discharge was identified, in the form of a possible grease blockage within a sewer siphon located at the intersection of Salem and Lynn Streets that passes beneath Linden Brook. This structure is located at the City line between Malden and Revere. Additional details pertaining to the ongoing investigation and inspection program may be referenced from Section 3.1.3. To assist in the review of the information contained within this report, a summary of the illicit discharges/connections identified to date is presented on Figure 1 and Table 1.0.

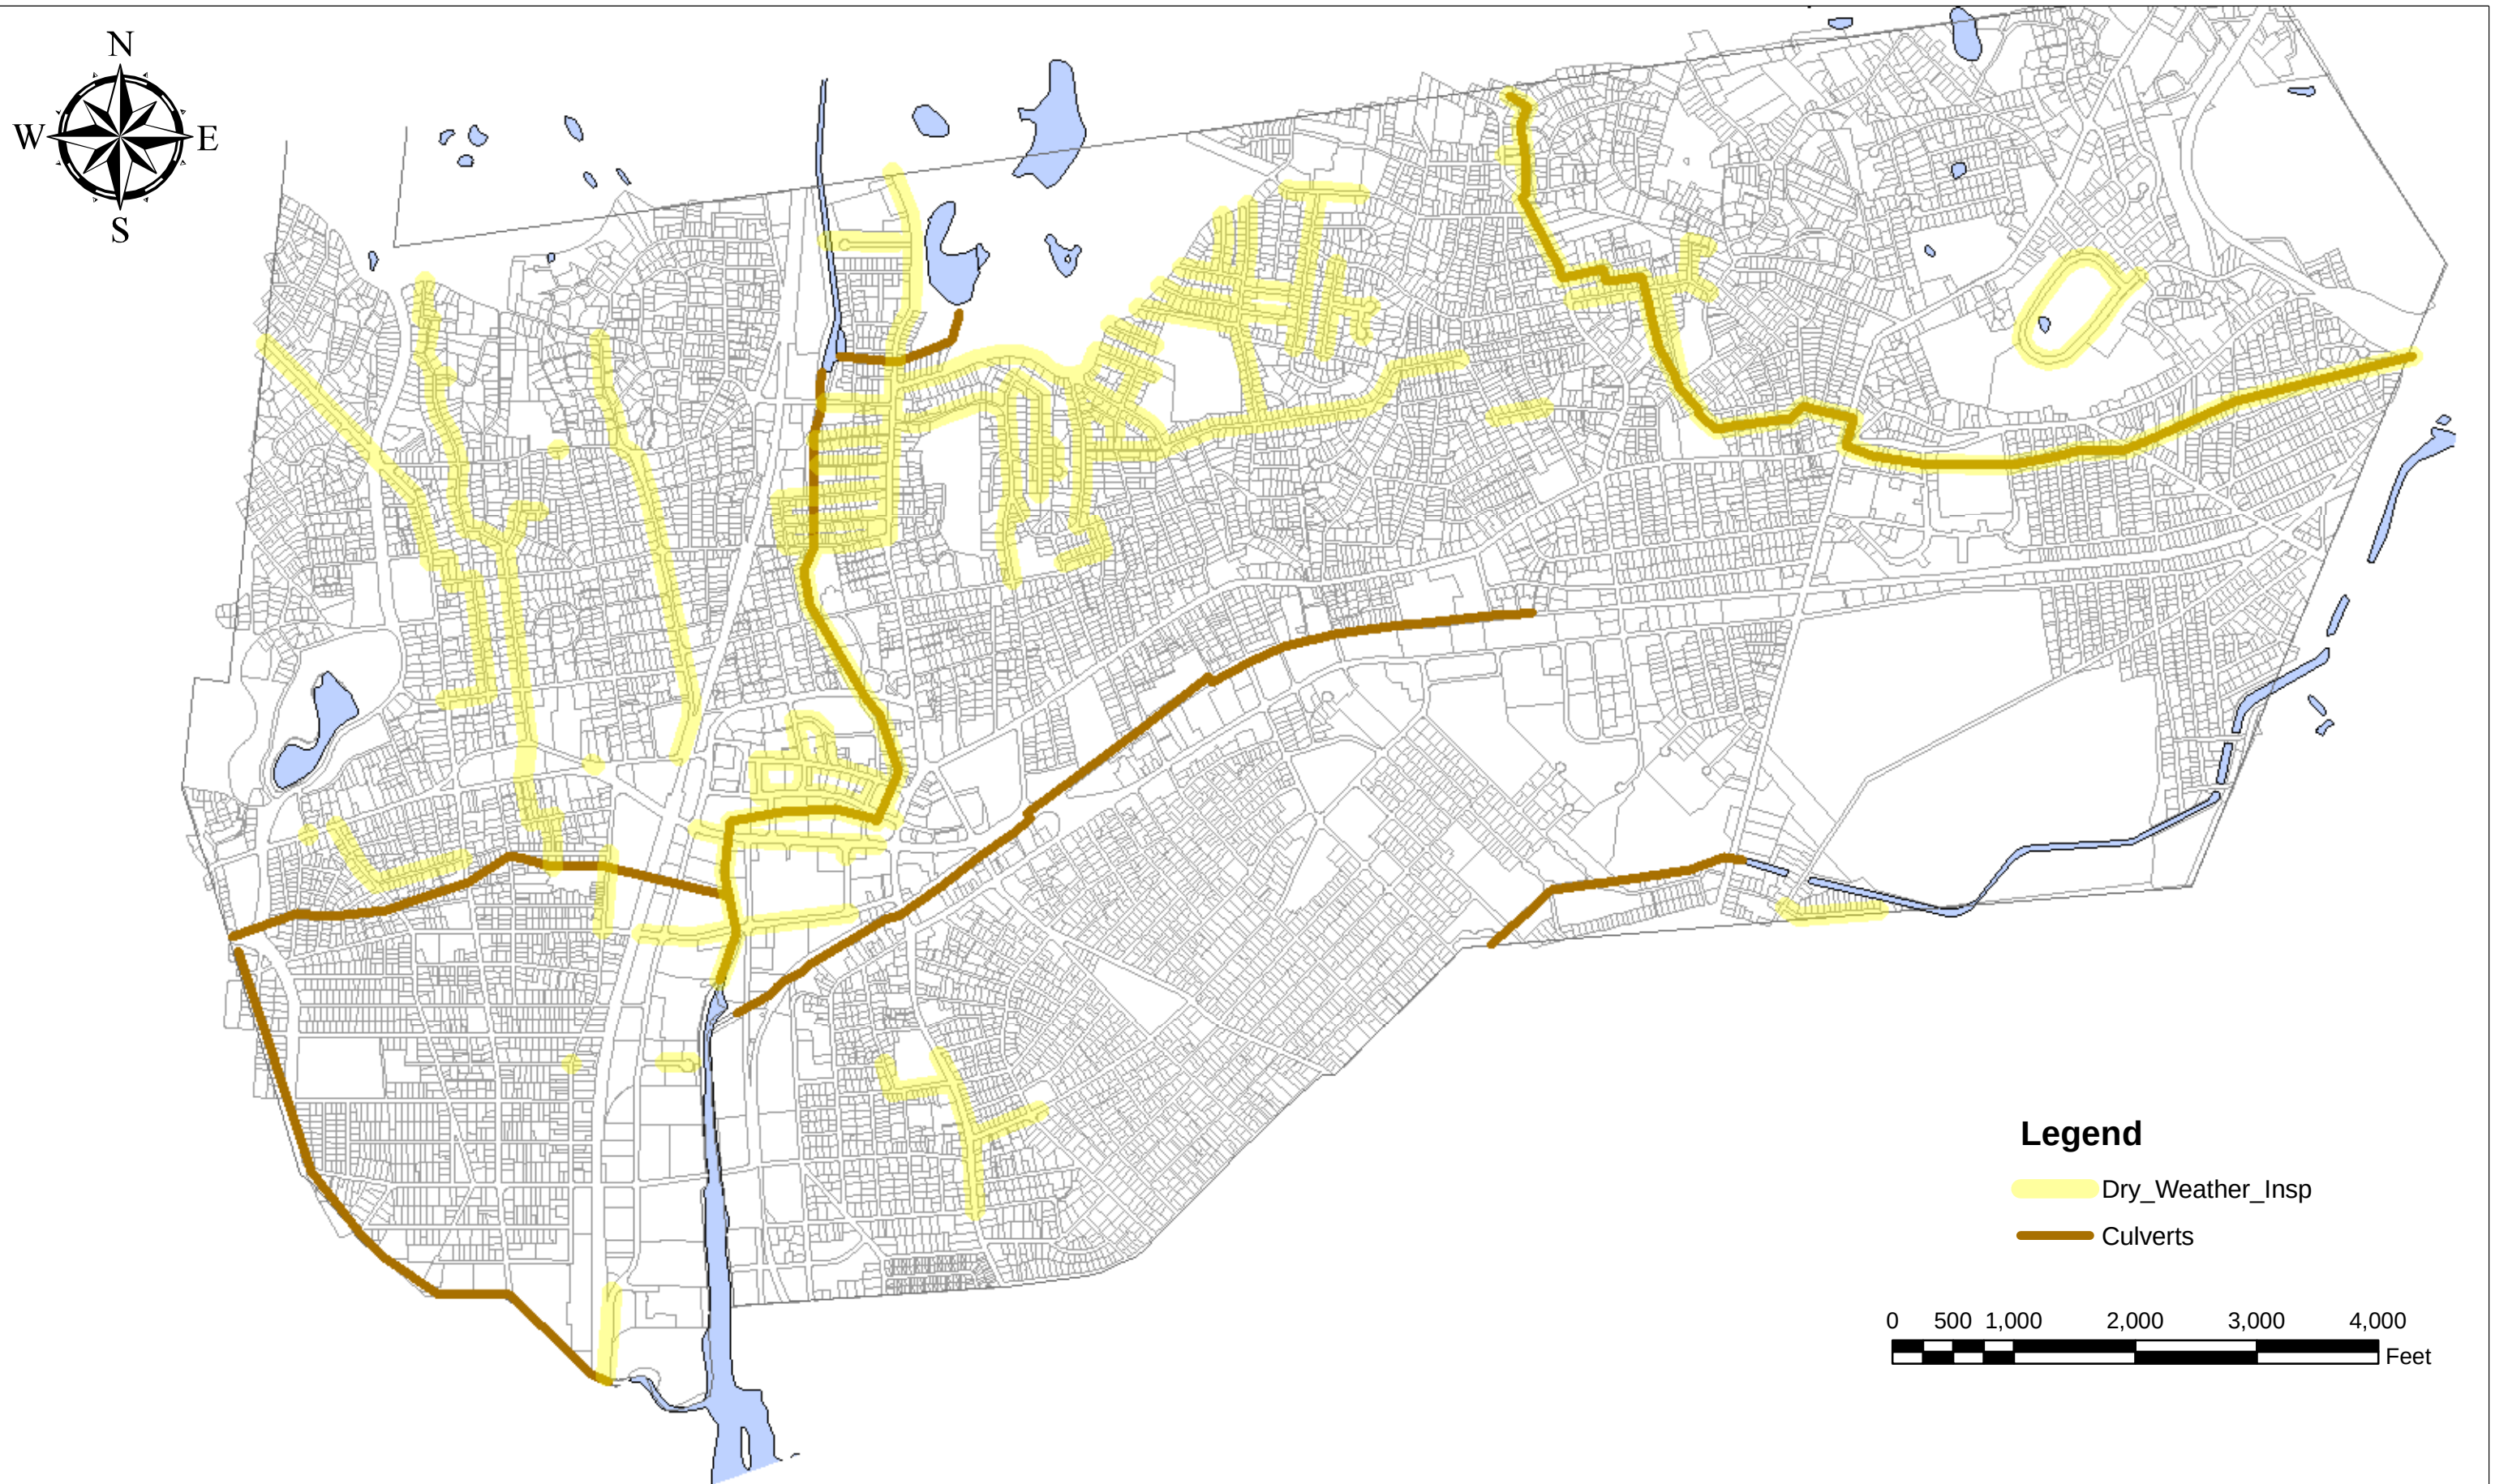
**Figure 2 - Dry Weather Inspection Areas (as of 6-30-13)**

A map depicting the approximate locations where targeted dry weather inspections have been conducted by NCA to date is presented as Figure 2. Areas inspected by DPW staff for illicit connections/discharges consist of portions of the infrastructure that are addressed during the catch basin cleaning program. During this effort, infrastructure components are mapped and the corresponding attributes are located. Upon the identification of previously unknown dry weather flows, the Engineering Department and NCA are immediately notified by MDPW personnel and targeted mass balance sampling efforts are performed. Portions of the municipal infrastructure that have been addressed by the compliance team including these targeted subset areas are summarized on Figure 3.

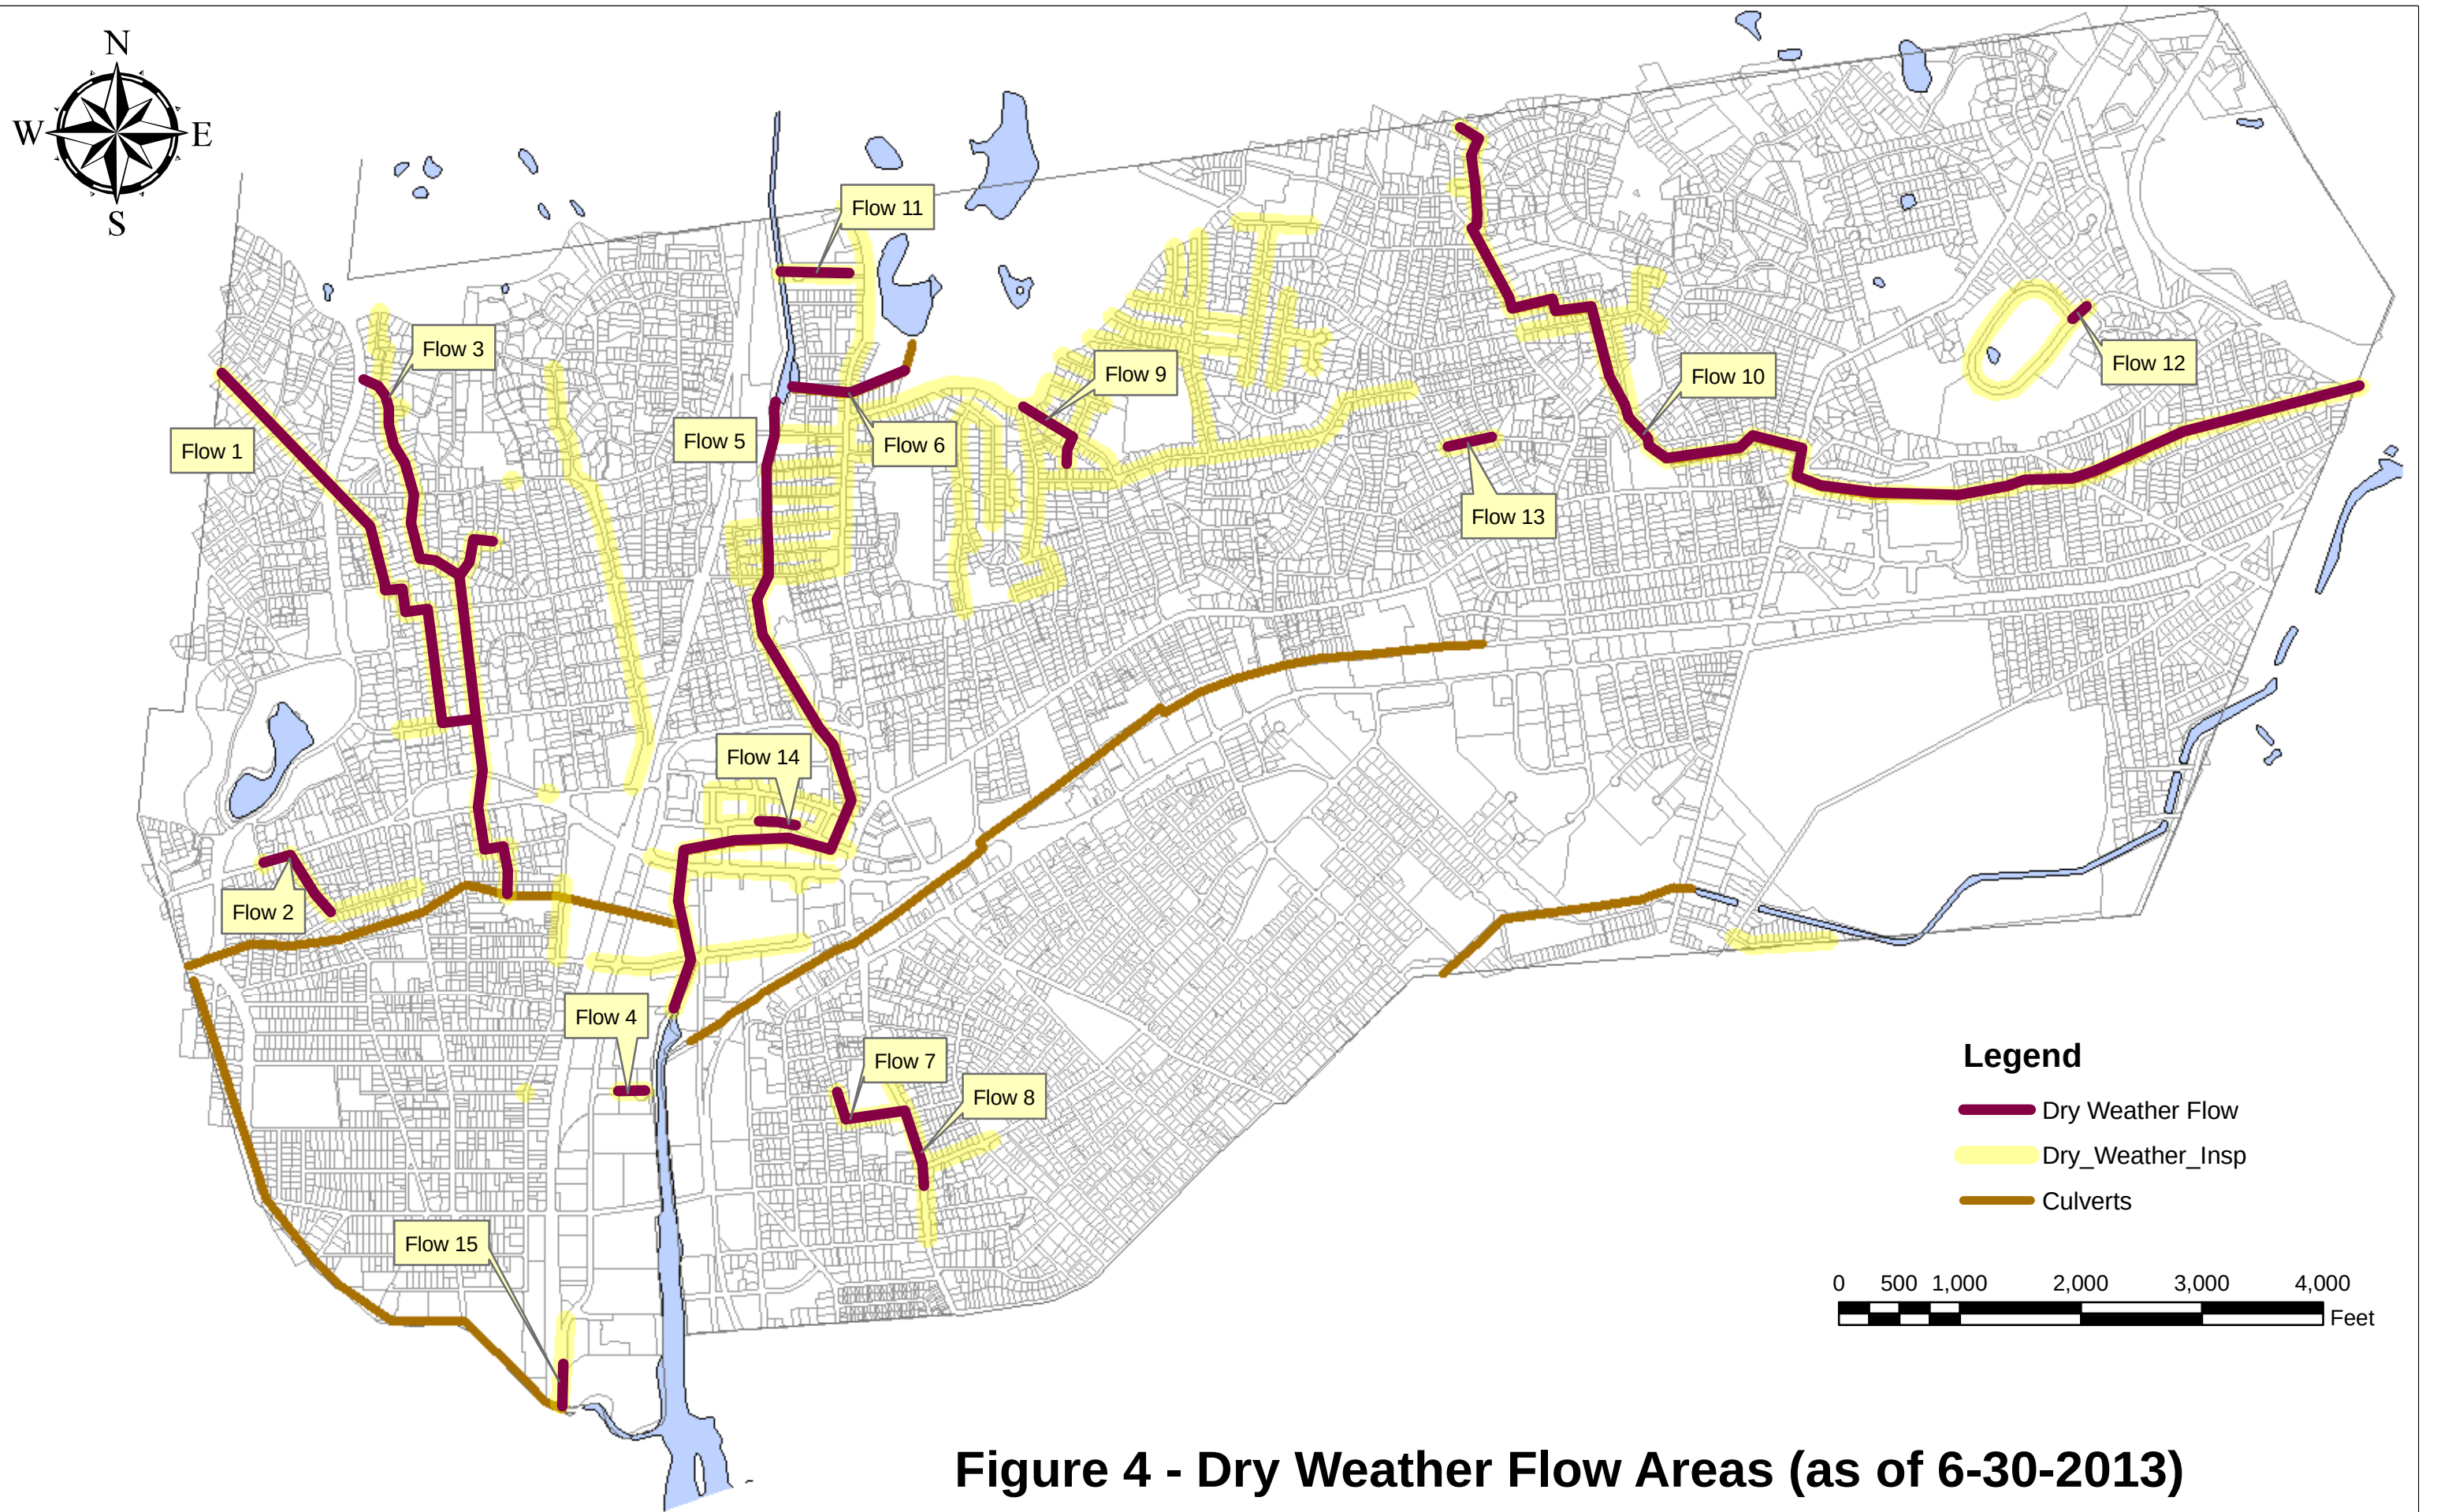
**Figure 4 - Dry Weather Flow Areas (as of 6-30-2013)**

A summary of these flows within the municipal system that have been identified to date are shown on Figure 4, and are described as follows.

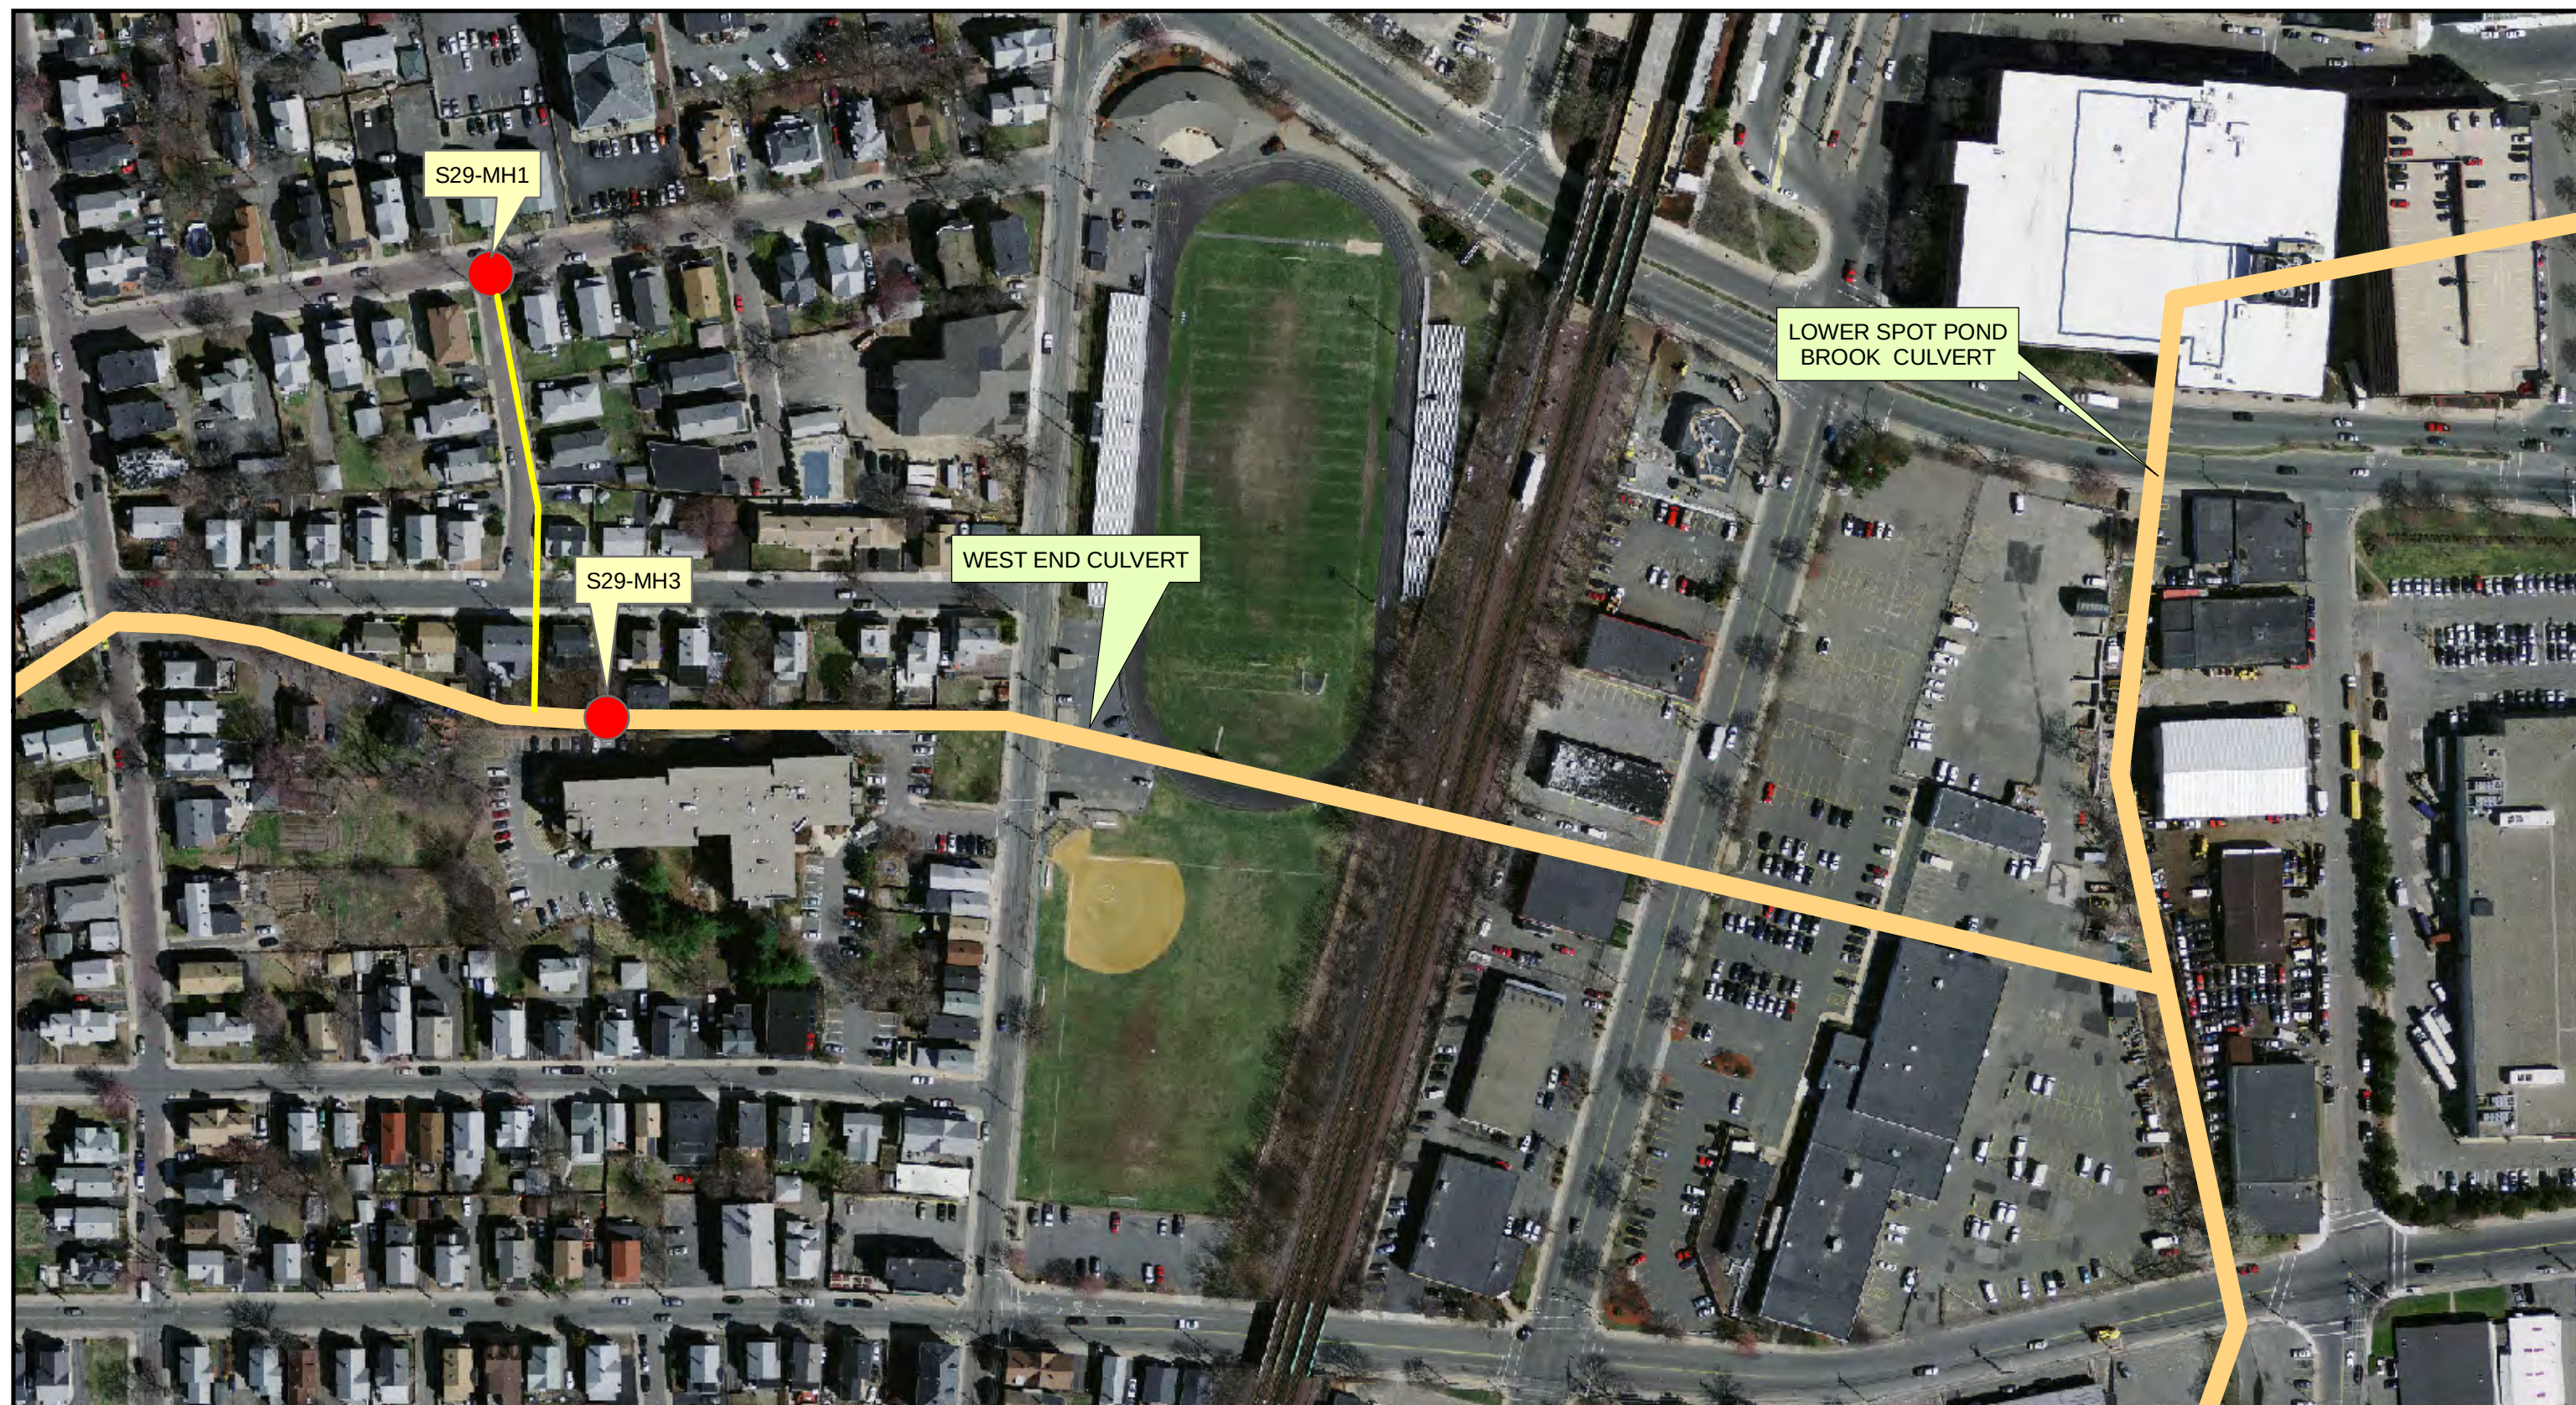
**Figure 6 - 6 April 2013 Dry Weather Sampling Program**  
WEST END/ SPOT POND BROOK CULVERTS - MALDEN, MA

As indicated previously, prior dry weather inspections have identified dry weather flows within the West End Brook Culvert at the manhole identified as S29-MH3 (Figure 6). Reference to Table 2.0 reveals that elevated levels of bacteria (13,330 MPN/100 ml) were detected during the September 11, 2012 sampling event at this location, which was in marked contrast to those obtained during prior sampling events. To further assess this area of the drainage system, another dry weather sample was collected on 5 April 2013. In addition, manhole S29-MH1 (Figure 6), which is located upstream of S29-MH3 was also sampled at that time. Consistent with prior results, the sampling of West End Brook Culvert during this reporting period revealed bacteria levels of 160 MPN/100ml at S29-MH1 and 190 MPN/100ml at S29-MH3, as summarized on Table 2.0.
