**Municipality/Organization:** City of Malden  
**EPA NPDES Permit Number:** MA041046  
**MADEP Transmittal Number:** 041088  
**Annual Report Number  
& Reporting Period:** No. 13: April 1, 2015-March 31, 2016

## NPDES PII Small MS4 General Permit Annual Report

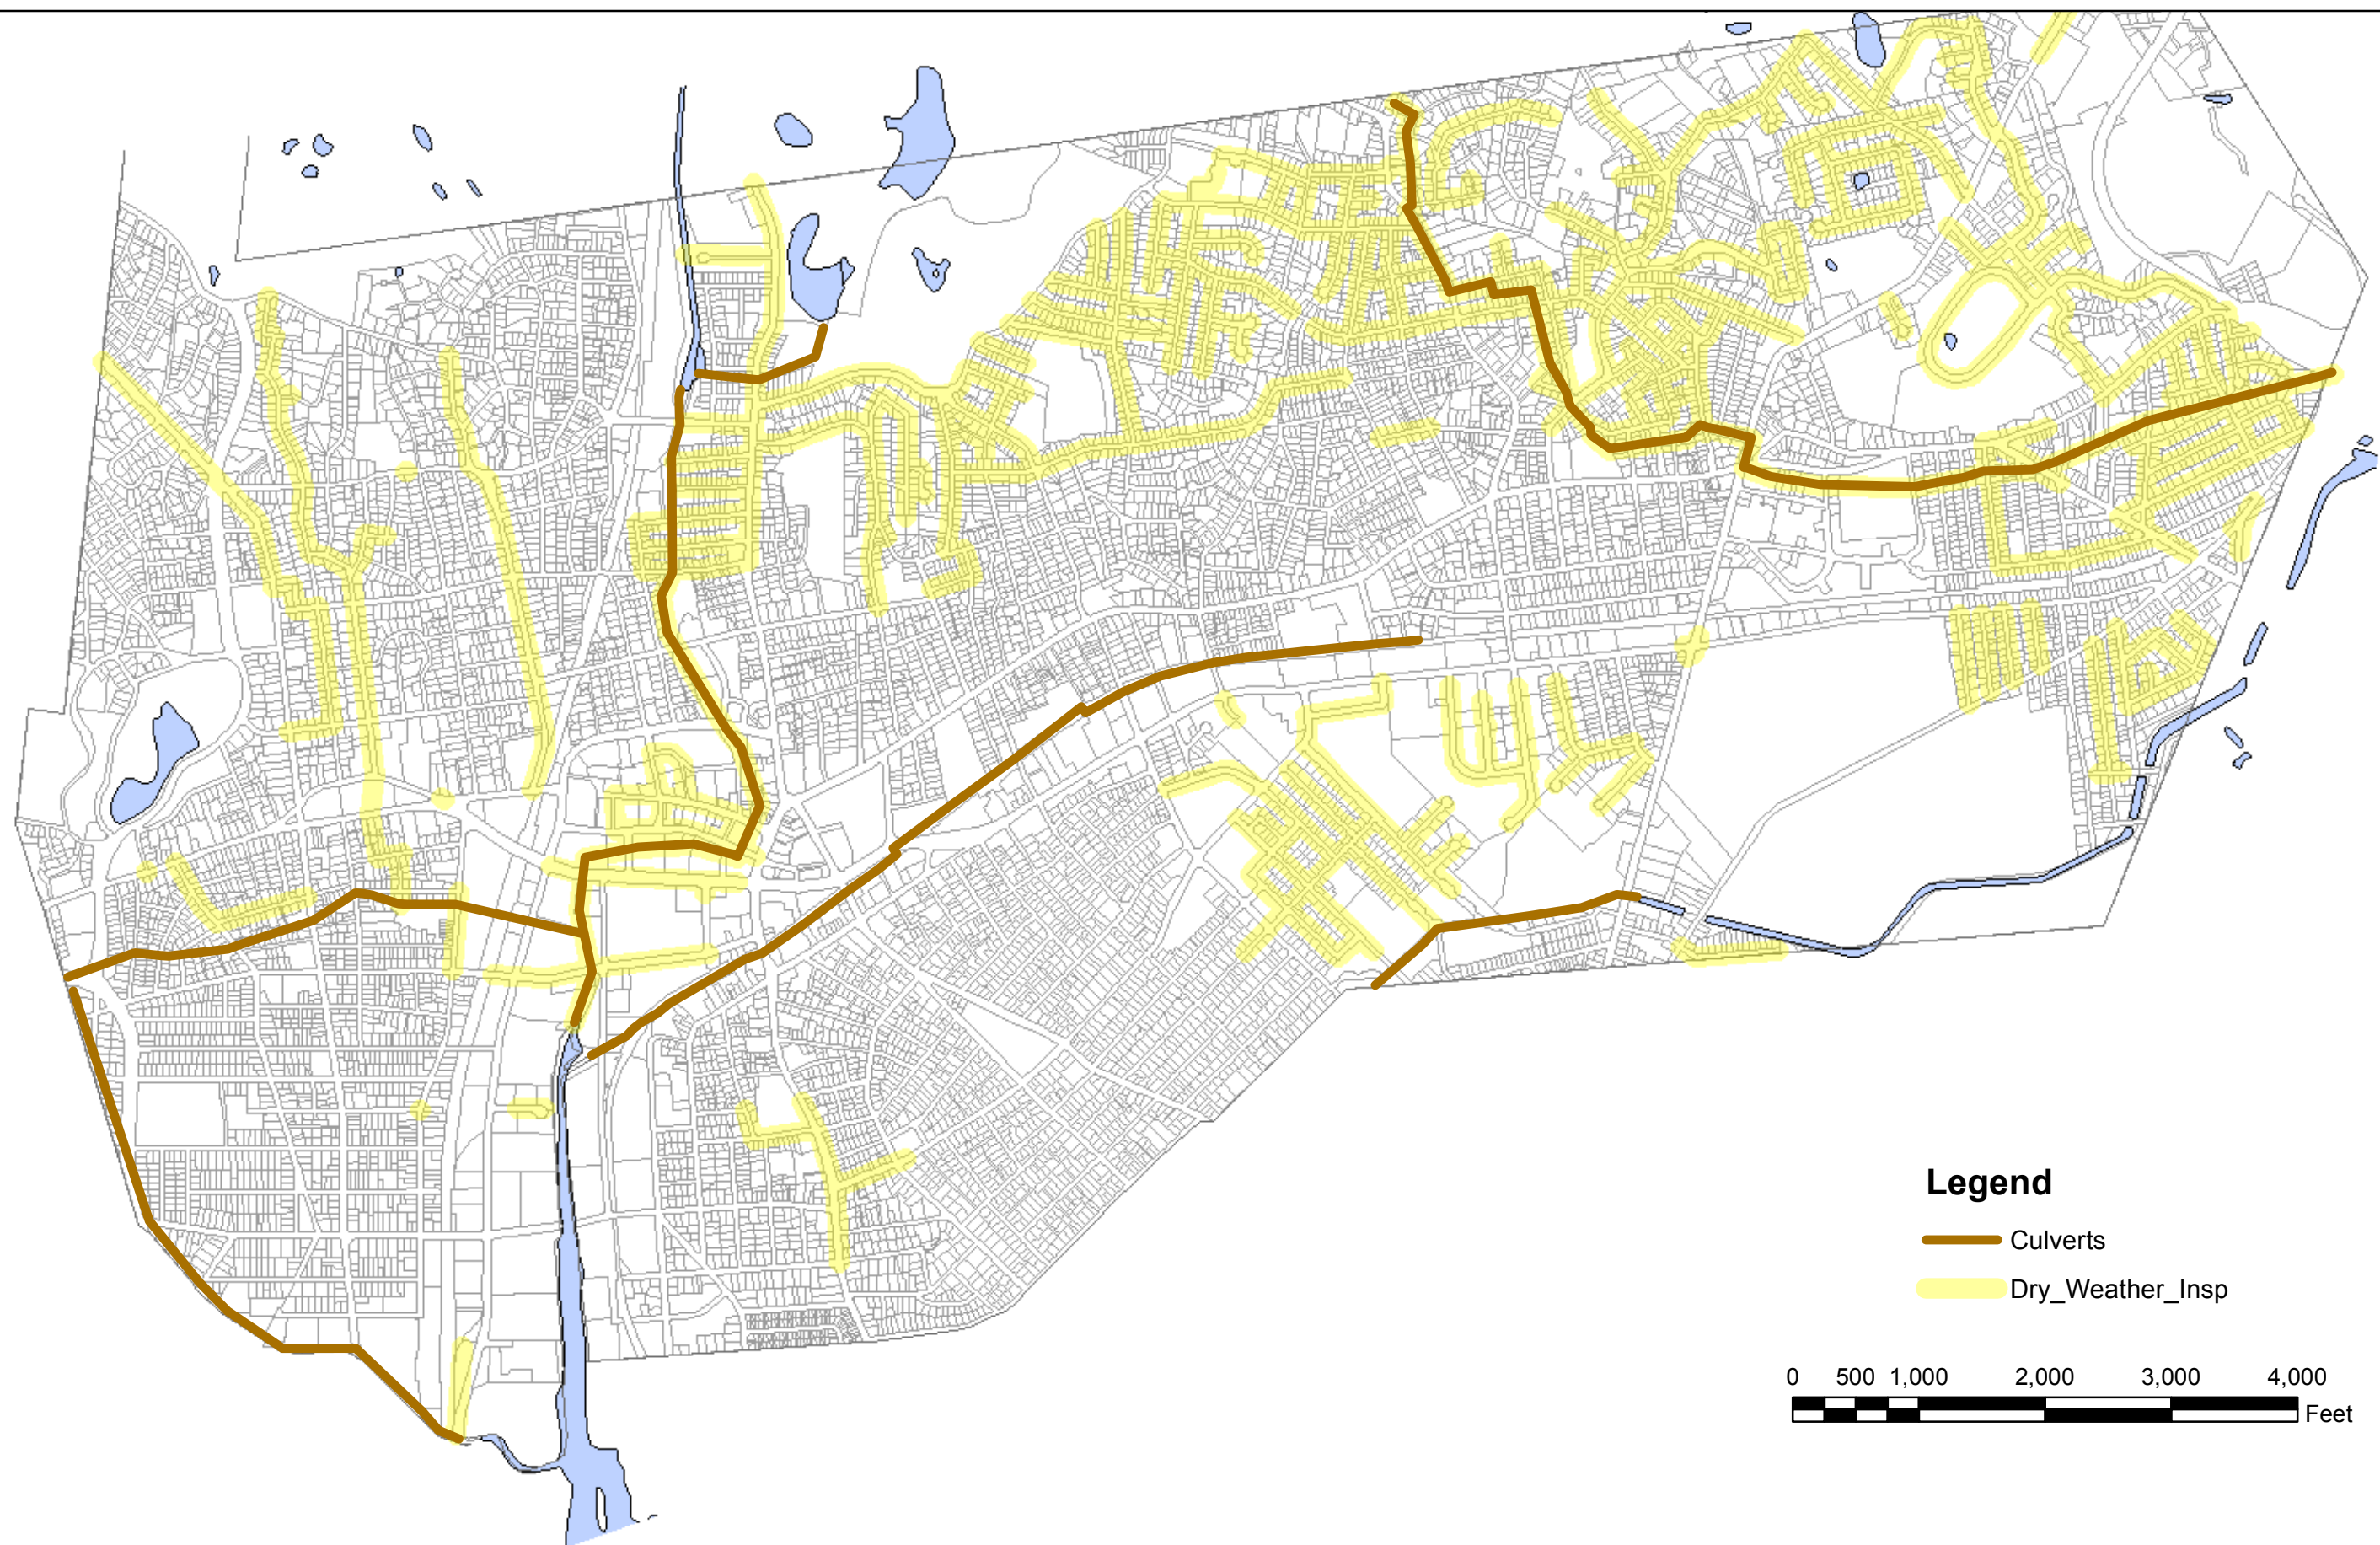
**Figure 2 - Dry Weather Inspection Areas (as of 12-31-15)**

A map depicting the approximate locations where targeted dry weather inspections have been conducted by NCA to date is presented as Figure 2. In addition, the drainage infrastructure is also inspected by the MDPW during the catch basin cleaning program. Upon the identification of previously unknown dry weather flows, the Engineering Department and NCA are immediately notified by MDPW personnel and targeted mass balance sampling efforts are performed. During dry weather inspections completed under the IDDE program, various dry weather flows have been identified. A summary of these flows within the municipal system that have been identified to date are shown on Table 2.0 and Figure 3. As stated previously, during this reporting period, dry weather investigations were performed within the Malden River watershed. Details pertaining to the sampling results may be referenced with Section 3.1.1.

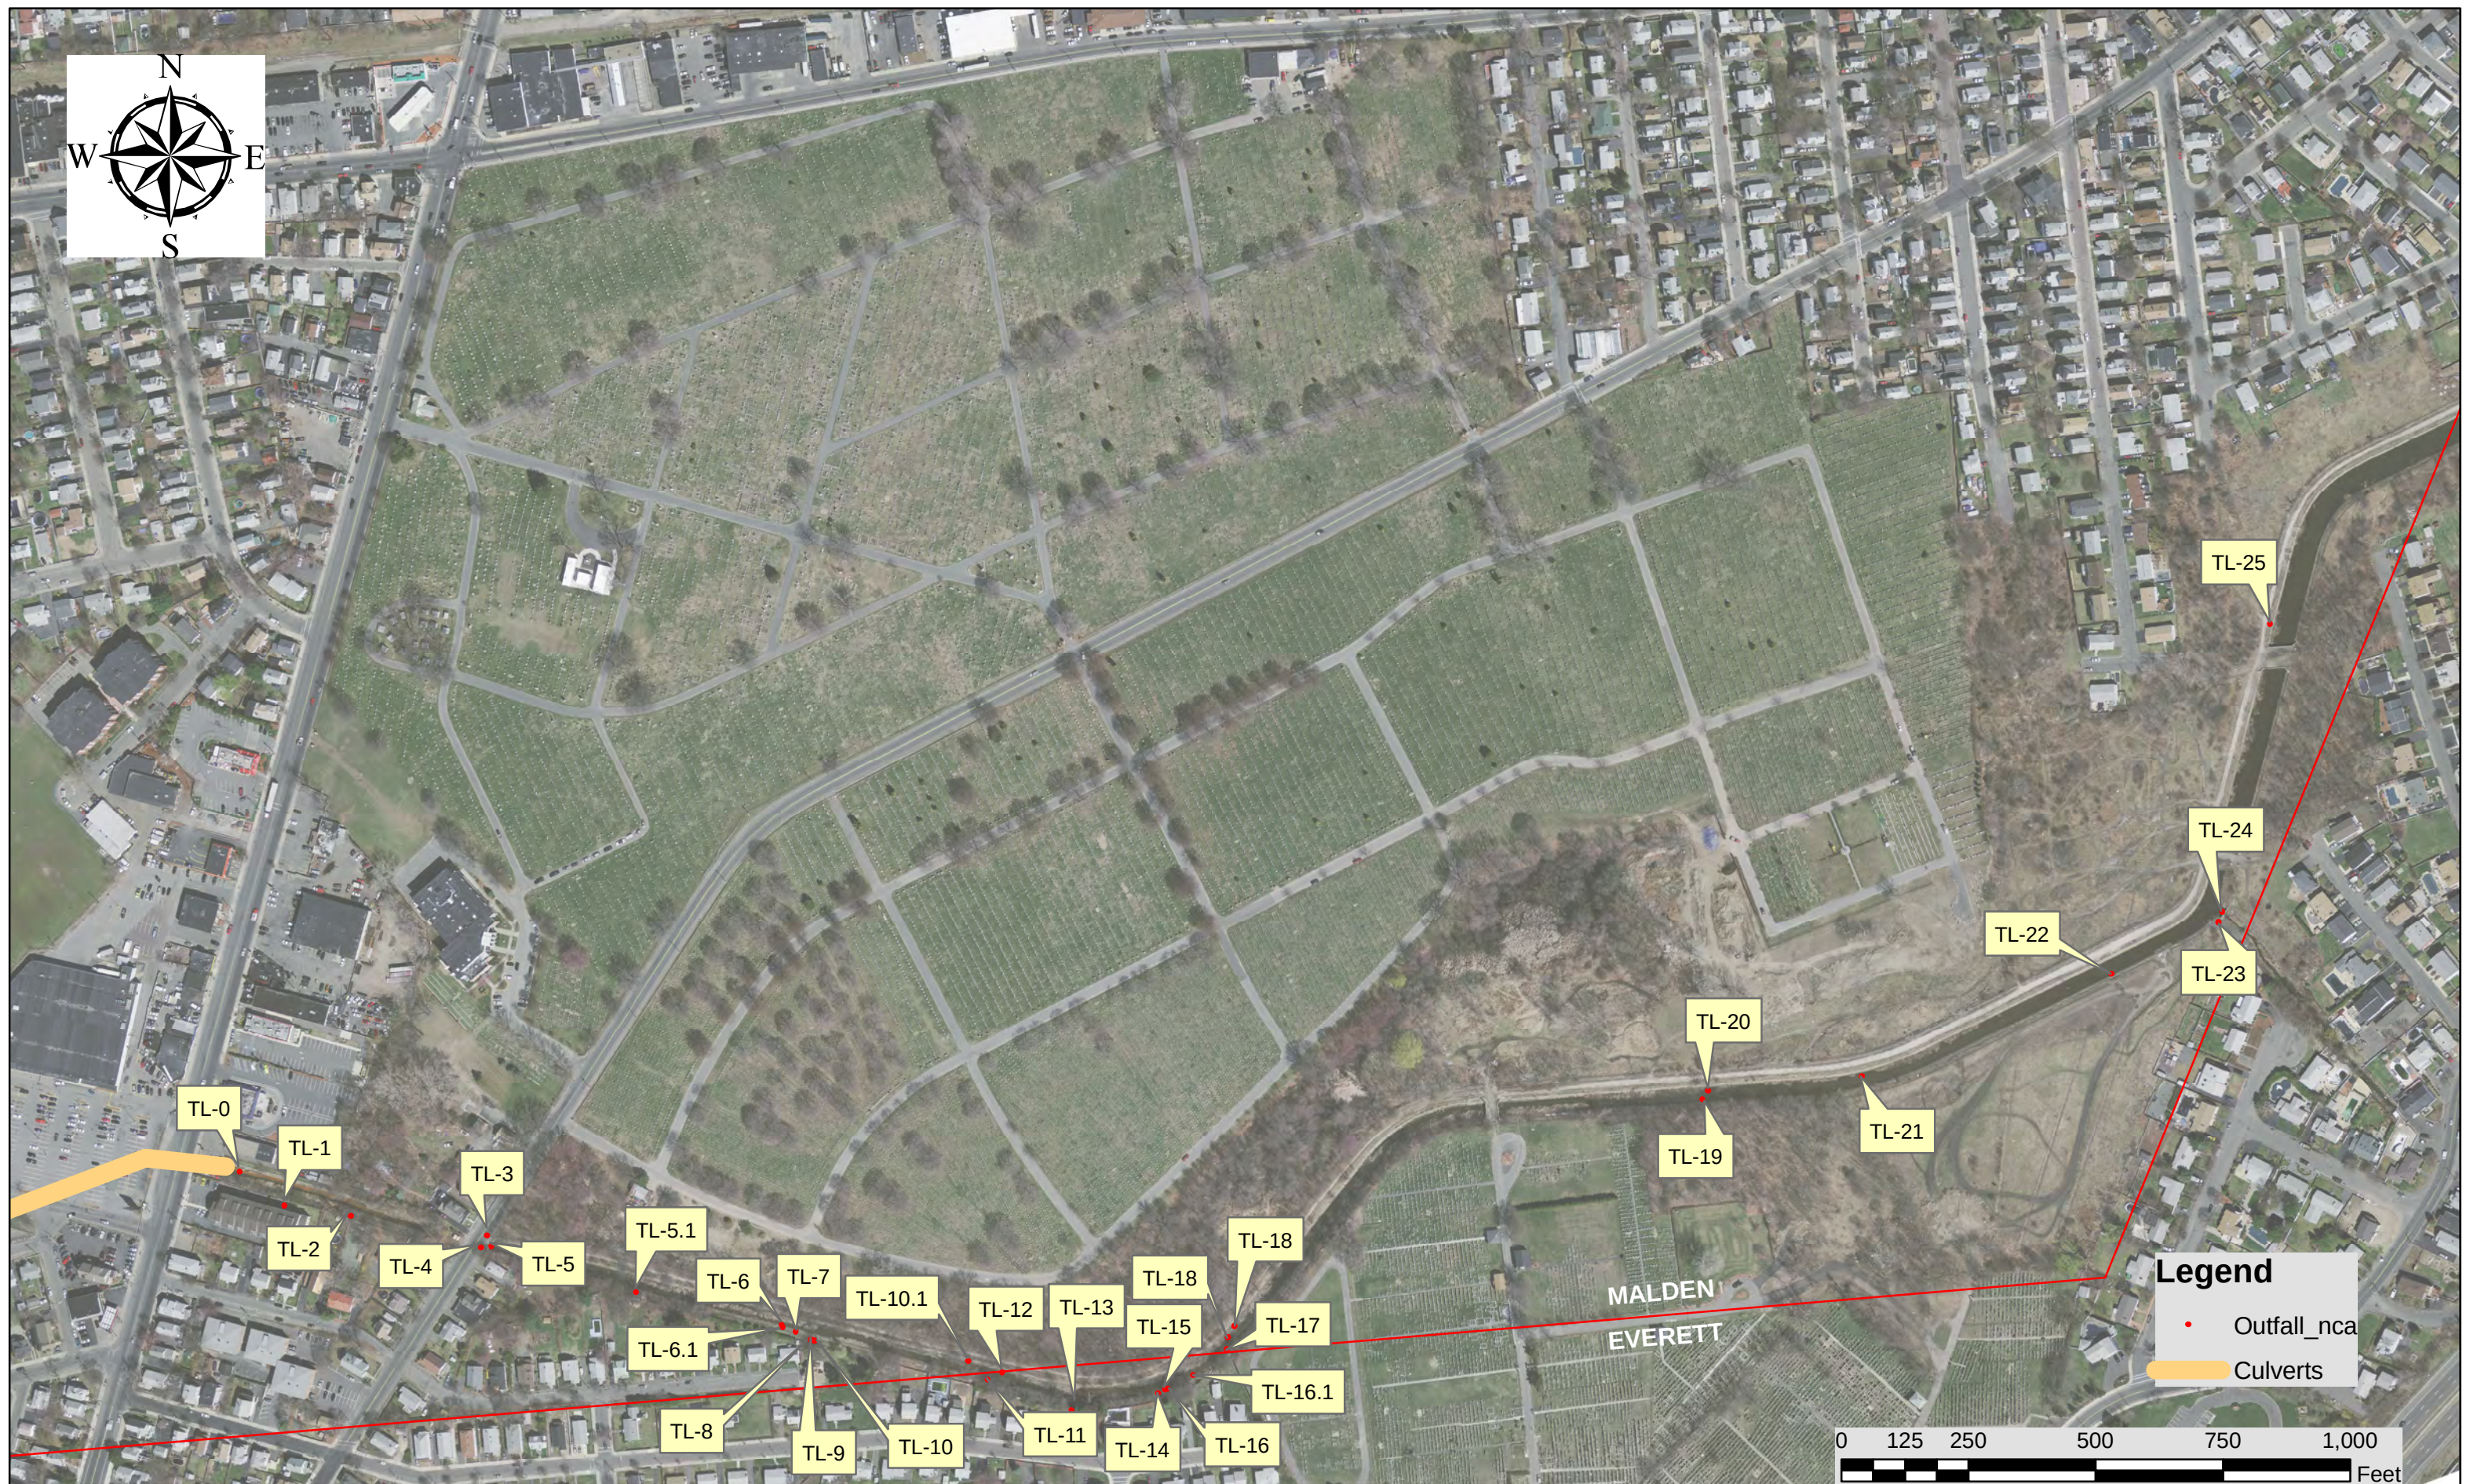
Figure 7 - Town Line Brook Outfalls

Town Line Brook in Malden begins at the Malden and Everett city boundary and is culverted until it daylights into an open concrete lined trapezoidal channel at Broadway. Significant tidal influences exist in the form of an approximate 2-3 foot change in surface water elevation between Broadway and the remaining length of the culvert to the Revere City line. As shown on Figure 7, a total of 29 outfalls to Town Line Brook in Malden have been identified. The historic monitoring data of Town Line Brook has revealed relatively uniform bacteria levels during dry weather sampling events. Several outfall locations have consistently exhibited bacteria loadings during dry weather sampling events, including S3-MH12, TL-0, TL-9 and Trifone Brook (TL-24). Manhole sample point S3-MH12 is the upstream sampling point for this section of the Brook as it enters the Malden system from Everett, while TL-0 is located at Broadway, where Town Line Brook daylights. TL-9 is located proximate to the terminus of Hadley Street in Malden and receives dry weather flows from the City of Everett, with Trifone Brook (TL-24), also flowing from Everett prior to discharging into Town Line Brook. Based upon the historic monitoring of these outfalls, it is apparent that contributions continue to enter the Malden system from upstream areas.

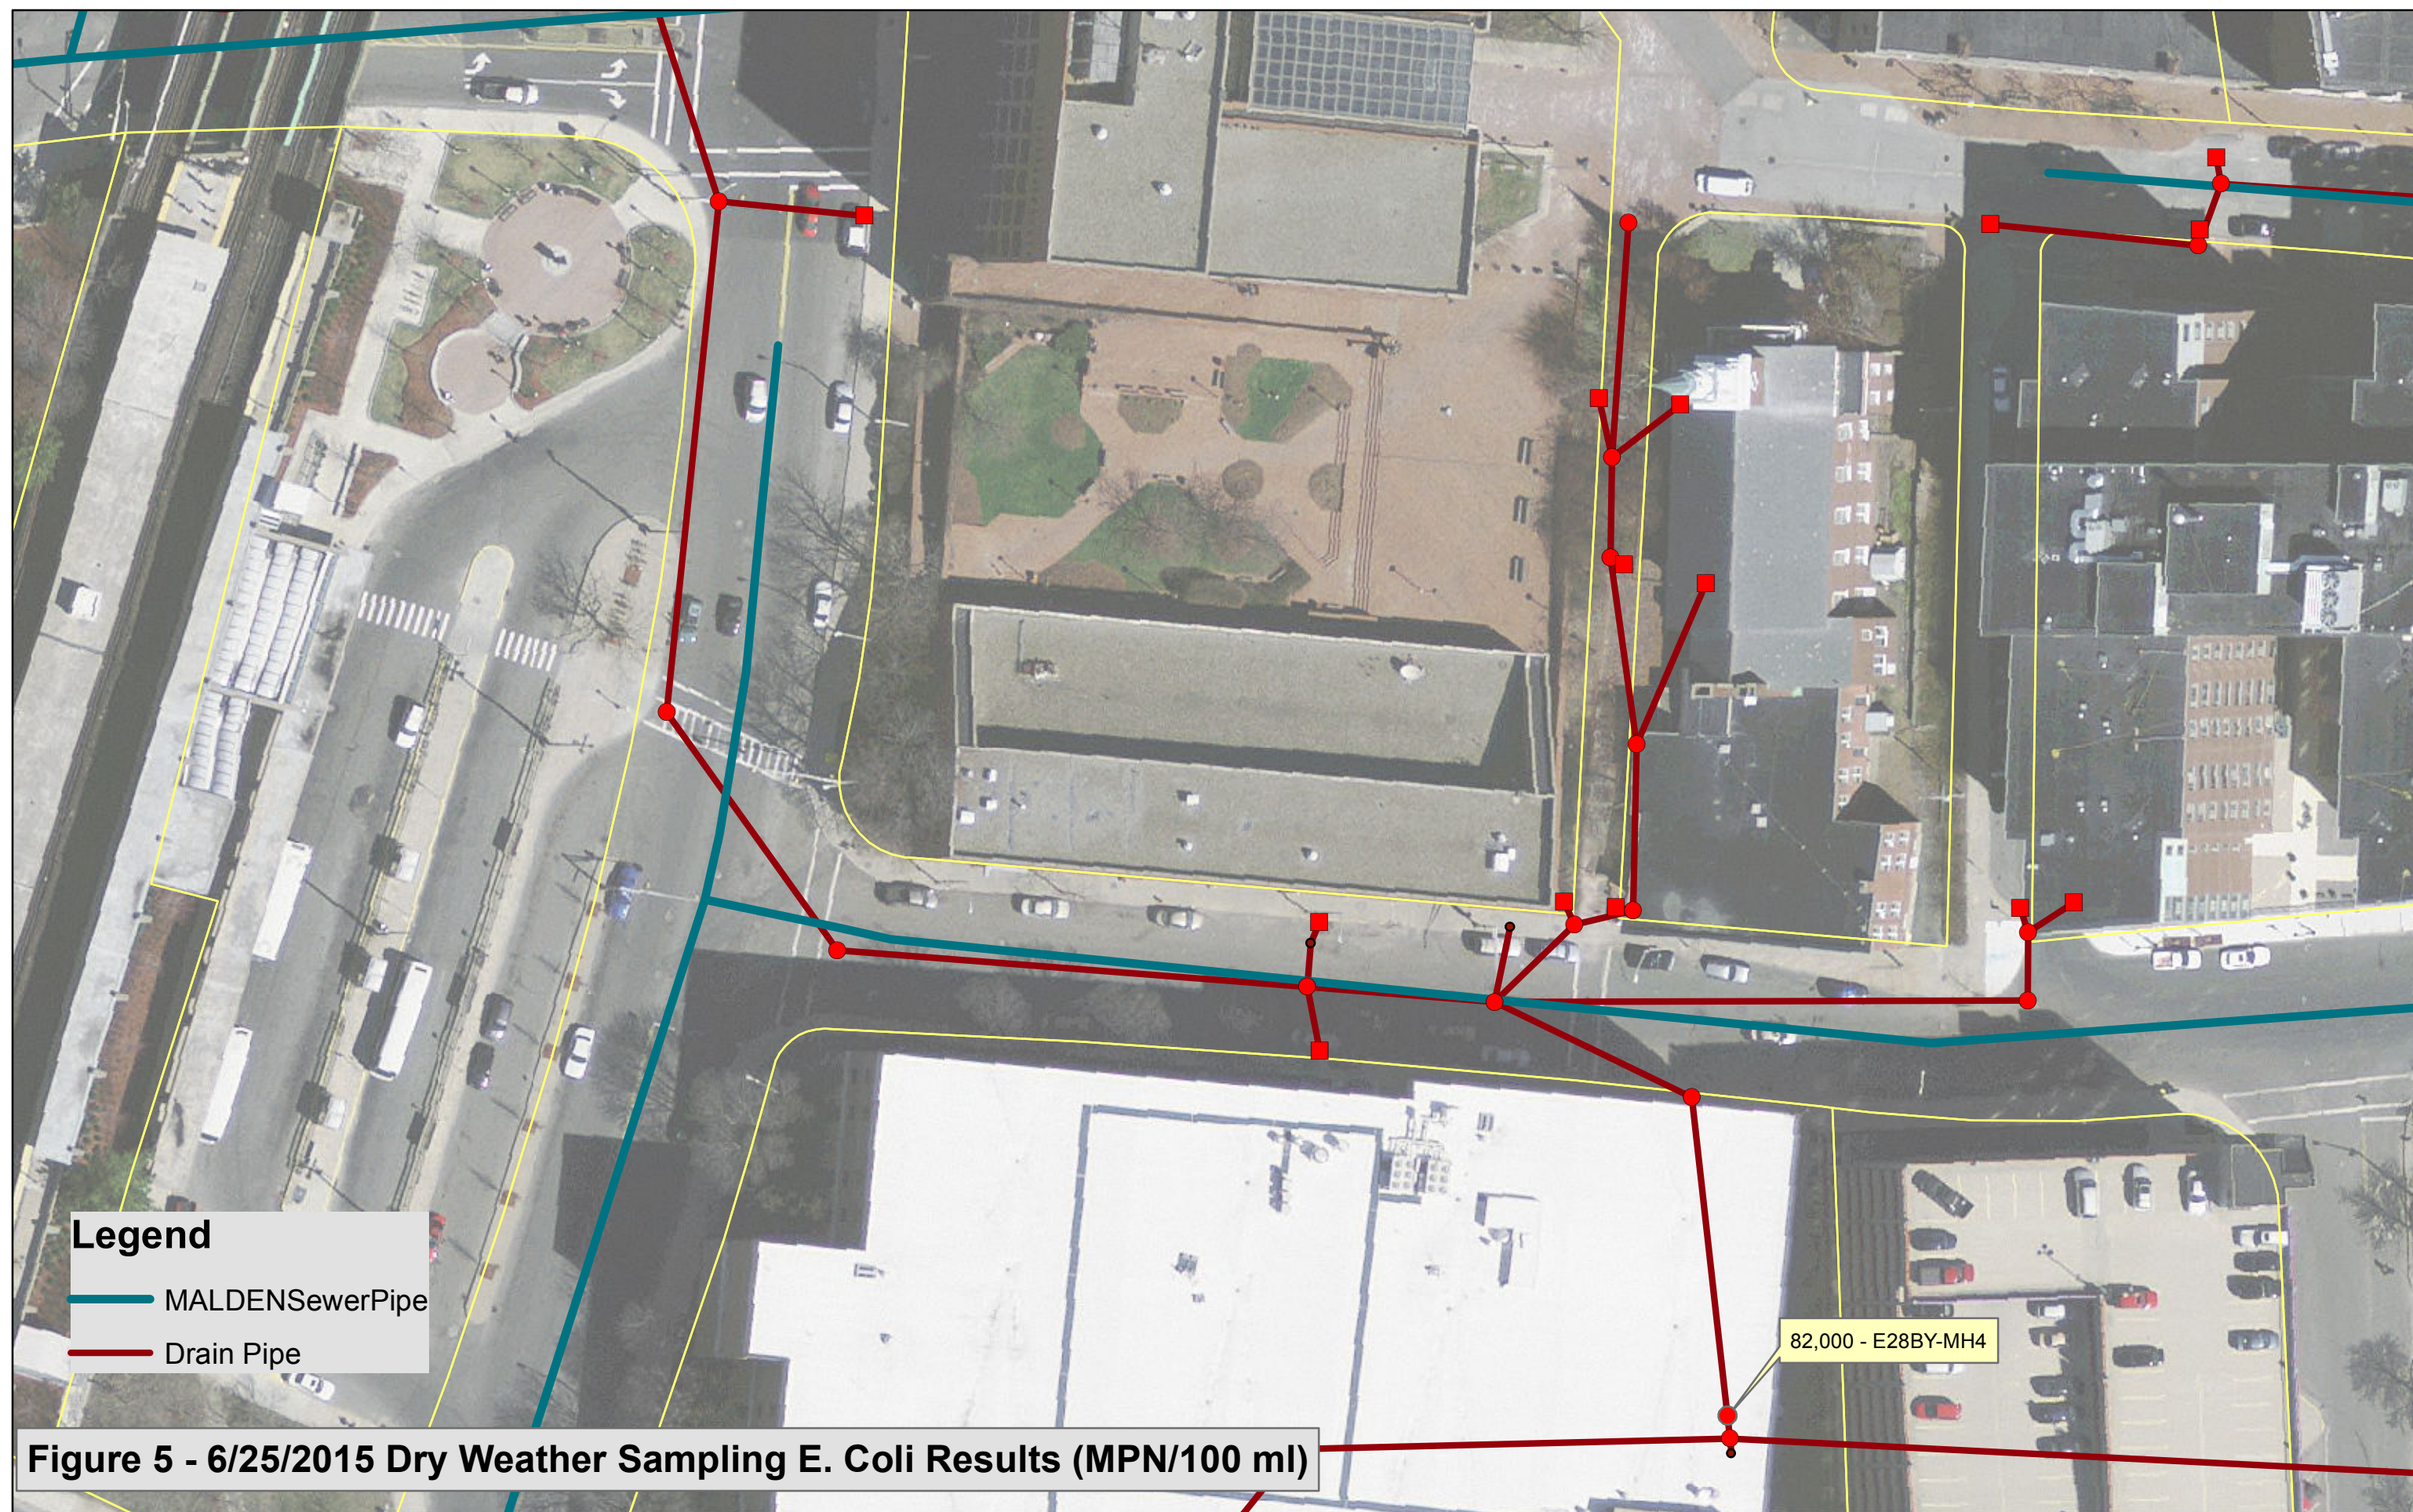
Figure 6 - Lower Spot Pond Brook Outfalls

The Stormwater Compliance Team has conducted numerous dry weather sampling events to investigate the elevated E. coli levels encountered previously at LSP-4, an outfall for the drainage system located within Eldrich Drive (Figure 6). Base flow, as groundwater, is consistently observed within this drainage network and to isolate potential sewage contributions to this base flow, a comprehensive evaluation of the flow conveyance network associated with LSP-4 was completed in February 2012. Given the proximity of the sewer and drain lines to LSP-4, as well as the settlement of the drain line in the area of Buildings 1054 and 1056 Elrich Drive, the focus of assessment activities was directed towards the sewer laterals and nearby drainage line servicing the two apartment buildings. Following dye testing by the Compliance Team, camera surveys performed by representatives of the property owner confirmed that compromises to the laterals servicing two (2) residential building had occurred. Recommendations made by the SCT involved restoring the integrity of the main drainage line to stop the discharges that have been documented at LSP-4.
